Keywords: carbon fiber foam sandwich structure ; Hashin failure criterion ; low-velocity impact ; impact damage ; finite element numerical simulation

Impact Damage Prediction of Carbon Fiber Foam Sandwich Structure Based on Hashin Failure Criterion

In this paper, the finite element equivalent model of low-velocity impact of carbon fiber foam sandwich panel was established based on Hashin failure criterion. The experimental results were compared with the finite element numerical simulation results to prove the effectiveness of the impact equivalent model. The impact damage of other carbon fiber foam sandwich panels with different ply structures was predicted. It provided theoretical basis and data support for the design of foam sandwich structure.

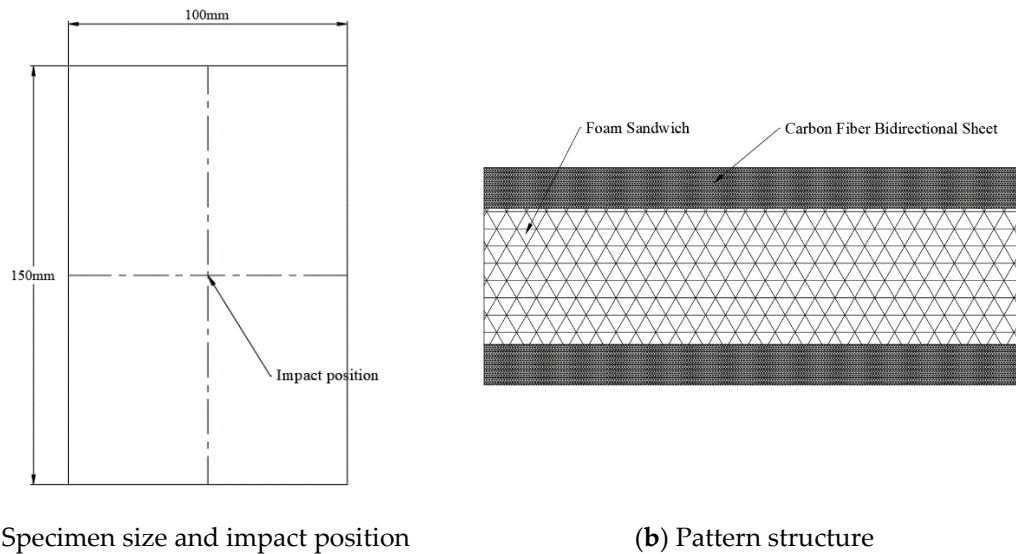
The structure of the specimen in this test was carbon fiber composite foam sandwich structure. Carbon fiber woven fabric grade W-3021FF and foam material grade H60. The specimen was processed by hand paste vacuum bag pressing process. The ply direction of carbon fiber reinforced fiber material was $[\pm 45^\circ/\pm 45^\circ/(\text{core})/\pm 45^\circ/\pm 45^\circ]$, and the thickness of foam sandwich foam was 4mm. The formed test pieces were cut into 150mm×100mm standard test pieces by water cutting machine, as was shown in Figure 1.

Figure 1. Schematic diagram of standard specimen dimensions and impact position.

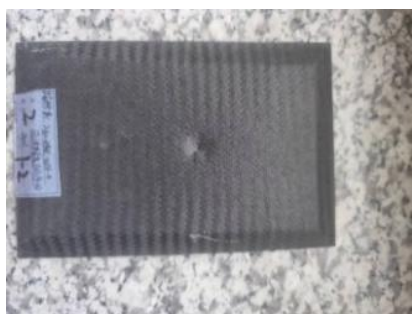
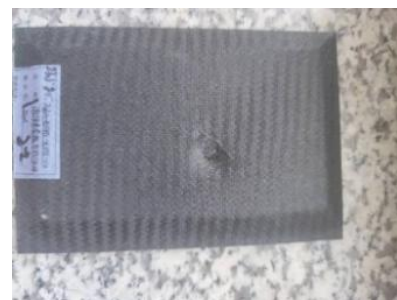
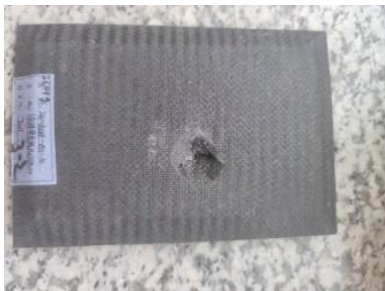
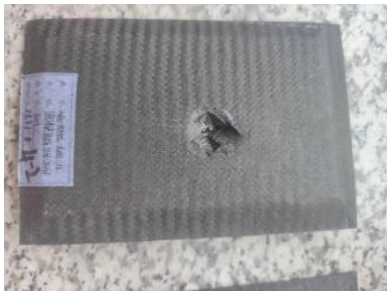
The impact damage of the specimen was shown in Figure 2. With the increase of impact energy, the surface damage of the specimen was increasing. The specimen was completely penetrated when the energy increases to 42.34J, and the foam crushed by the impact can be observed. The upper panel had X-shaped damage marks, and fiber cracks can be observed along the 45° direction at the impact location.

(a) Damage condition of specimen San-A01

(b) Damage condition of specimen San-A02

(c) Damage condition of specimen San-A03

(d) Damage condition of specimen San-A04

Figure 2. Typical diagram of impact damage at different energies.

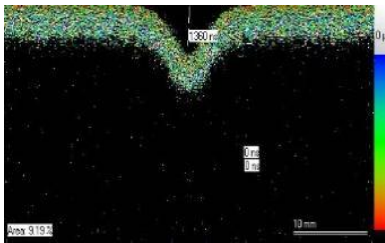
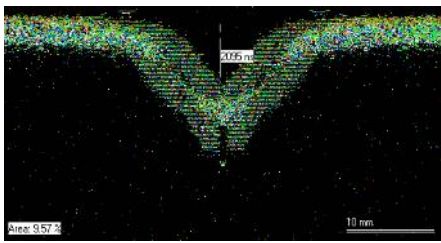
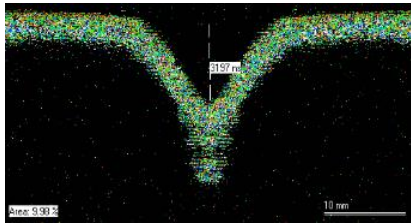
The damage characteristics of the specimen after impact obtained by microscope C-scan were shown in Figures 3 and 4. The variation of the depth and size of the impact damage area of each group of test specimens under different impact energy was the same. With the increase of impact energy, the depth and diameter of the impact damage area of the test specimen gradually increased.

(a) Damage condition of specimen San-A01

(b) Damage condition of specimen San-A02

(c) Damage condition of specimen San-A03

(d) Damage condition of specimen San-A04

Figure 3. Typical depth electron microscopy C-scan at different impact energies.

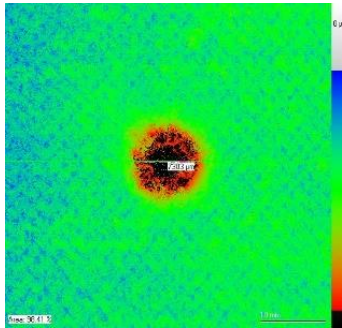
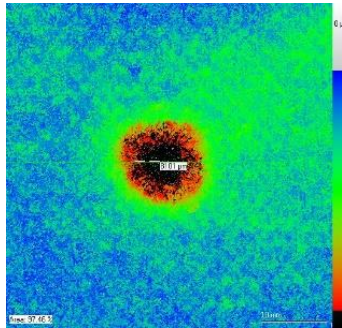
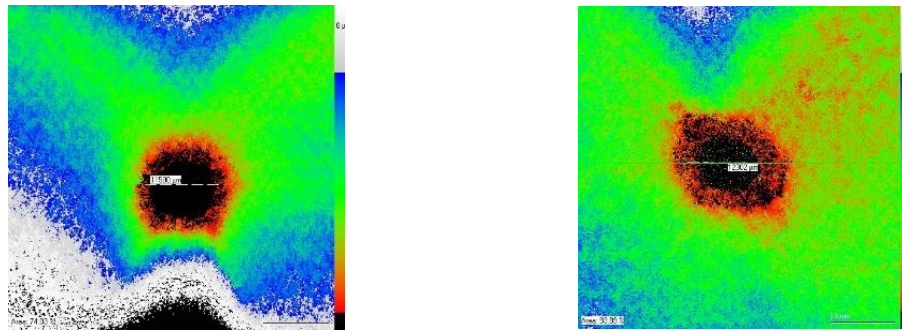
(a) Damage condition of specimen San-A01

(b) Damage condition of specimen San-A02

(c) Damage condition of specimen San-A03 (d) Damage condition of specimen San-A04

Figure 4. Typical electron microscope C-scan image of area damage at different impact energies.

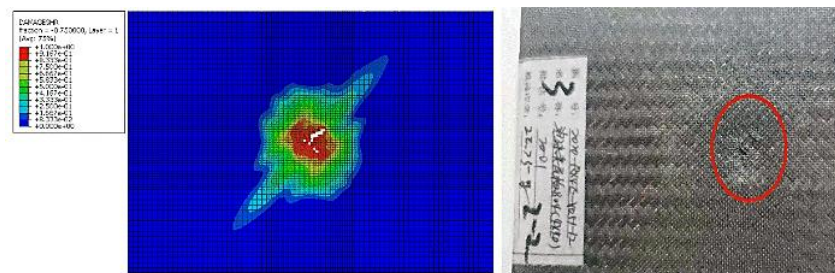
The simulation type was EXPLICIT display analysis. The upper and lower panels of the model used the universal continuous shell element SC8R in the 8-node quadrilateral plane to simulate the carbon fiber panel, to effectively reduce the hourglass integration. The foam core material was defined as isotropic material, and the eight-node hexahedron C3D8R solid element of linear reduced integral element was used for modeling. The impact head was set as a rigid body, the elastic modulus was 210 GPa, the Poisson's ratio was 0.3, the mass was set to 5.5kg by adjusting the density, and the unit type was C3D8R solid unit. The impact height of the drop hammer was equivalently replaced by the dynamic formula. The initial velocity of the punch was 2.775m/s, which corresponds to the corresponding impact energy of 21.17J, and the corresponding test specimen number was San-A02. The finite element numerical simulation results of the San-A02 specimen were compared with the damage of the upper panel of the impact test. As shown in Figure 5, the damage shapes of both were nearly X-shaped, and the fibers were broken along the punch to the periphery. The damage can be obviously seen in upper panel, and the damage areas of both are consistent.

Figure 5. Diagram of damage comparison of the upper panel of the specimen of San-A02.

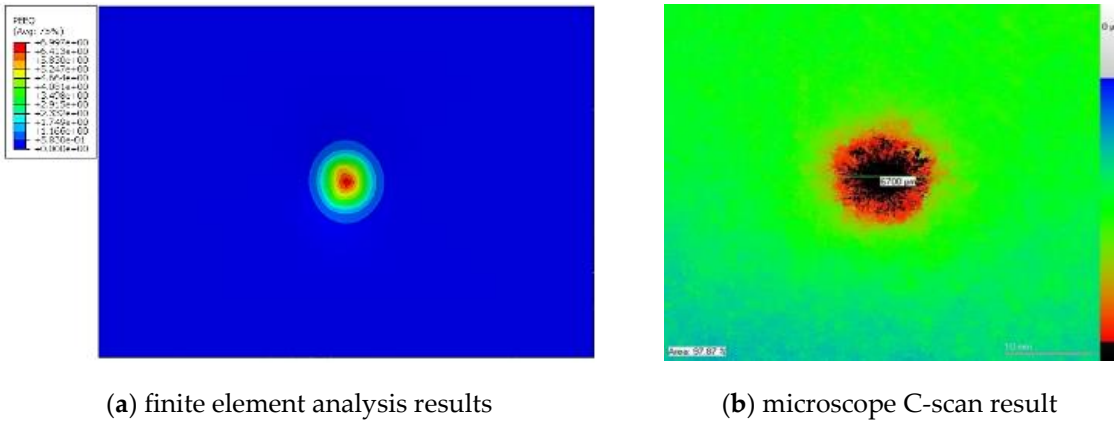
Considering the elastic properties of the foam, the impact force on the panel was taken as the target for analysis, and the deformation of the overall model when the impact force changes from low to high and then to zero was taken as the target to reflect the real damage. The comparison between the damage area of finite element simulation and the C-scan was shown in Figure 6. The direct contact position of the punch was the damage position. The upper panel of carbon fiber composite was directly impacted in the finite element numerical simulation, and the panel damage was only in the local area near the impact position. The comparison between the test values and the predicted values of finite element model simulation of San-A01~04 was shown in Table 2. The test and simulation had good consistency since the error between the test values and the predicted values was less than 10%, and it proved that the composite sandwich plate model and the compressible foam model theory used in this paper can effectively simulate the damage process of carbon fiber composite foam plate under low-speed impact.

Figure 6. Typical diagram of damage area comparison of the specimen of San-A02.

The damage depth and surface damage diameter measured by microscope C-scan were compared with the result of finite element numerical simulation to verify the effectiveness of the model in forecasting the low-velocity impact response and impact loss of carbon fiber composite foam sandwich panels. The finite element simulation process started as the punch contacts the panel, and the speed dropped to zero and then to the sandwich panel rebound punch until the specimen was stable.
