Analyzing Traditional Building Materials: A Case Study on Repair Practices in Konuralp, Düzce-Türkiye

¹ Faculty of Art, Design and Architecture, Düzce University, 81600 Düzce, Türkiye

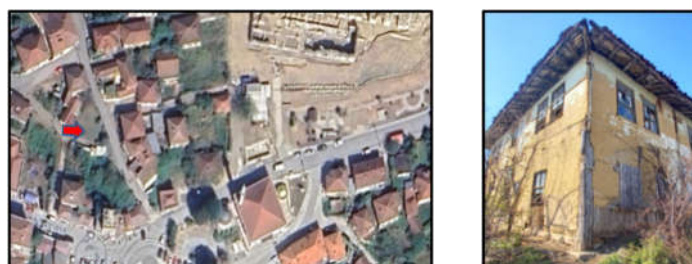
The Konuralp Central Mosque is located to the southeast of the building, and the Prusias ad Hypium Ancient Theater is located to the northeast. The house, consisting of two floors, the ground floor and the first floor, was built with a wooden roof system, and wood was used as the filling material. Adobe was used as the filling mortar between the timbers. Paint was applied over mud plaster on the interior and exterior walls. A general view and a bird's eye view of the building and its site plan are given in Figure 2.

Figure 2. A general view and a bird's eye view of the building.

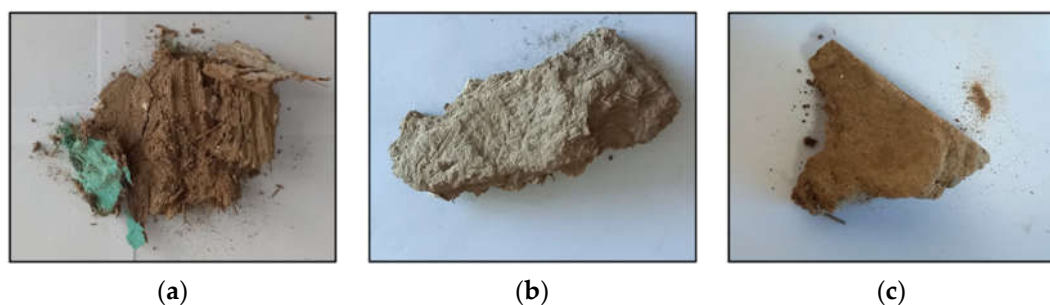
The general structure of the building consists of wooden filling between wooden frames. Filling mortar was used as the binder in the parts built with filling wood. Filling mortar between timbers was taken from the eastern façade of the building, exterior plaster from the northern façade, and interior plaster from the interior. The samples taken are shown in Figure 3.

Figure 3. Mortar and plaster samples of building number 1766: (a) interior plaster number H5, (b) exterior plaster number H6, and (c) filling mortar number H7.

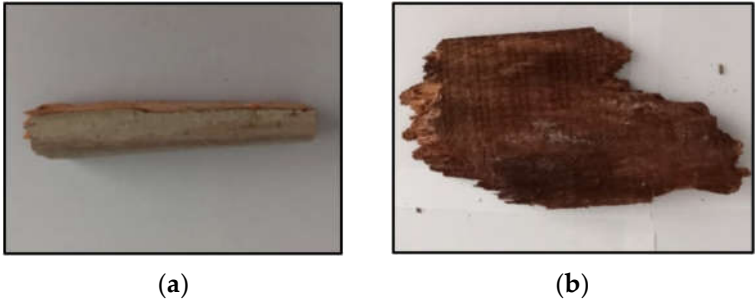
In traditional Turkish houses, there are often areas called loaders/built-in wardrobes next to the stoves, which are usually located in the rooms. These built-in wardrobes were included in planning during construction. Samples were taken from the building to determine the type of wood used in the wardrobe of one of the rooms. The stone base of the building is not high enough, which caused the floor covering to be built too close to the ground, and in some places, the floor coverings have collapsed and rotted. A floor covering sample was taken from one room of the building to determine its type. The wood samples are shown in Figure 4.

Figure 4. Images of wood samples: (a) cabinet joinery and (b) floor covering.

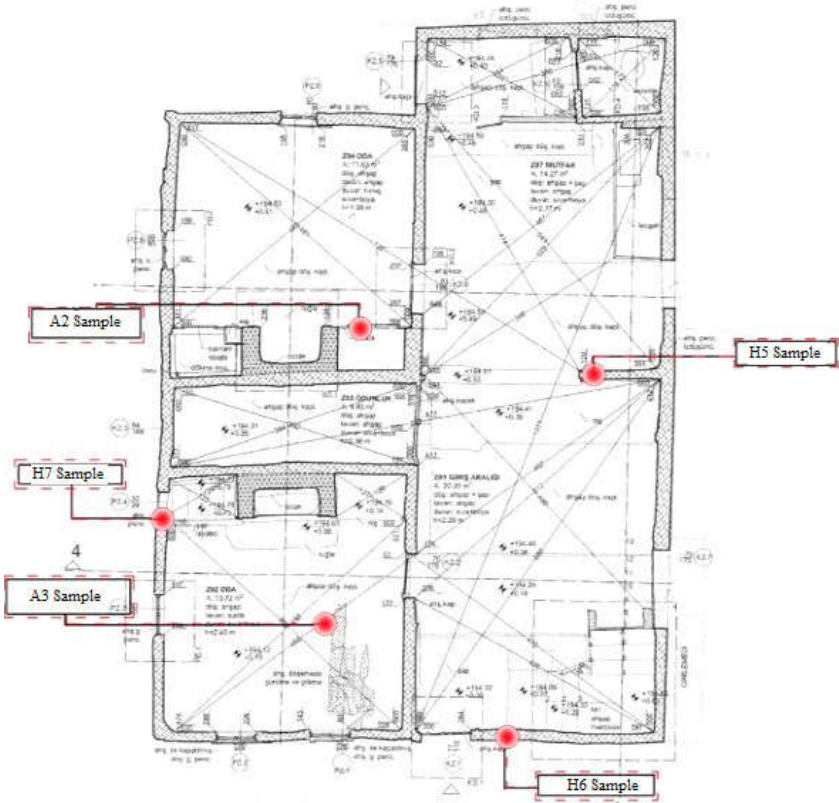
In order to proceed systematically during the sample collection and to record the locations of the samples taken, survey drawings of the building obtained from the Düzce Municipality [13] were used. Figure 5 shows the ground floor sampling sheets.

Figure 5. Plot 1766, ground floor sampling numbers on the blueprint.

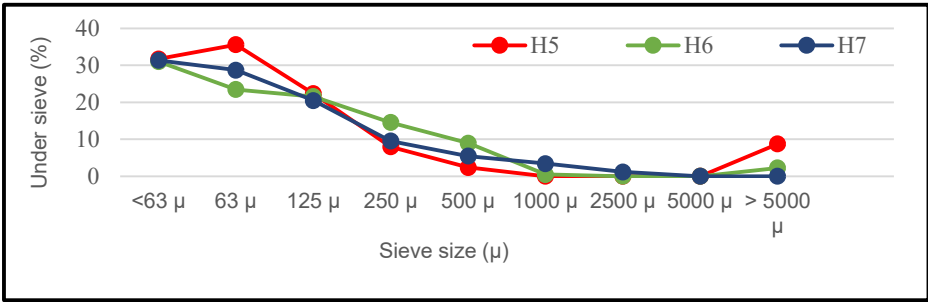
Ignition loss, acid loss, sieve analysis after acid loss, salt tests, and protein-oil tests were performed on mortar and plaster samples taken from both buildings. The ignition and acid loss results are given in Tables 2 and 3, respectively, and the sieve analysis results are presented in Figure 6.

Figure 6. Grain size distribution of aggregates.

When the acid loss and sieve analysis results were analyzed, the binder–aggregate ratios of samples H5 and H7 belonging to the building numbered 1766 were determined to be 1:6–7; the ratio of sample H6 was 1:5.

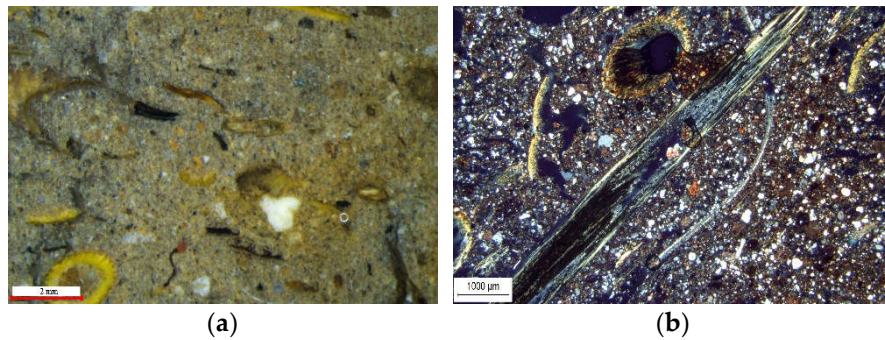
Sample H5, taken from the ground floor interior partition wall of the building numbered 1766, was a brown-colored, weak plaster sample with abundant fibers, and its binder was determined to be 5–10% hydrated lime-reinforced abundant clay soil. Approximately 3–5% of the sample aggregates were ash, 3–5% were carbonated rock fragments, and all the remaining aggregates were abundant clay soil formed by the decomposition of potassium-based feldspars. The minerals were mainly quartz, feldspar, and small amounts of mica and amphibole. It was determined that 8–10 kg of fiber was used per cubic meter of mortar. Stereomicroscope and polarizing microscope images of the sample are shown in Figure 7.

Figure 7. (a) Stereomicroscope and (b) polarizing microscope images of sample H5.

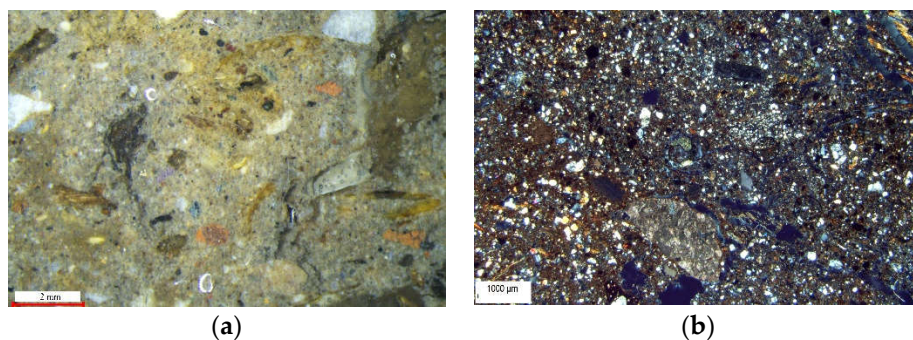
Sample H6, taken from the ground floor east façade of the building numbered 1766, was a brown-colored, weakly structured exterior plaster sample with abundant fibers and white masses, and its binder was determined to be 15–20% hydrated lime-reinforced abundant clay soil. Approximately 3–5% of the sample aggregates were ash, 3–5% were limestone and marble fragments, and 1–2% were brick crumb particles in the mortar content as impurities, and all the remaining aggregates were abundant clay soil of terrestrial origin formed as a result of the decomposition of potassium-based feldspars. The minerals were mainly quartz, feldspar, and a small amount of mica. It was determined that 2–2.5 kg of fiber was used per cubic meter of mortar. Stereomicroscope and polarizing microscope images of the sample are shown in Figure 8.

Figure 8. (a) Stereomicroscope and (b) polarizing microscope images of sample H6.

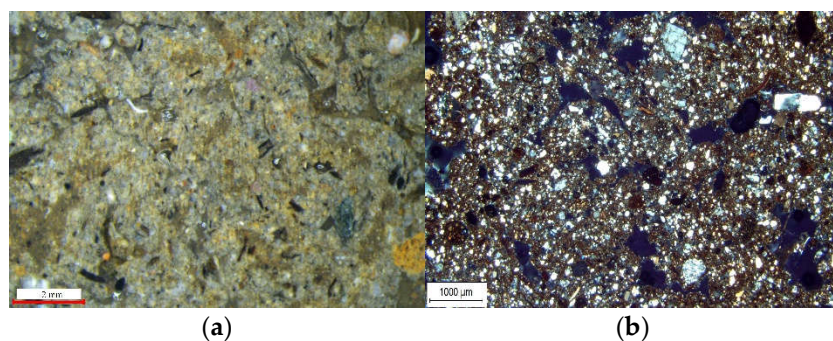
Sample H7, taken from the ground floor south façade of the building numbered 1766, was a brown-colored, dispersed mortar sample containing sand aggregates, white masses and a small number of fibers, and its binder was determined to be 10–15% hydrated lime-reinforced abundant clay soil. Approximately 5–8% of the sample aggregates were ash, 2–3% were carbonated rock particles, and the remaining aggregates were all terrestrial abundant clay soil formed as a result of the decomposition of potassium-based feldspars. The minerals were mainly quartz, feldspar, and a small amount of amphibole. Fiber fragments were detected in the sample. Stereomicroscope and polarizing microscope images of the sample are given in Figure 9.

Figure 9. (a) Stereomicroscope and (b) polarizing microscope images of sample H7.

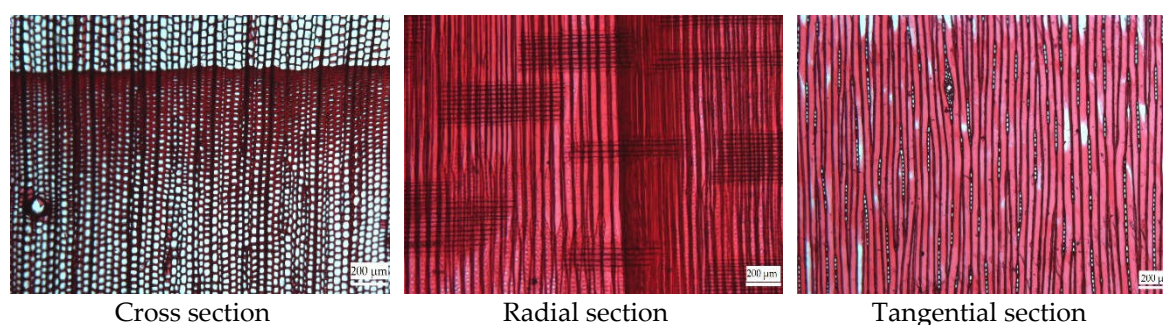
The cross-sectional properties of sample A2, a fungal-damaged wood sample with a white paint layer from the cabinet part of building numbered 1766, were examined (Figure 11). It was observed that the annual ring boundaries were clear, the transition from spring wood to summer wood was rapid, and resin channels were present in its structure. In the radial section characteristics, it was observed that the marginal passages on the radial walls of the longitudinal tracheids were single-row, the medullary rays were heterogeneous, and the tracheid cell walls were coarsely toothed. It was also observed that the meeting place passages were of a large window type. In the tangential section characteristics, it was determined that the medullary rays were mostly 1–12 cells high. As a result of the macroscopic and microscopic examinations, the genus of the A2 sample taken from the cabinet joinery was determined to be yellow pine (*Pinus sylvestris* L.).

Figure 11. Thin section images of A2 sample.

The wood species of the floor covering and cabinet joinery samples from the building numbered 1766 were determined to be yellow pine (*Pinus sylvestris* L.). It is predicted that the same type of wood can be used as a wood species specific to the region during the repair phase.

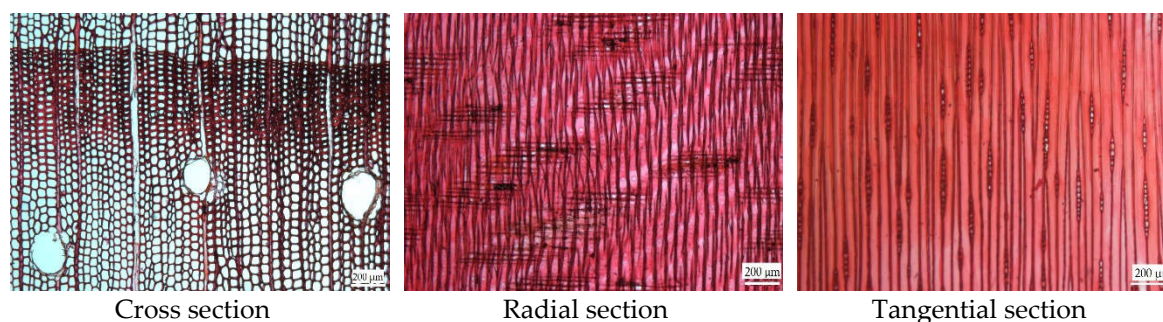
The cross-sectional properties of sample A3, a wood sample taken from the floor covering of building 1766, which has no paint layer and has been damaged by fungus and insects, were examined (Figure 12). It was observed that the annual ring boundaries were clear, the transition from spring wood to summer wood was rapid, and resin channels were present in its structure. In the radial section characteristics, it was observed that the marginal passages on the radial walls of the longitudinal tracheid cells were single-row, the medullary rays were heterogeneous, and the walls of the tracheids were coarsely toothed. It was also observed that the meeting place passages were of a large window type. In the tangential section characteristics, it was determined that the medullary rays were mostly 1–12 cells high. As a result of macroscopic and microscopic examinations, the species of the A3 sample taken from the pavement was determined to be yellow pine (*Pinus sylvestris* L.).

Figure 12. Thin section images of A3 sample.
