Comparison of Damages Occurring on the Bonding Surface of Carbon and Glass Fiber Reinforced Polymer Composite Materials Used in Wind Turbine Blades and Marine Vessels in Terms of Three-Point Bending and Four-Point Bending Tests

Keywords: Adhesive Bonding; Composite Materials; Diffusion; Four Point Bending Test; Three Point Bending Test

In this study, single lap bonded specimens made from seven layer glass fiber reinforced polymer (GFRP) and eight-layer carbon fiber-reinforced polymer (CFRP) composite materials were immersed under controlled conditions in seawater obtained from the Aegean Sea, characterized by a temperature of 22 °C and salinity levels between 3.3–3.7%. To evaluate the mechanical strength of the samples, three-point bending tests were performed on composites used in marine environments, while four-point bending tests were conducted on composites applied in offshore wind turbine structures. After testing, microstructural damages and deformations in the interfacial regions of the materials were examined in detail using a high-resolution scanning electron microscope (SEM). The comparative analysis of the results enabled the identification of the initiation stages of

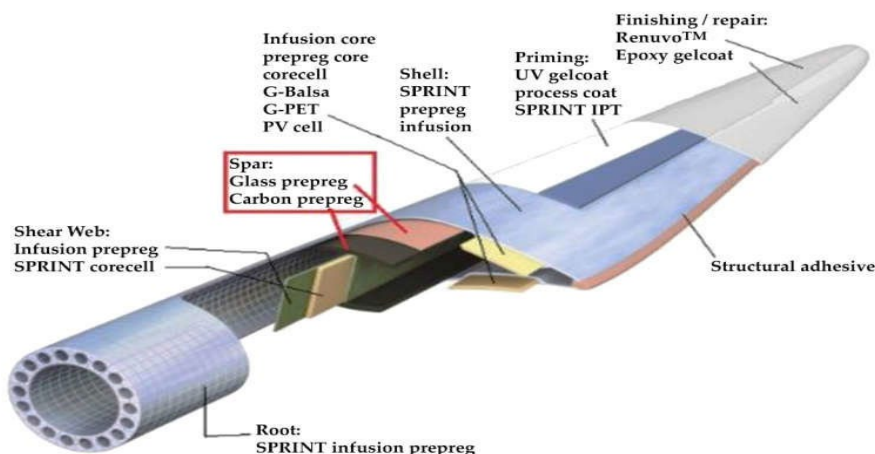
Figure 1. Material types according to structural components of wind turbine blade [25].

regions, GFRP distributes the stresses generated by aerodynamic loads uniformly, maintaining the overall structural stability of the blade. In contrast, since the root and spar (main beam) sections of the blade require higher stiffness and bending strength, CFRP reinforcements are commonly employed. CFRP materials, with their high elastic modulus and fatigue resistance, contribute to reducing the overall weight of long blades and improving their vibration performance [23,24].

Figure 1 illustrates the types of materials preferred in different structural regions of a wind turbine blade.

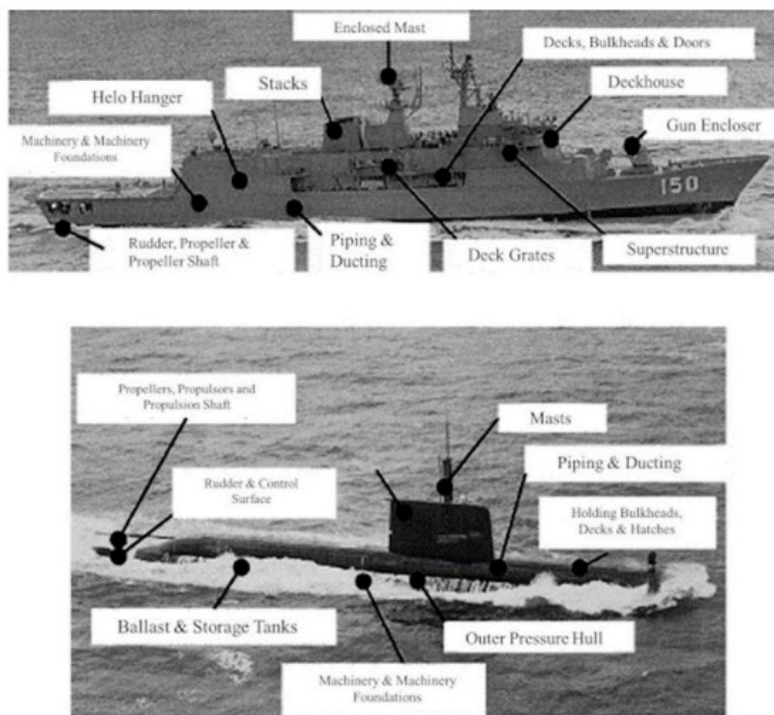
Figure 2. Applications of composite materials used in marine vessels [27].

Hybrid lamination strategies are increasingly being used in modern wing designs. In this approach, GFRP and CFRP layers are used together to achieve a balance between cost-effectiveness and mechanical performance. CFRP is used in high-load-bearing layers, particularly in spar skins or spar-cover transition areas, while GFRP is preferred for external surfaces. This helps control material costs and extends the fatigue life of the structure [26]. In marine vessels, the use of composite materials has become widespread for reasons such as reducing structural weight, increasing corrosion resistance, and reducing maintenance costs. GFRP has become the standard material in the production of small and medium-sized vessels (yachts, boats, submarine hulls, etc.). Due to its ease of production, low cost, and high resistance to seawater, it is frequently used in hull panels, deck skins, and interior structural elements [21]. Figure 2 shows the main applications of composite materials in marine vessels.

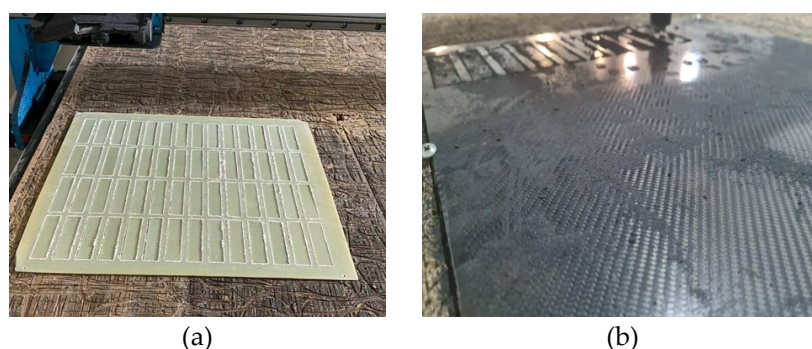
Figure 3. Machining of GFRP and CFRP Samples by CNC Router.

Prepreg production was performed with a drum-type machine, and the fiber-reinforced sheets were manufactured by Fibermak Engineering Company, located in İzmir, Turkey. The composite laminates were cut into 500 mm × 500 mm sheets using CNC machining, and the final laminate thickness was set to 2 mm (Figure 3). The mechanical properties of the laminates were determined as follows: tensile strength 80 MPa, tensile modulus 3300 MPa, flexural strength 125 MPa, and flexural modulus 3200 MPa.

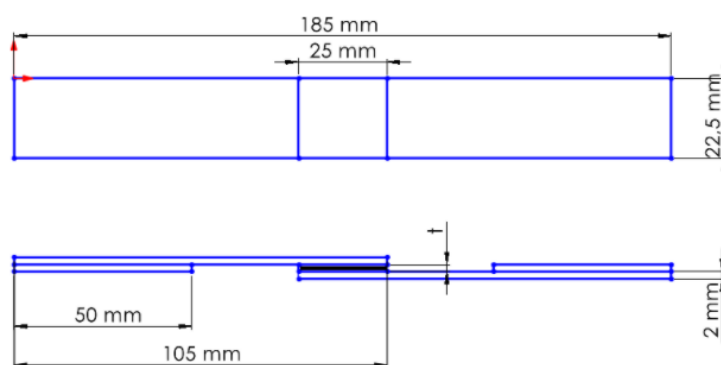
Figure 4. Schematic Representation of GFRP and CFRP single lap configurations.

GFRP and CFRP specimens were then cut to the required dimensions in accordance with the ASTM D5868–01 standard [30] (Figure 4). Afterwards, 25 mm from the ends of the specimens were measured and marked (Figure 5).

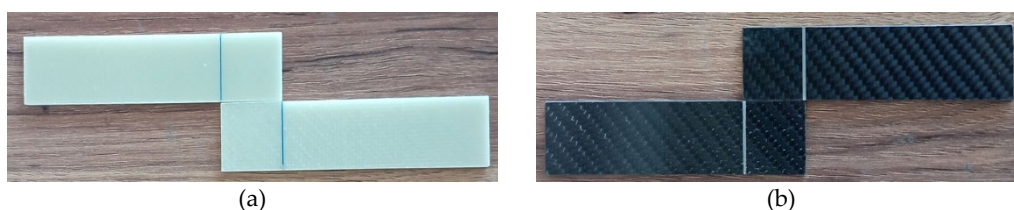
Figure 5. Marking of GFRP and CFRP single lap configurations.

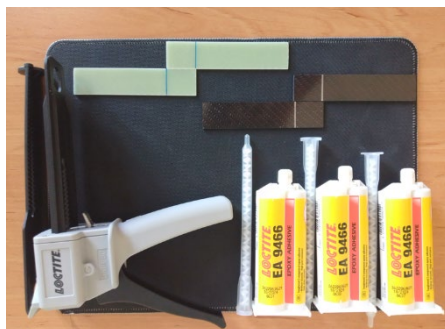
Figure 6. Bonding Process of GFRP and CFRP Specimens Using Loctite Hysol-9466.

The samples were prepared by bonding solvent-cleaned surfaces with adhesive. Bonding was achieved with two-component Loctite Hysol-9466 (Alpanhidrolık, Eskişehir, Turkey) epoxy, cured at room temperature and mixed at a 2:1 ratio in the applicator gun (Figure 6). Literature reports that adhesive layers of 0.1–0.3 mm thick provide high bond strength, while thicknesses greater than 0.6 mm reduce strength [31].

This is attributed to the fact that thin layers provide more effective mechanical resistance. After bonding, the samples were cured at room temperature for 7 days, in accordance with the product data sheet, and then moved on to the testing phase. This is attributed to the thin adhesive layers' ability to support mechanical loads more effectively. Application was carried out under a constant pressure of 0.1 MPa and a target thickness of 0.2 mm; the evenness of the adhesive layer was confirmed by measuring it with a digital caliper.

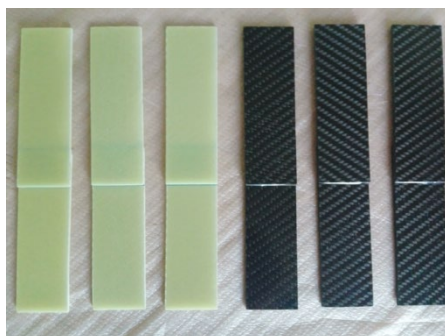
Figure 7. Visual observation of the surface morphology of GFRP and CFRP specimens prior to the three-point bending test.

General views of the surface areas of the GFRP and CFRP samples bonded with Loctite Hysol-9466 epoxy adhesive before the three-point and four-point bending tests are presented in Figure 7 and Figure 8, respectively. At this stage, it is observed that the adhesive layer is evenly distributed and a homogeneous bond is achieved between the samples.

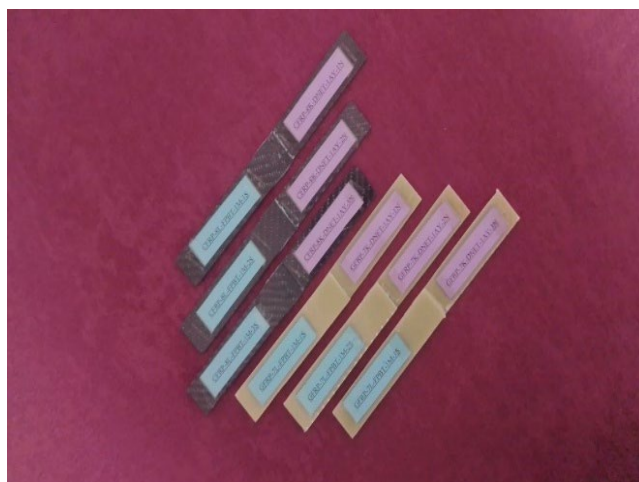
Figure 8. Visual observation of the surface morphology of GFRP and CFRP specimens prior to the four-point bending test.

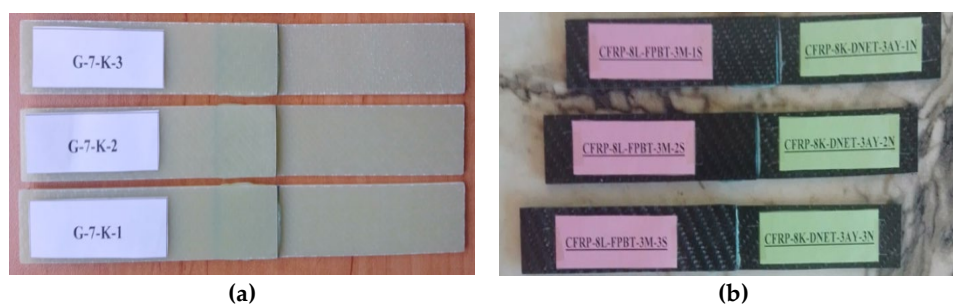
Figure 9. GFRP (a) and CFRP (b) specimen configurations used during the three-point bending test.

For instance, the code G-7-K-1 refers to the first specimen made of glass fiber, consisting of seven layers, and tested in a dry environment (not exposed to seawater). Similarly, G-7-1A-1 represents the first specimen with the same properties but exposed to seawater for one month before testing. For the specimens made of carbon fiber, C-8-K-1 denotes the first eight-layer specimen tested under dry conditions (Figure 9).

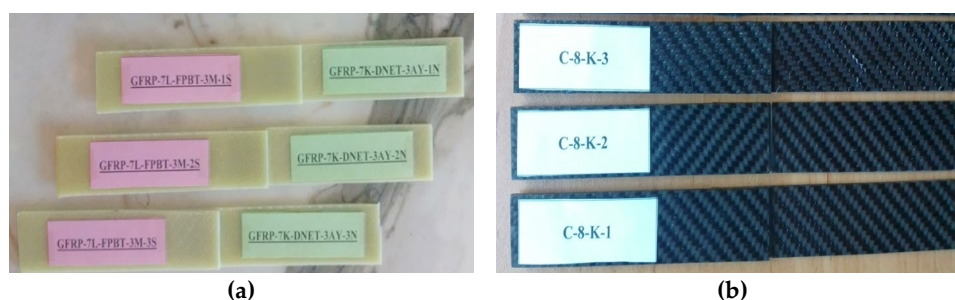
Figure 10. GFRP (a) and CFRP (b) specimen configurations used during the four-point bending test.

In the specimens subjected to the four-point bending test, the coding system was arranged as follows: for example, GFRP-7L-FPBT-DE-1S represents a specimen made of glass fiber-reinforced polymer (GFRP), consisting of seven layers (7L), tested under the four-point bending test (FPBT), kept in a dry environment (DE not exposed to seawater), and being the first specimen (1S). Similarly, GFRP-7L-FPBT-2M-1S indicates a specimen with the same structural features but immersed in seawater for two months (2M) before testing. For carbon fiber-reinforced specimens, CFRP-8L-FPBT-DE-1S denotes an eight-layer (8L) specimen tested under dry conditions (DE not exposed to seawater) and identified as the first specimen (1S) (Figure 10).

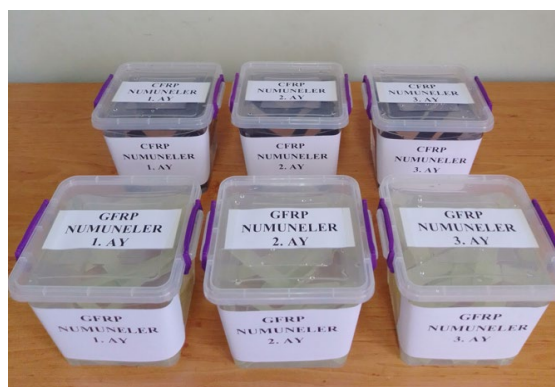
Figure 11. Soaking GFRP and CFRP samples in sea water for 1, 2 and 3 months for three-point bending.

Samples prepared using the single-lap method were first conditioned in a dry environment for three-point bending tests and then conditioned in seawater for periods of 1, 2, and 3 months, respectively. The same procedure was applied for the four-point bending tests. The seawater medium was prepared with a salinity range of 3.3–3.7% and a constant temperature of 22 °C, and all experiments were conducted under the same conditions (Figure 11).

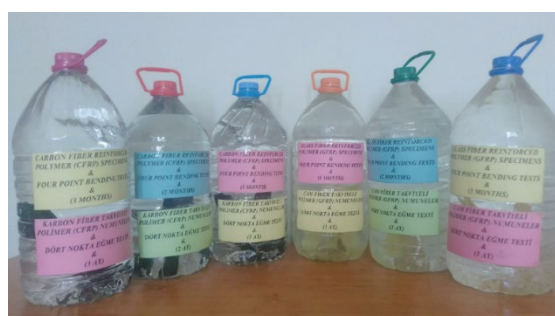
Figure 12. Soaking GFRP and CFRP samples in sea water for 1, 2 and 3 months for four-point bending tests.

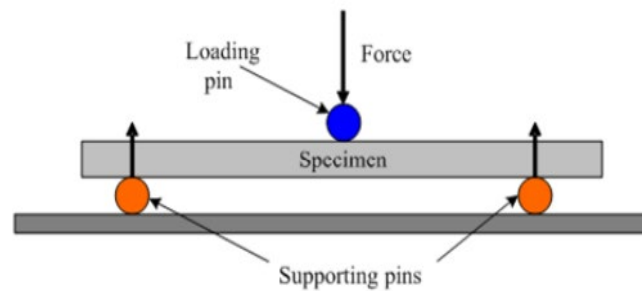
Figure 13. Schematic view of the three point bending test conditions.

In this study, the effects of adhesive type, joint geometry, and composite material type on mechanical performance were comprehensively investigated through both three-point and four-point bending tests. In the three-point bending test, the specimen was supported at both ends, and a load applied at the center generated maximum stress; this condition caused the highest stress to occur in the outermost fibers at the midspan of the beam, thus identifying the region most susceptible to failure under bending (Figure 13). This test method is particularly useful for determining the damage mechanisms that occur in the adhesive interface and joint regions of single-lap GFRP and CFRP composite joints aged in marine environments, as well as for analyzing time-dependent variations in their mechanical properties.

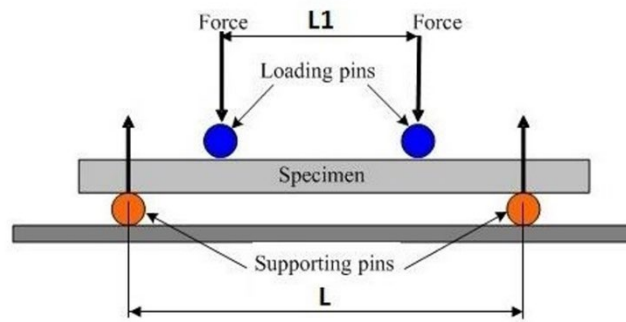
Figure 14. Schematic view of the four point bending test conditions.

On the other hand, the four-point bending test was applied to offshore wind turbine blade composites. The presence of a constant moment region enabled a detailed assessment of the specimen's elastic and plastic behavior (Figure 14). During this test, the maximum stress and strain values occurring at the center of the adhesive-bonded joint specimens were calculated at each load level, allowing for a reliable evaluation of the mechanical performance of the composite joints. Both testing methods provide a systematic and comprehensive approach to analyzing the behavior of different composite materials and bonding parameters under marine environmental conditions.

During the test, the stress and strain values at the center of the adhesively bonded joint specimen were determined at each loading step in the four-point bending test, thus evaluating the material's mechanical performance.

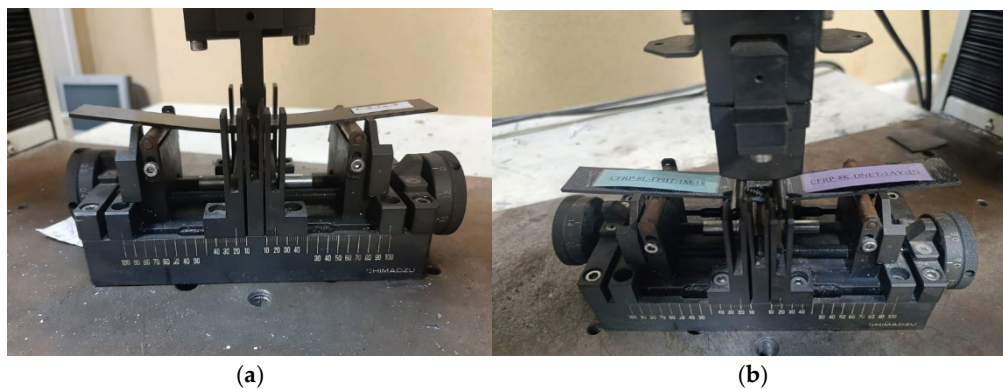
Figure 15. Placement of the sample in the three-point bending test (a), placement of the sample in the four-point bending test(b).

Both the three-point and four-point bending tests were conducted in the Biomechanics Laboratory of Ege University, Department of Mechanical Engineering, using bending fixtures compatible with a 100 kN capacity Shimadzu AG-100 testing machine. The experiments were performed under a 5 kN load and a crosshead speed of 1 mm/min. All tests were carried out in accordance with the ASTM D790 standard [26] on smooth GFRP and CFRP single-lap joint specimens with an adhesive thickness of 0.2 mm. The specimens were tested under both dry and seawater-conditioned environments to investigate the effects of environmental exposure on mechanical performance.

As a result, the influence of environmental factors on the flexural behavior of the adhesive interface was evaluated for all specimens, and variations in mechanical properties were comparatively analyzed based on the experimental findings. Figure 15 shows the placement of the specimens in the testing machine during both the three-point and four-point bending tests.

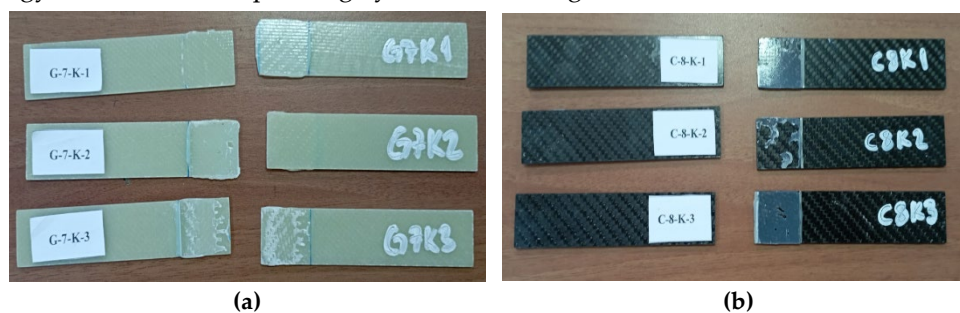
Figure 16. Views of the G-7-K sample after the three-point bending test (a) and the C-8-K sample after the test (b).

Figure 16a shows that separations occurred along the connection line in specimens G-7-K-1 and G-7-K-2. These separations are believed to be due to tensile stresses concentrated at the specimen ends during the bending test.

Figure 16b also shows that failures initiated at the connection line in specimens C-8-K-2 and C-8-K-3. These failures were caused by the localized effect of the maximum bending stress generated by the applied load in the three-point bending test. Despite this, it was observed that the surface morphology of the CFRP samples largely retained its brightness and smoothness.

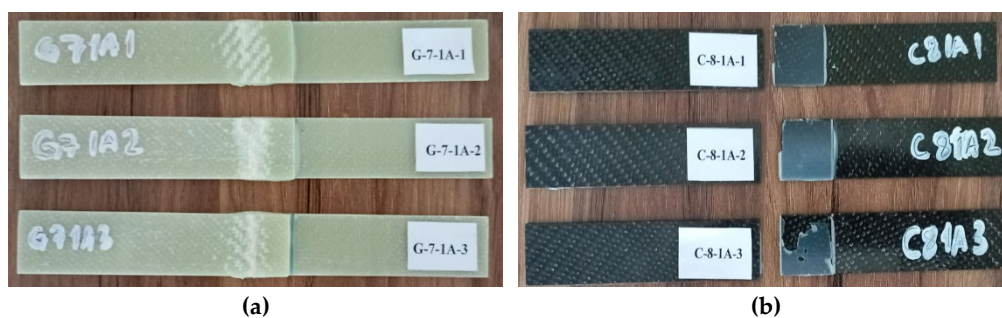
Figure 17. Views of the G-7-1A sample after the three-point bending test (a) and the C-8-1A sample after the test (b).

The damage patterns observed before and after the three-point bending test applied to the G-7-1A and C-8-1A specimens, which were stored under dry conditions for one month, are presented in Figure 17. As shown in Figure 17a, no significant fracture occurred along the bonding line in the G-7-1A specimens that were immersed in seawater for one month. Instead, whitish separation traces were observed, particularly in the central regions of the specimens. These whitish zones indicate localized micro-separations at the fiber matrix interface of the GFRP material under the applied bending load. The slight ductility of the GFRP enabled partial absorption of the applied load energy through deformation.

In contrast, as shown in Figure 17b, the C-8-1A-1 and C-8-1A-2 specimens exhibited sudden fractures along the bonding line. The damage observed in the midsection of these specimens indicates a brittle fracture behavior, where load transfer was abruptly interrupted. However, in the C-8-1A-3 specimen, a portion of the adhesive layer remained attached to the specimen surface, suggesting that the interfacial bond was not completely broken and that partial load transfer continued.

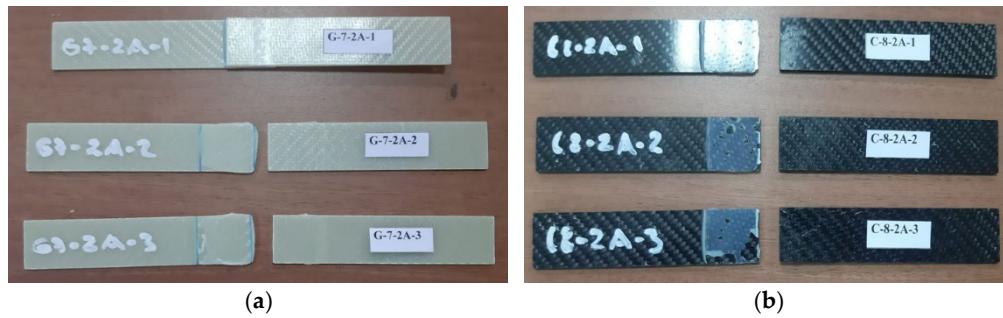
Figure 18. Views of G-7-2A sample (a) and C-8-1A sample (b) after three-point bending test.

In the G-7-2A series shown in Figure 18a, the G-7-2A-1 specimen exhibited no significant fracture after the test and remained largely intact structurally, indicating that the bonding integrity was maintained. The G-7-2A-2 specimen showed a more pronounced fracture surface along the bonding line, where part of the adhesive material had detached from the interface. The G-7-2A-3 specimen, on the other hand, failed at the bonding region, exhibiting both fracture and localized deformation behavior. Especially in the edge regions of the G-7-2A-2 and G-7-2A-3 specimens, adhesive separation and weakened adhesion were observed.

In Figure 18b, the C-8-2A-1 specimen generally preserved its surface integrity, though localized cracking occurred in the bonding region. The C-8-2A-2 specimen showed partial degradation of the bond between the laminate and the adhesive; adhesive separation and void formations were evident on the surface. This suggests that the adhesive layer was more affected by environmental exposure. In the C-8-2A-3 specimen, distinct adhesive residues were observed along the bonding line.

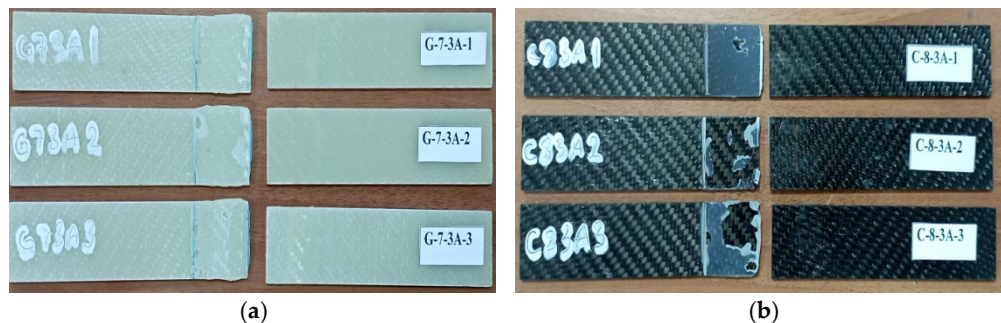
Figure 19. Views of G-7-3A sample (a) and C-8-3A sample (b) after three-point bending test.

As shown in Figure 19a, the G-7-3A series exhibited various fracture types. In the G-7-3A-1 specimen, fracture propagated directly along the bonding line, indicating a complete loss of adhesion in this region. The G-7-3A-2 specimen showed surface-level adhesive failure due to insufficient bonding between the adhesive and the substrate surfaces. The G-7-3A-3 specimen exhibited a mixed fracture pattern, with both interfacial failure and visible adhesive residues on the surfaces. While the first two specimens showed damage concentrated on the upper surfaces, the third specimen displayed fracture spreading across both surfaces.

In Figure 19b, the C-8-3A-1 specimen showed separation over a large portion of the adhesive layer but largely retained its structural integrity. The C-8-3A-2 specimen displayed the most distinct signs of fracture and delamination in the bonding region. In the C-8-3A-3 specimen, some adhesive remained on the surface, indicating that the bonding effect was not completely lost.

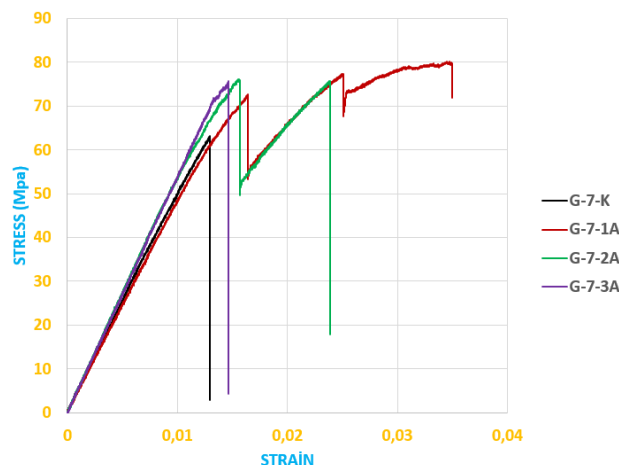
Figure 20. Stress–strain curves of GFRP specimens exposed to seawater for different durations and stored under dry conditions.

The stress-strain results presented in Figure 20 were obtained from three-point bending tests performed after storage of GFRP composite specimens in dry conditions and in seawater for 1, 2 and 3 months.

The data obtained from the bending stress-strain graph given in Figure 20 are shown in Table 2.

Specimen Code	Exposure Time	Flexural Stress (MPa)	Strain (ϵ)	Description / Status
G-7-K	Dry (Reference)	63.0726	0.0129	Maximum stress value
G-7-1A	1 month	72.2704	0.0163	Initial stress
		54.4886	0.0113	Minimum stress
		80.0818	0.0347	Maximum stress
G-7-2A	2 months	75.8136	0.0156	Initial maximum stress
		50.8163	0.0094	Stress reduction
		75.6766	0.0154	Stress increase
G-7-3A	3 months	75.6723	0.0146	Initial maximum stress

The Elastic Modulus, also known as Young's Modulus, is a fundamental mechanical property that defines how elastic or rigid a material behaves under external loads. This modulus is considered a quantitative indicator of a material's stiffness. Materials with a high Young's Modulus deform very little under applied force, indicating that they are stiffer and more rigid. Conversely, materials with a low elastic modulus tend to deform more under the same load and are therefore regarded as more flexible [32]. Here, the elastic modulus (E) values were calculated from the slope of the linear (elastic) regions of the stress-strain (σ - ϵ) curves. The elastic modulus values presented in Table 4 were obtained from the slope of the linear portion of the stress-strain data shown in Figure 20 and, similarly, from the slope of the linear portion of the data shown in Figure 21.

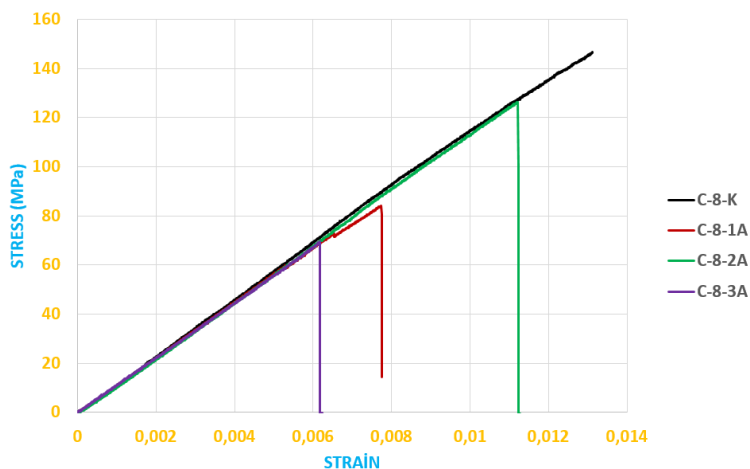
Figure 21. Stress–strain curves of CFRP specimens exposed to seawater for different durations and stored under dry conditions.

The data obtained from the bending stress-strain graph given in Figure 21 are shown in Table 3.

For both material types, a decrease in the elastic modulus was observed as the exposure time to seawater increased. However, this reduction was more pronounced in the GFRP specimens, while it was relatively limited in the CFRP specimens. This suggests that CFRP exhibits more stable mechanical properties against moisture and environmental effects.

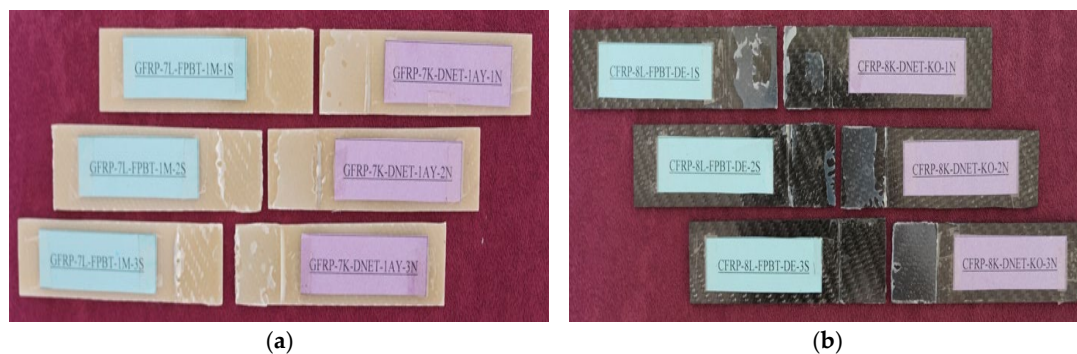
Figure 22. Views of the GFRP-7L-FPBT-DE-1S specimen (a) and CFRP-8L-FPBT-DE-1S specimen (b) after the four-point bending test.

In Figure 22a, it was observed that in the GFRP-7L-FPBT-DE-1S specimens, the damage initially started at the bond line and propagated toward the surfaces. In the regions where the separations were concentrated, fine cracks and partial delaminations progressing along the adhesive interfaces were detected. This indicates that the stress within the material accumulated in a specific region, exceeding the strength limit of the bond line. As the damage progressed, the interlaminar separation increased; however, the overall structural integrity of the specimen was maintained. This demonstrates that the failure occurred gradually rather than abruptly.

In the CFRP-8L-FPBT-DE-1S specimens shown in Figure 22b, a similar fracture pattern was observed. The separation generally initiated along the bond line and propagated toward the surface layers. In some specimens, parts of the adhesive remained on the opposite surfaces, indicating that adhesion was locally maintained. The concentration of damage in a specific area reveals that load transfer along the bond line was not uniform, and stress concentration in that region played a significant role.

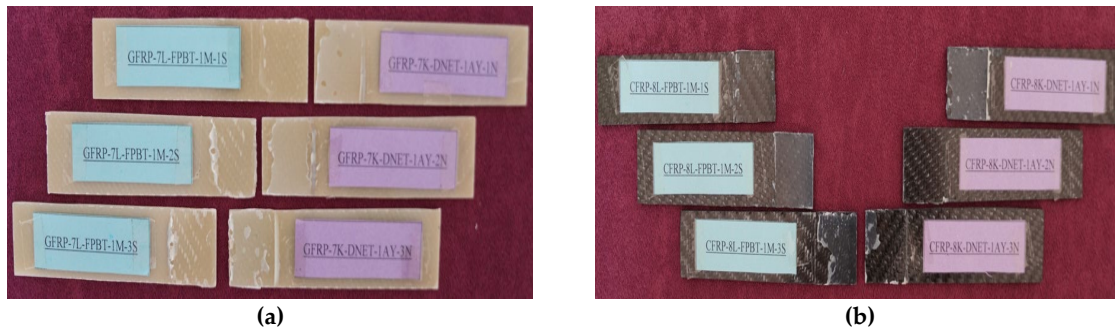
Figure 23. GFRP-7L-FPBT-1M numunesi (a) ve CFRP-8L-FPBT-1M numunesinin (b) dört nokta eğme test sonrası görünümleri.

In the GFRP-7L-FPBT-1M specimens shown in Figure 23a, a significant weakening was observed at the bond interface due to the influence of seawater. The prolonged exposure to the saline environment caused ions, along with water molecules, to diffuse into the adhesive layer, which weakened the chemical bonds and disrupted the adhesive integrity at the microscopic level. The accumulation of moisture and ions at the interface reduced the mechanical strength of the adhesive, leading to localized delaminations and the formation of microcracks. As a result of these effects, the adhesion strength along the bond line of the GFRP-7L-FPBT-1M specimens decreased, and fracture typically initiated in these regions.

In the CFRP-8L-FPBT-1M specimens shown in Figure 23b, a different damage mechanism was observed. The low water absorption capacity of carbon fiber-reinforced composites significantly limited the penetration of seawater into the interface. Consequently, the bond between the adhesive and the composite surface maintained its stability for a longer period. However, when fracture occurred, it was sudden and brittle in nature. This behavior is attributed to the high elastic modulus and tensile strength of carbon fibers along the fiber direction. Therefore, although the fracture load of the CFRP-8L-FPBT-1M specimens was higher compared to that of the GFRP-7L-FPBT-1M specimens, the failure occurred more abruptly.

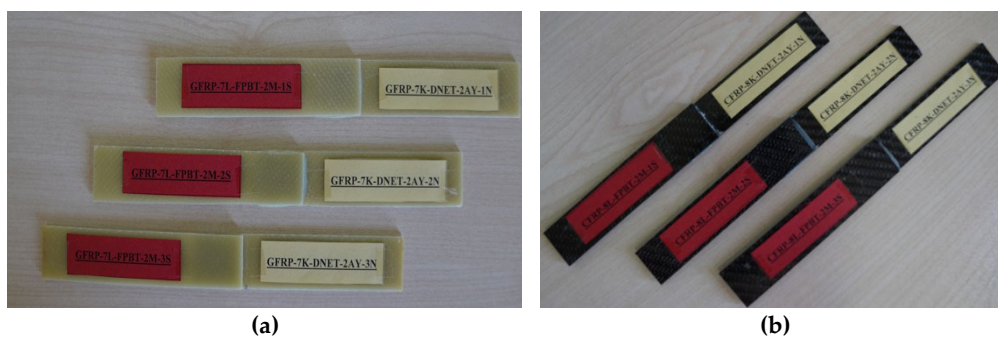
Figure 24. Views of the GFRP-7L-FPBT-2M specimen (a) and CFRP-8L-FPBT-2M specimen (b) after the four-point bending test.

In the GFRP-7L-FPBT-2M specimens shown in Figure 24a, it was observed that the damage was not limited to the adhesive bond line but also involved adhesive residues on both surfaces. This indicates that the fracture occurred both within the adhesive layer and at the bond interface, revealing a mixed failure mode consisting of cohesive and adhesive fractures. During loading, the adhesive layer along the bond line began to lose its internal structural strength; simultaneously, the reduction in interfacial adhesion forces caused the layers to separate from each other. This distribution of damage demonstrates that the stress along the bonding line was not uniformly distributed and that local stress concentrations developed. In addition, prolonged exposure to seawater caused both chemical degradation and physical weakening along the bond line, leading to a mixed-mode fracture progression.

In the CFRP specimens shown in Figure 24b, a similar type of damage was identified. The occurrence of adhesive residues on both surfaces, along with fracture within the adhesive layer, indicates that cohesive and adhesive failures developed simultaneously. However, a noteworthy observation is that in the CFRP-8L-FPBT-2M specimens, the fiber-reinforced structure allowed for a more balanced load transfer along the bond line. The high elastic modulus and low water absorption property of the carbon fibers limited seawater penetration into the adhesive region, contributing to the preservation of bonding quality. Therefore, despite two months of seawater exposure, the bond line strength of the CFRP-8L-FPBT-2M specimens was largely maintained, and fracture occurred in a more controlled manner.

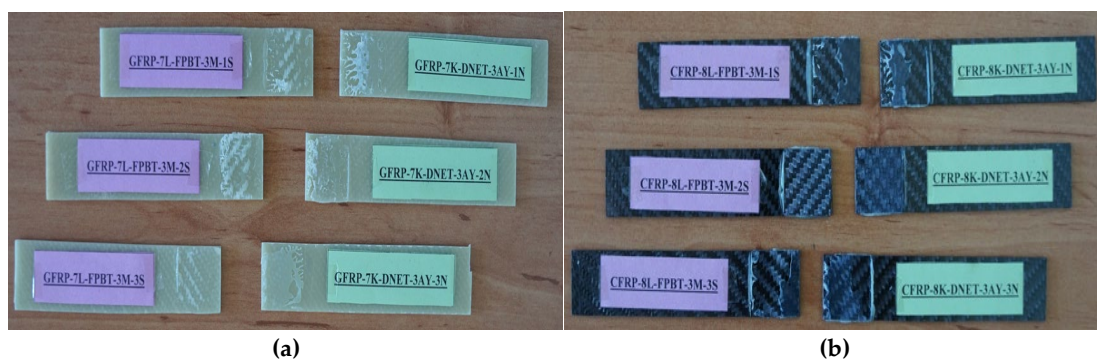
Figure 25. Views of GFRP-7L-FPBT-3M specimen (a) and CFRP-8L-FPBT-3M specimen (b) after four-point bending test.

In the GFRP-7L-FPBT-3M specimens shown in Figure 25a, which were immersed in seawater for three months, the damage was found to develop directly along the bond line. It was observed that the fracture was concentrated mainly in the central region of the joint, where the adhesive partially

remained attached to both surfaces. This indicates that the damage primarily occurred within the adhesive layer and that the bond interface had weakened. The penetration of ions and moisture from seawater into the adhesive layer caused degradation and plasticization of the polymer structure. This effect led to the formation of microscopic voids and structural discontinuities at the interface, reducing the mechanical strength of the bonding line. As a result, the bond strength of the GFRP-7L-FPBT-3M specimens decreased, and fracture occurred at lower load levels.

In the CFRP-8L-FPBT-3M specimens presented in Figure 25b, a similar damage pattern was observed, although the severity of the damage was more limited. After the fractures developed along the bonding line, the presence of adhesive residue on both surfaces indicated that cohesive and adhesive failures occurred simultaneously. However, due to the high fiber strength and low water absorption capacity of the CFRP-8L-FPBT-3M specimens, seawater penetration into the interfacial region was significantly reduced, and the bonding quality was largely preserved. Therefore, despite prolonged seawater exposure, the CFRP-8L-FPBT-3M specimens maintained their structural integrity and exhibited higher bond strength compared to the GFRP-7L-FPBT-3M specimens.

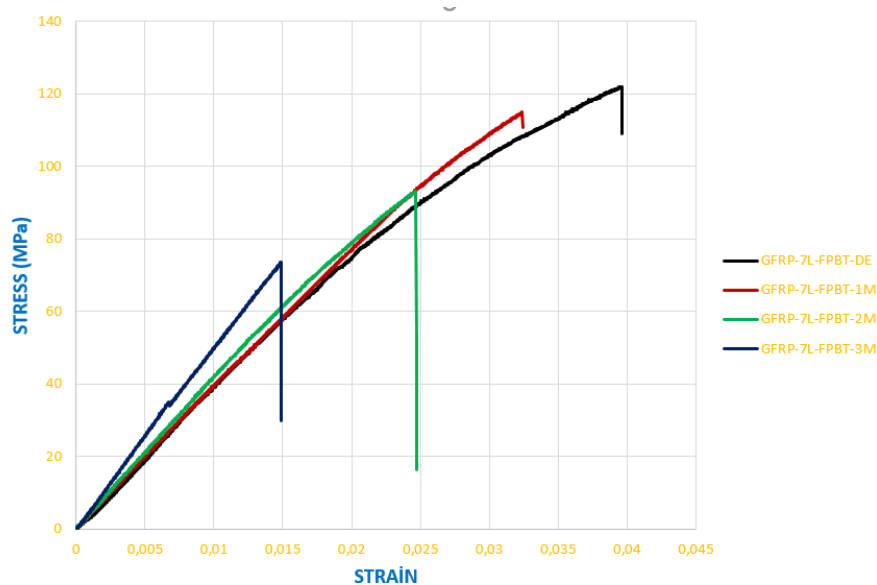
Figure 26. Stress–strain curves of GFRP specimens exposed to seawater for different durations and stored under dry conditions.

Figure 26 presents the stress–strain results obtained from four-point bending tests conducted on GFRP composite specimens after being stored in dry conditions and in seawater for 1, 2, and 3 months.

The data obtained from the bending stress-strain graph given in Figure 26 are shown in Table 5.

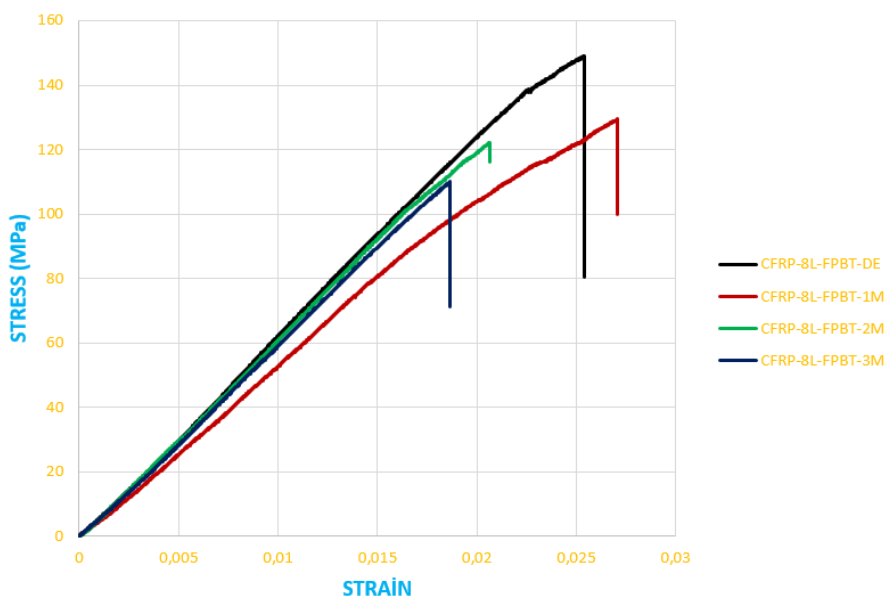
Figure 27. Stress-strain curves of CFRP specimens exposed to seawater for different durations and stored under dry conditions.

The data obtained from the bending stress-strain graph given in Figure 27 are shown in Table 6.

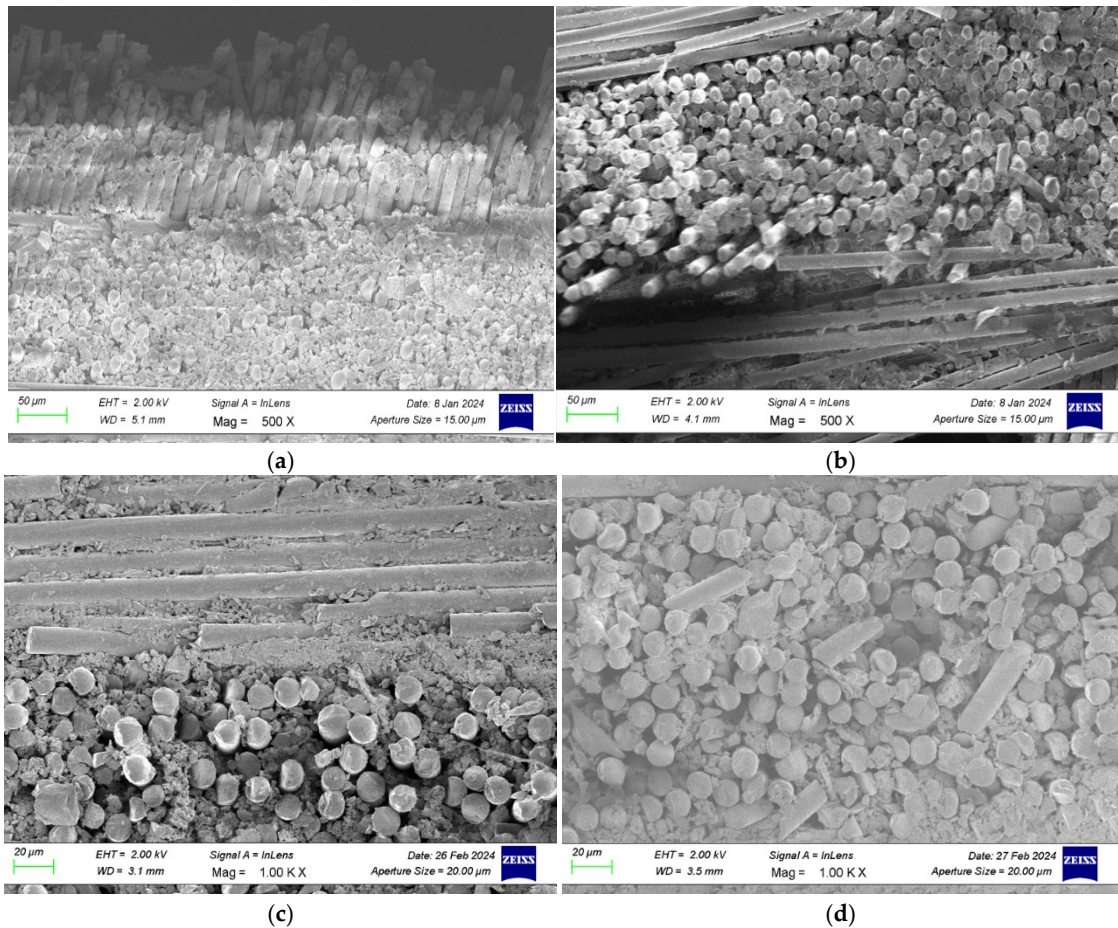
Figure 28. Reference (dry condition) (a), 1 month (b), 2 months (b), 3 months (c) seawater-exposed GFRP specimens.

Here, the elasticity modulus (E) values were calculated from the slope of the linear (elastic) regions of the stress–strain (σ – ϵ) curves. The elasticity modulus values presented in Table 7 were obtained from the slope of the linear portion of the stress–strain data shown in Figure 28 and, similarly, from the linear portion of the data presented in Figure 29.

In Figure 28a, for the GFRP specimens stored under dry conditions, i.e., without exposure to seawater, the three-point bending test revealed local fiber breakages and limited fiber pull-outs as the load increased. Such damage results from the fibers in the tensile and compressive regions being subjected to different stress levels under the applied bending load [33]. Since the specimens were in a dry environment, no chemical degradation, swelling, or structural weakening occurred at the fiber–matrix interface, and therefore, the interfacial bonding strength was largely preserved. This indicates that strong load transfer between the fibers and the matrix was maintained.

In Figure 28b, for specimens exposed to seawater for 1 month, the slow diffusion of water into the matrix caused weakening and microscale degradation at the fiber–matrix interface. Ionic components in seawater chemically interacted with the epoxy matrix, reducing the bond strength and creating microvoids and detachments at the interface. This process led to fiber breakage under load and the formation of microcracks on the matrix surface. A slight increase in surface roughness was observed, making the material more susceptible to further water absorption in subsequent stages.

In Figure 28c, for specimens exposed to seawater for 2 months, deeper penetration of water into the layers significantly weakened the fiber–matrix interaction, and structural integrity began to deteriorate. At this stage, fiber fractures, matrix cracks, and delamination damage were clearly observed. Water progression at the fiber–matrix interface facilitated crack propagation. Moreover, SEM images showed that the surface had become more irregular compared to earlier stages, with an increase in microscale pits and fracture traces. This contributed to a reduction in mechanical strength.

In Figure 28d, for specimens exposed to seawater for 3 months, extensive damage developed as moisture reached saturation within the material. Pronounced separations occurred at the fiber–matrix interface, with voids and swelling forming around fiber bundles. Fiber breakages and crack propagation combined under load to create macro-scale delamination regions. Additionally, chemical degradation and water-induced swelling in the matrix significantly reduced interfacial bonding strength, leading to a considerable decline in the overall mechanical performance of the material. Although water absorption slowed in later stages, the structural degradation process did not stop; instead, the existing damage expanded and merged, further compromising the integrity of the material.

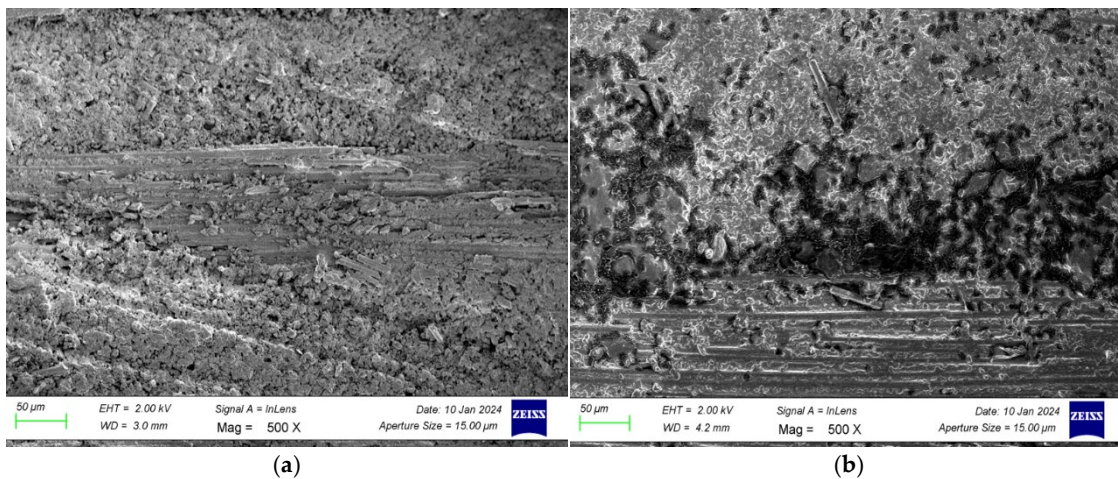
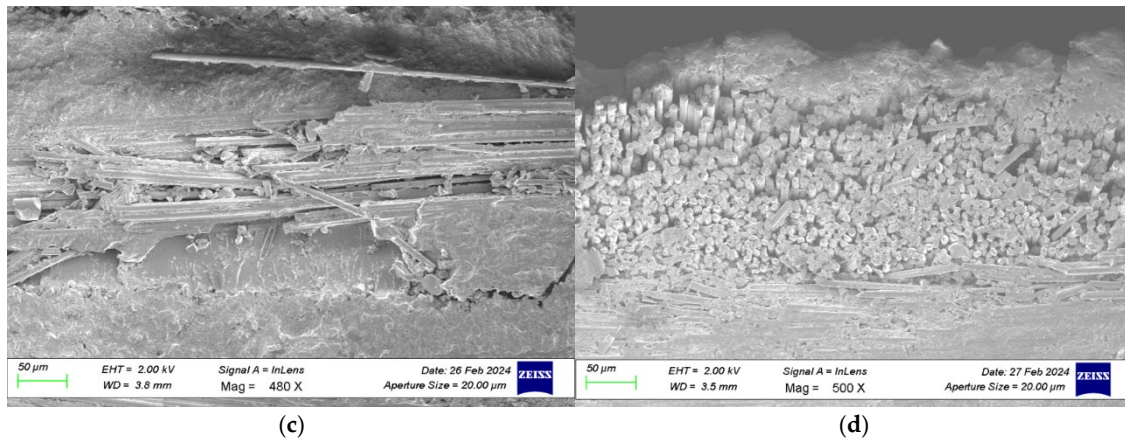
Figure 29. Reference (dry condition) (a), 1 month (b), 2 months (b), 3 months (c) seawater-exposed CFRP specimens.

In Figure 29a, for CFRP specimens stored under dry conditions (without exposure to seawater), the fibers were observed to be regularly aligned and exhibited strong bonding with the epoxy matrix. The matrix phase formed a homogeneous and continuous structure, with no voids, bubbles, or interfacial separations detected between the fiber bundles. However, as a result of the applied three-point bending load, local fiber breakages and fractures occurred in regions where load transfer was most concentrated. These fractures developed due to the high stresses experienced by the fibers in the tensile regions.

In Figure 29b, for specimens exposed to seawater for 1 month, initial signs of microstructural changes were observed, indicating the onset of early damage. Diffusion of seawater into the matrix caused microscale irregularities on the matrix surface, slight swelling, and increased surface

In Figure 29c, for specimens exposed to seawater for 2 months, the damage types became more pronounced, and various microstructural deformations appeared in the material. Seawater penetration into the matrix weakened the chemical bonding of the epoxy chains, leading to the development of microcracks and localized deterioration. Wider separation zones were detected at the fiber–matrix interfaces, and in some areas, fiber bundles began to detach from the surface. Additionally, capillary-driven water movement along the interface resulted in the formation of micropores and bubbles.

In Figure 29d, for specimens exposed to seawater for 3 months, microstructural deterioration reached an advanced stage. Pronounced cracks, localized delaminations, and surface peeling occurred in the matrix phase. The size of the separations at the fiber–matrix interface increased, with some carbon fibers protruding from the matrix and exposed at the surface. Prolonged seawater exposure led to the development of micropores and capillary voids within the matrix, facilitating water penetration into the interior and accelerating the damage process.

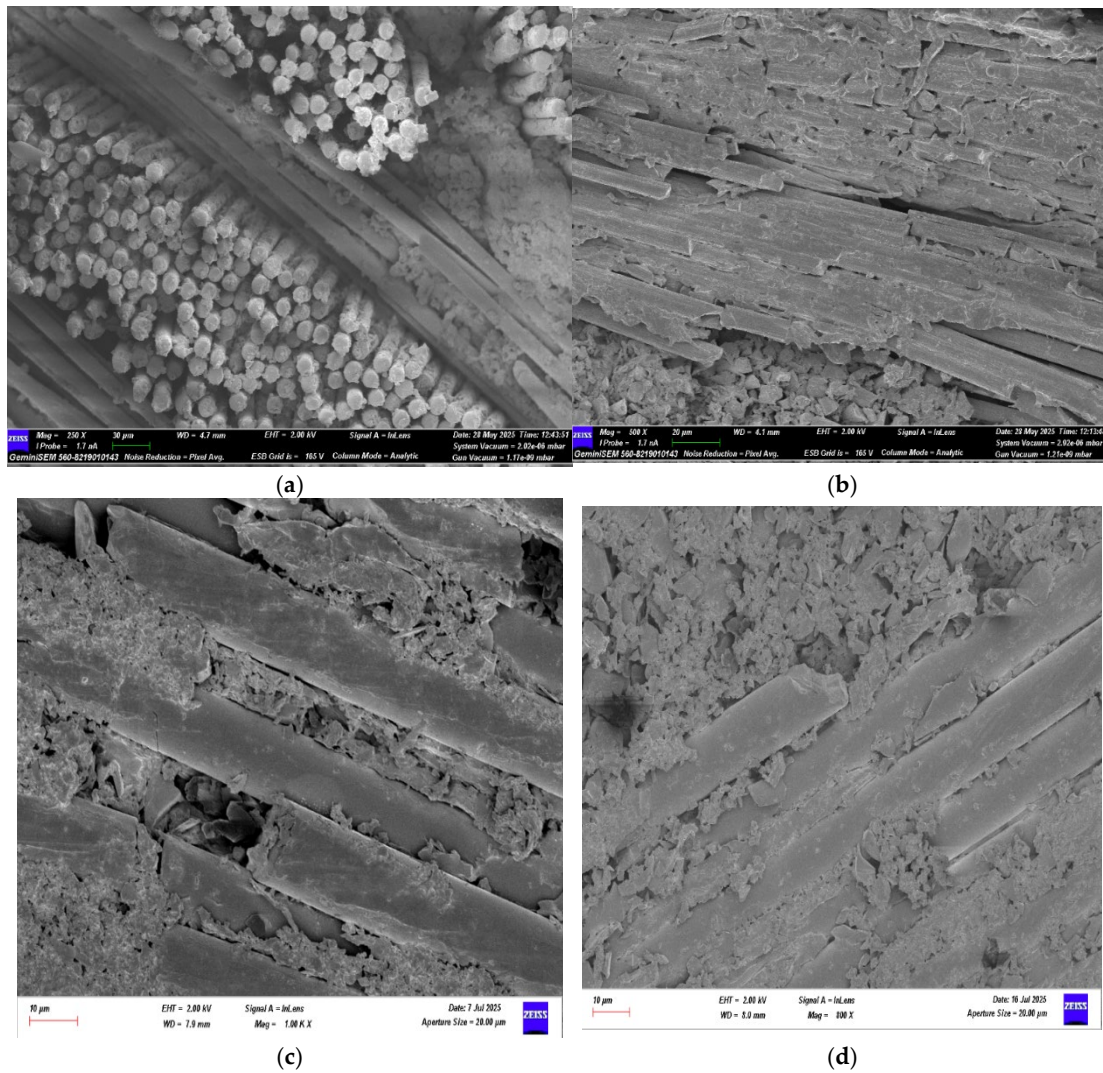
Figure 30. Reference (dry condition) (a), 1 month (b), 2 months (c), 3 months (d) seawater-exposed GFRP specimens.

In Figure 30a, the SEM images of the GFRP control specimen stored under dry conditions show strong bonding between the glass fibers and the polymer matrix. The fibers are evenly distributed, with minimal voids between them, and the fiber–matrix interface maintains its continuity. The absence of cracks or fracture traces in the fibers indicates that the specimen's flexural strength remains high.

In Figure 30c, for GFRP specimens exposed to seawater for 2 months, microstructural deterioration becomes more pronounced. Fiber breakages and shrinkages, along with numerous microcracks, voids, and fragmented areas within the matrix, are observed. Fiber–matrix interaction is largely lost, and interfacial bond failure limits load transfer. This results in reduced flexural strength and the emergence of brittle behavior in the specimen.

In Figure 30d, for specimens exposed to seawater for 3 months, the microstructural integrity is almost completely lost. The fibers have detached from the matrix, becoming free, and severe chemical degradation has occurred in the polymer matrix. Microscale cracks have coalesced into macroscopic fractures over time, leading to sudden and brittle failure. The mechanical strength of the matrix has been significantly reduced due to water exposure.

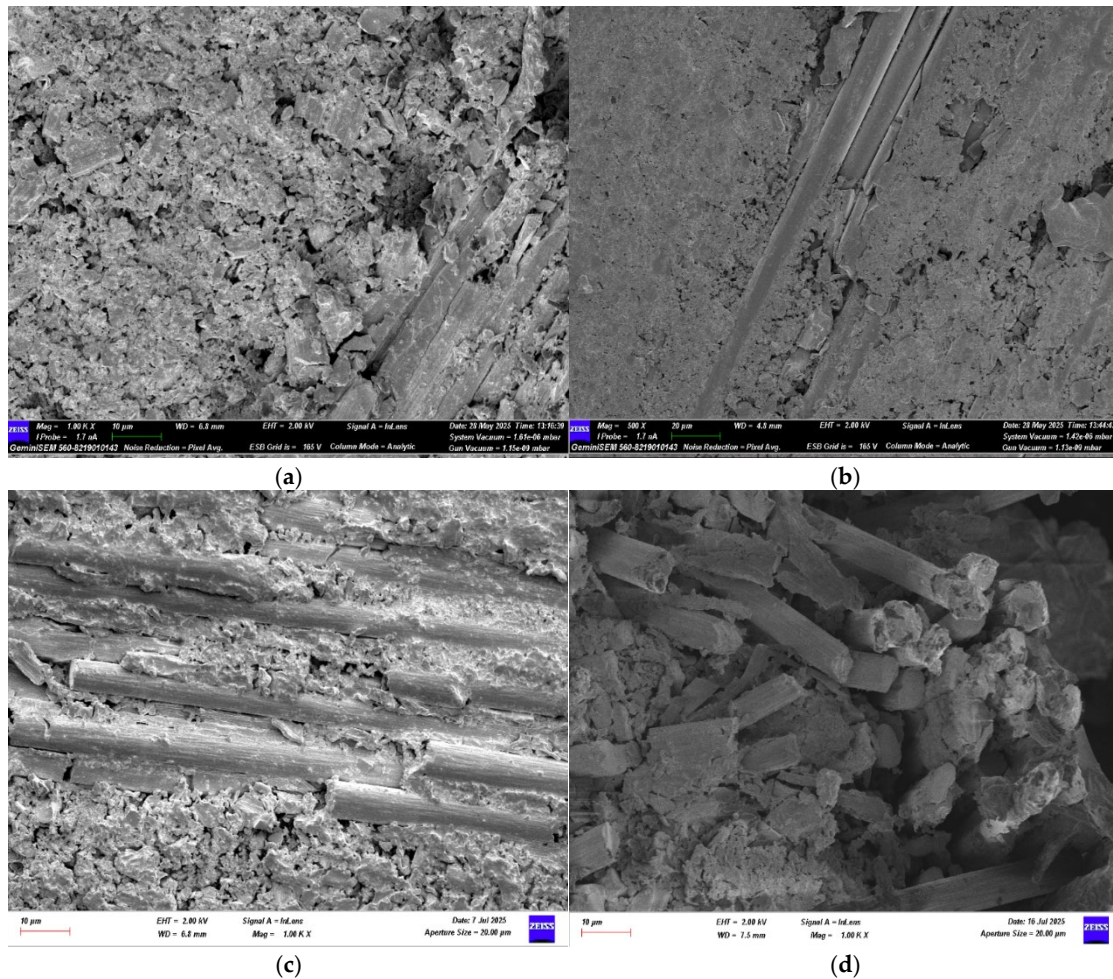
In Figure 31a, the SEM images of the CFRP control specimen stored under dry conditions show strong bonding between the fibers and the matrix. The fibers are properly embedded in the matrix, exhibiting a regular structure and high interfacial integrity at the fracture surface. Some fiber pull-out is observed, but overall the fracture occurs in a balanced manner. This indicates that energy during mechanical loading is dissipated in a ductile way, and the fracture occurs in a controlled rather than sudden manner.

Figure 31. Reference (dry condition) (a), 1 month (b), 2 months (c), 3 months (d) seawater-exposed CFRP specimens.

In Figure 31b, for CFRP specimens exposed to seawater for 1 month, initial microstructural deterioration is observed. Local separations appear in the interfacial regions, and microcracks and deformation traces become noticeable on the matrix surface. These changes indicate that the fiber-matrix bonds are beginning to weaken, and the mechanical properties of the specimen show a decreasing trend.
