# Flow Performance Investigation of Francis Turbine Stay Vanes Restoration in Powerful Pumped Hydro Energy Storage Plants

Keywords: Francis turbines; water flow investigation; stay vanes restoration; pumped hydro energy storage

The presented paper discusses and analyzes the methods for restoration of damaged stay rings and vanes of large Francis turbines. The focus is set on the crack damages that were also observed in stay vanes of Francis turbines in “Chaira” Pumped Hydro Energy Storage (PHES) plant, Hydro Unit 4 (HU4), where cracks occurred in all ten stay vanes. Additionally significant cavitation patches were noticed overall the front surface of the turbines stay vanes. Two approaches are examined in the study. The first approach for repairing adds material by welding over the damaged places, which are then polished. Although welding of damaged areas is a widespread method, some adverse effects are observed, mainly because of changes in the characteristics of the base metal and the impact of the high temperatures. The second approach is based on the removal of the damaged material till elimination of the cracks. Virtual models for computer simulation of both methods are prep

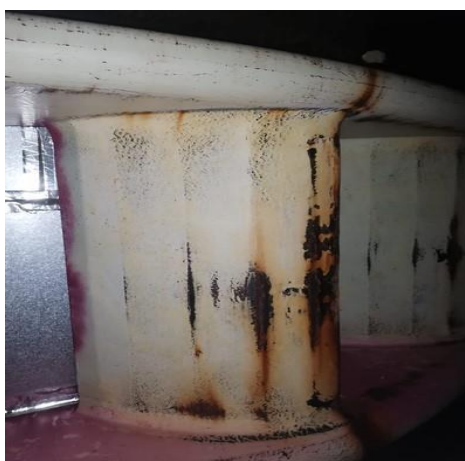
**Figure 1.** A damaged stay vane.

The aforementioned BBA Consultants company in its publication [2] presented the work carried out on the repair of the stay vanes, the spiral case and the covers a 125 MW Francis turbine in Turkey in 2021. Figure 1 and Figure 2 show the damages to the stay vanes and spiral casing after 10 years of operation. The stay vanes had lost thickness due to erosion. During a routine inspection, the surfaces had also been identified as being rough, resulting in a loss of efficiency and an increase in power consumption. The cause of roughness on the stay vanes was due to foreign matter (sand, silt, mud etc.) within the process [2]. The BBA Consultants recently completed a major turbine[1–3 repair project for a Hydroelectric Plant located in the Nueva Ecija province Central Luzon, The Philippines [3]. Two Francis turbines housed within the plant were suffering from corrosion, erosion due to cavitation in several key areas (Figure 3).

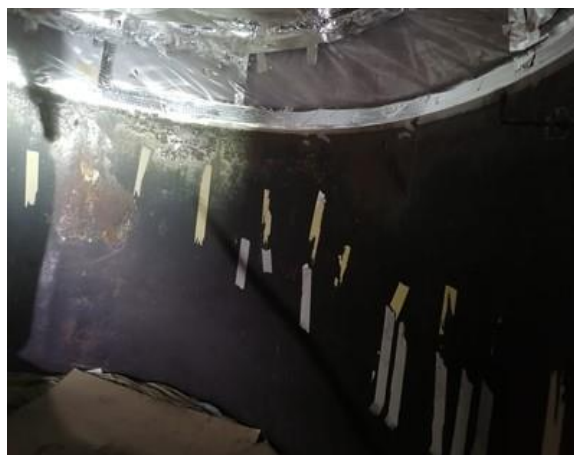
**Figure 2.** A damaged cover.

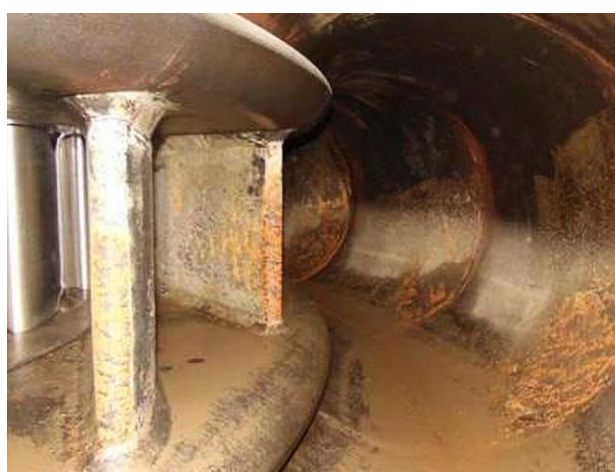
**Figure 3.** Corrosion/erosion to the spiral casing and stay vanes.

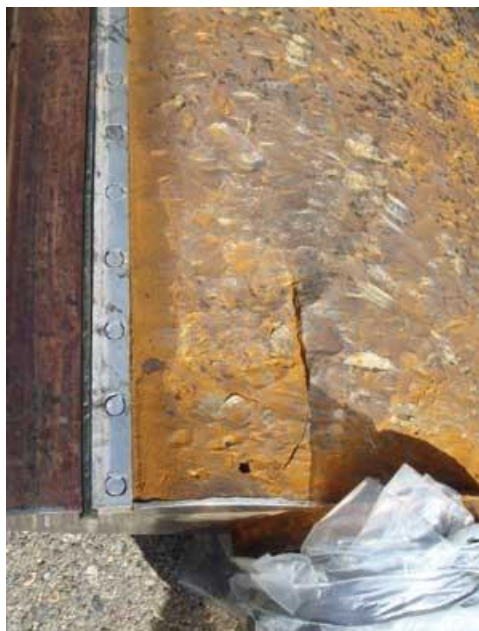
**Figure 4.** The skin plate damages of a guided vane of G.M. Shrum, BC Hydro [7].

G.M. Shrum, BC Hydro largest facility in Canada [7] began operating in 1968 with ten turbine-generating units. Units 1 to 5 were installed in 1968 and 1969 with a capacity of 261 MW each. On March 2, 2008, the Unit 3 runner experienced a major failure. Except the runner many other components of the unit were damaged including stay and guided vanes. In Figure 4 shows guided vane damages uncovered after the runner failure. The skin plate of all 24 guided vanes had deep gouges on up to 75 percent of the metal surface. Cracks and surface damages of guided and stay vanes were repaired using welded plates and/or secured bolts. Heat treatment was applied to eliminate thermal stresses.
