# Numerical Simulation of Damage and Failure of a Concrete Gravity Dam Under Seismic Loads

Keywords: earthquake; particle flow code; damage accumulation; Koyna; inertial effects

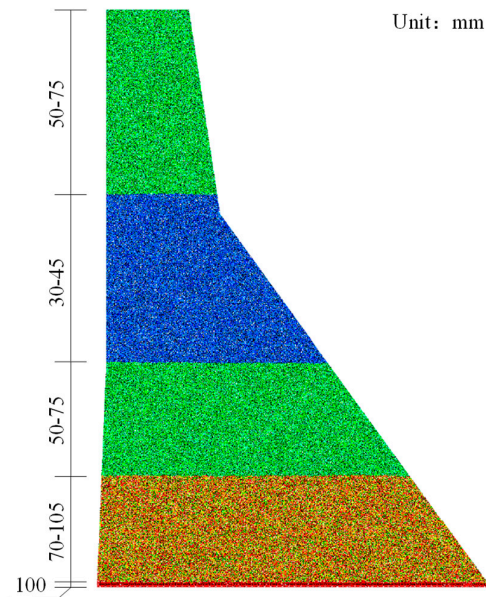
A force load was applied at the bottom of the model to simulate the effects of seismic acceleration on the dam. The particle radius was fixed at 100 mm to ensure uniform acceleration of the bottom particles and to reduce the computational load associated with varying particle radii. The particles at the downstream slope of the Koyna Dam model, where tensile stress concentration was more likely, were refined. The particle distribution of the dam is shown in Figure 3. The particle size ratio was 1.5, and the model generated 133380 particles.

**Figure 3.** Particle size distribution of the numerical model of the Koyna gravity dam.

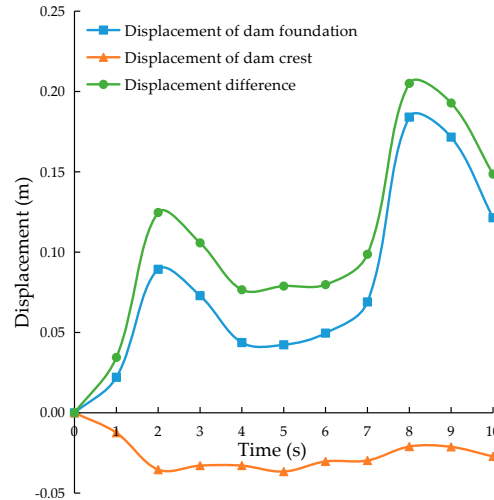
Figure 10 shows the displacements at the dam's crest and toe at different times and their differences.

**Figure 10.** Displacements at the dam's crest and foundation and their differences.

As shown in Figure 10, the variation in displacement at the dam crest was relatively small (0.03 m) from 2.0 s to 10.0 s. Therefore, the displacement difference curve closely resembled the displacement trend at the dam foundation, which exhibited two peaks. The first peak occurred at 2.0 s. No cracks had formed, but significant shear forces existed. As shown in Figure 8, the shear forces were primarily located on the upstream and downstream faces corresponding to the dam's slope transition zone. The second peak occurred at 8.0 s. Cracks had completely penetrated the dam, and the displacement of the dam foundation was less constrained by the fractured upper portion, resulting in greater displacement.

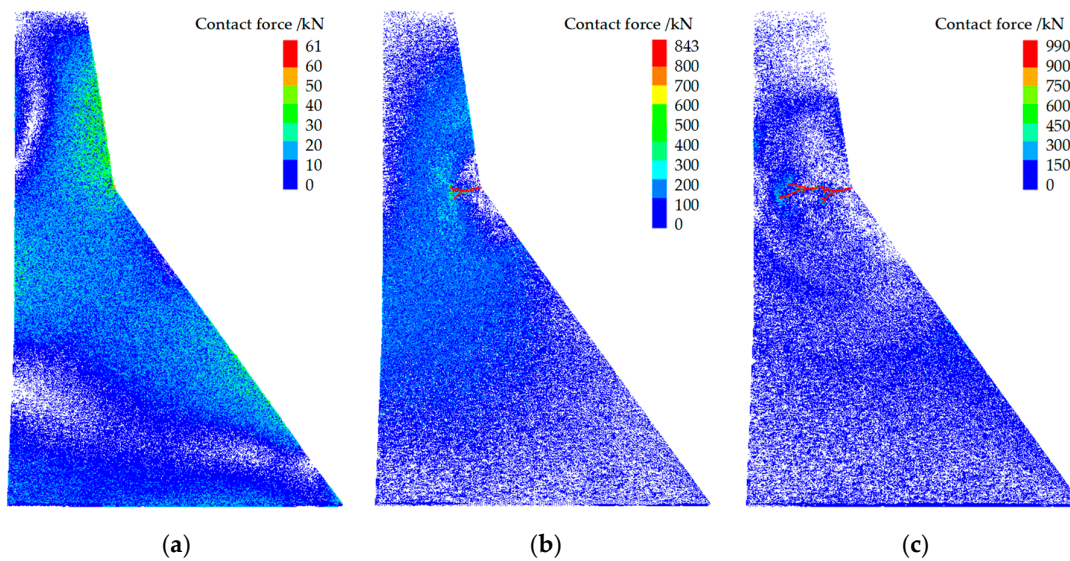
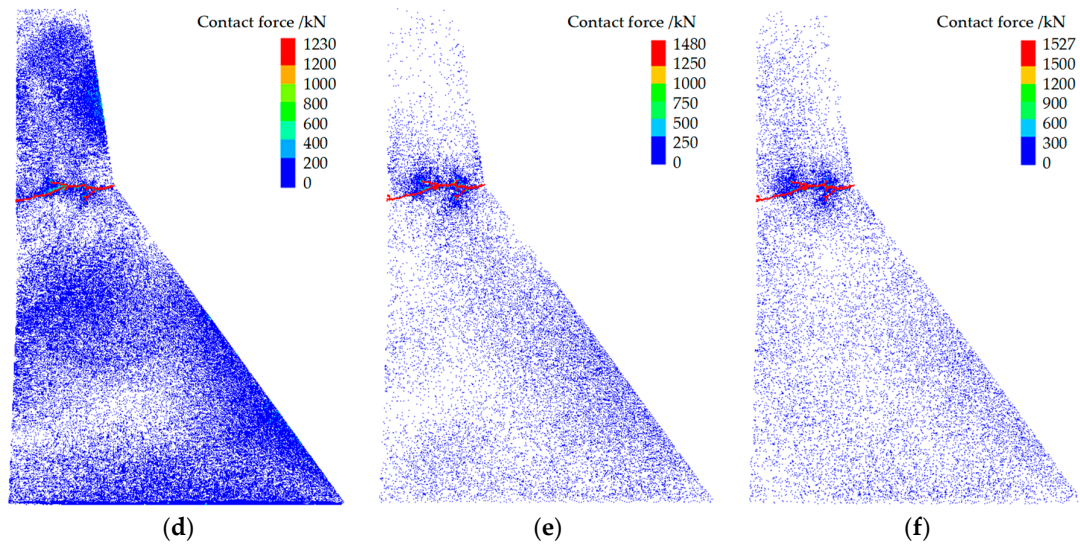
The evolution of the contact force chain of the Koyrna Dam under vertical seismic loading is shown in Figure 13.

**Figure 13.** Evolution of the contact force chain: (a) 1.0 s; (b) 4.26 s; (c) 4.265 s; (d) 4.277 s; (e) 6.0 s; (f) 10.0 s.

After 1.0 s of vertical seismic loading (Figure 13(a)), stress concentrations appeared on both the upstream and downstream faces of the dam's slope. They were located lower on the upstream face, and the force chains were concentrated along the inclined surfaces. At 4.26 s (Figure 13(b)), cracks formed on the downstream face at the slope transition point. The stress was concentrated at the crack tips, and the curve had an S-shape. At 4.265 s (Figure 13(c)), an oblique crack propagated into the dam rapidly, with stress still concentrated at the crack tips, and the contact force continued to increase. After 4.277 s of loading (Figure 13(d)), the crack penetrated the entire dam, with a maximum contact force of 990 kN. It was primarily concentrated at the crack inflection point and the tips of the branching cracks. The contact force remained constant at around 1500 kN from 6 s to 10 s (Figure 13(e-f)), and the number of cracks did not increase.

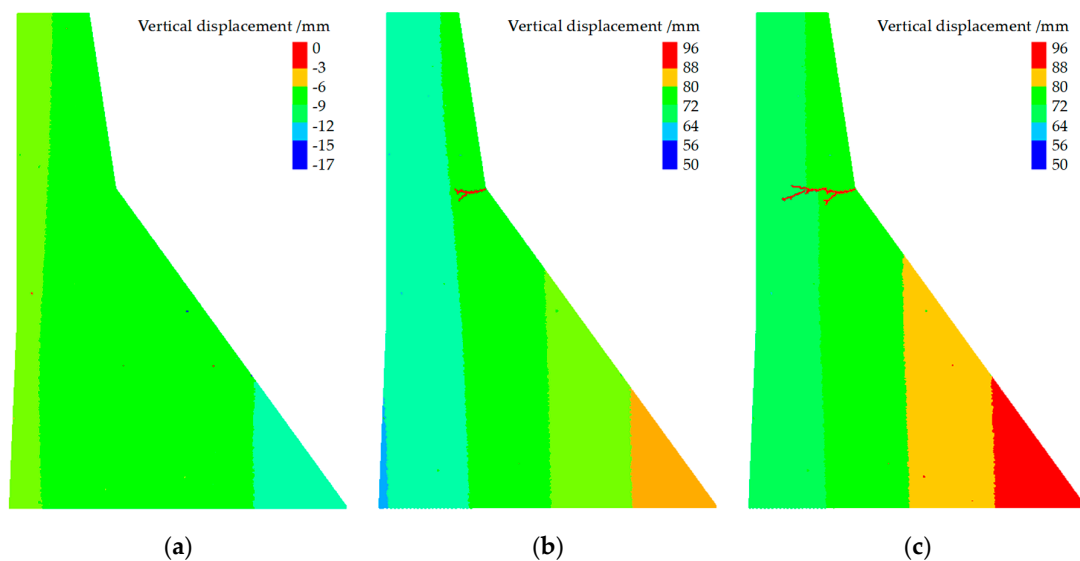
The evolution of the dam's vertical displacement over time is shown in Figure 14.

**Figure 14.** Evolution of vertical displacement: (a) 1.0 s; (b) 4.26 s; (c) 4.265 s; (d) 4.277 s; (e) 6.0 s; (f) 10.0 s.

After 1.0 s of loading (Figure 14(a)), a layered pattern was observed in the horizontal displacement of the dam's upstream and downstream faces. The displacement increased from the upstream face to the downstream face, resulting in a vertical displacement difference. At 4.26 s (Figure 14(b)), the dam could no longer withstand the unbalanced vertical forces, causing cracks to form at the downstream slope transition. From 4.265 to 4.277 s (Figure 14(c–d)), the cracks propagated and penetrated the entire dam, while the magnitude of vertical displacement remained nearly constant. At 6.0 s (Figure 14(e)), the dam's displacements were inconsistent. The upper half had completely detached from the dam body, and the displacement magnitude had increased. By 10.0 s (Figure 14(f)), the displacement of the dam body increased slightly, whereas the displacements of the upper and lower fractured sections were greater.
