# Unshoring Process of a Temporary Column, in a Seventeen Storey Building in Sant Adrià Del Besós

Keywords: unshoring; high-rise building; hydraulic pistons; temporary prop; monitoring

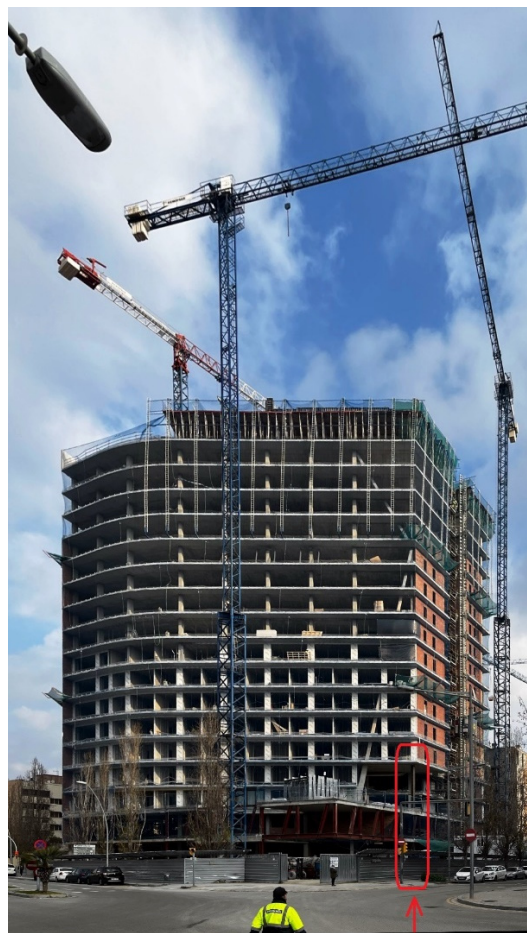
**Figure 2.** Image of the construction process of the hotel already finished in January 2022. Indicated with a red rectangle the vertical provisional column that has not yet been removed, can be seen.

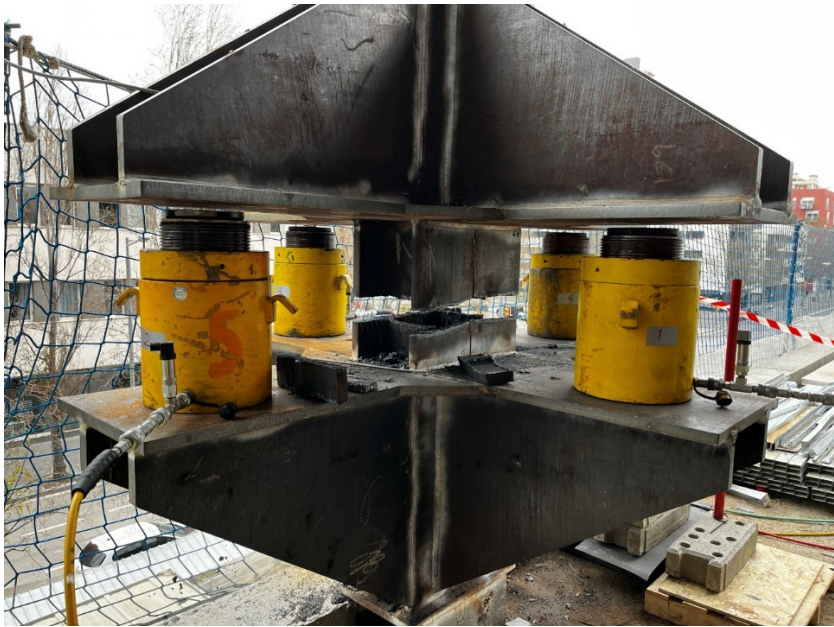
**Figure 6.** Image of the system after the column is cut and separated from the system. In the top head of each piston a space is visible. The transducers were removed before this photo was made.

During the next day, as a safety measure, the pistons were not removed as shown in Figure 6. This decision was considered so that if the structure were to settle suddenly, subsequent corrective action could be taken, leaving the structure momentarily retained. Since the hydraulic pistons had to be used urgently on another job, and since renting more days would significantly increase the final cost of the operation, the pistons were replaced with pieces of HEB sections, leaving a separation of approximately ten millimeters from the upper cantilever beams. Thus, if the system went down due to some unconsidered problem, the piece remained stabilized without the possibility of falling.
