Article

Fatigue Behavior of the Rare Earth Rich EV31A Mg Alloy: Influence of Plasma Electrolytic Oxidation

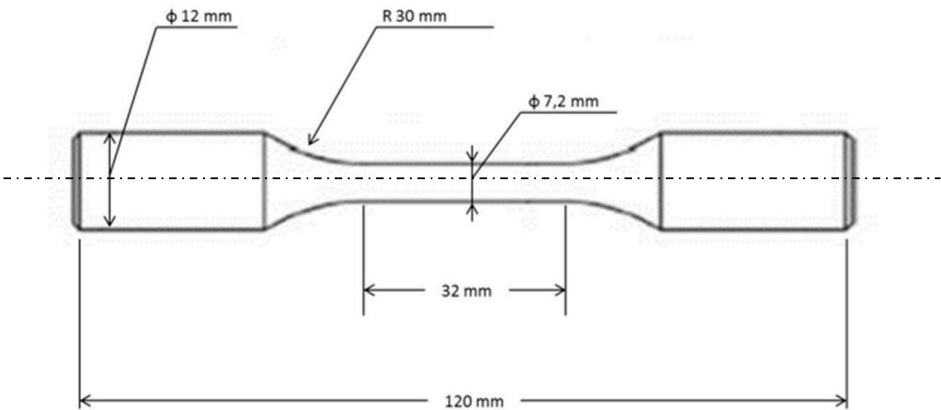
Figure 1. Geometry of rotating bending fatigue specimens

Fatigue test samples were machined from sand castings to the final geometry reported in Fig. 1 according to ISO-1143 [31] and then were T6 heat treated according to standard conditions (solutionising at 520°C for 8 h; quenching in water at 70°C; and aging at 200°C for 16 h). These treatment conditions were defined on the basis of the results of a previous work, carried out by the authors, focused on the influence of heat treatment on microstructure and tensile strength of this alloy [34].

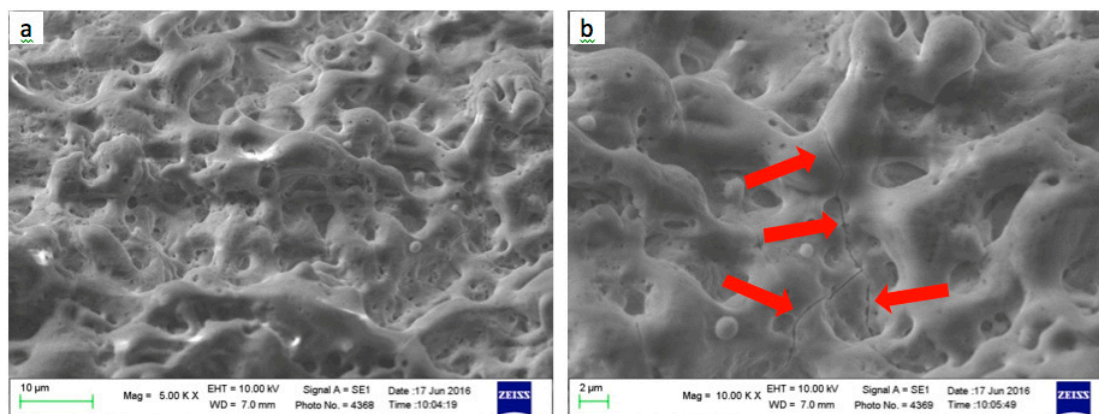
Figure 4. SEM images at different magnification of the surface of PEO treated and sandblasted fatigue specimens: smooth surface (a) with very few small cracks through the pores (b).

SEM images on the outer surface of the PEO treated and sandblasted fatigue samples are shown in Fig. 4. The sandblast process led to a relatively smooth surface, with a significant reduction of the typical cracks and microcracks present on the outer surface of the PEO layer. However, some small cracks through the pores are still present, as shown at higher magnification in Fig. 4-b.

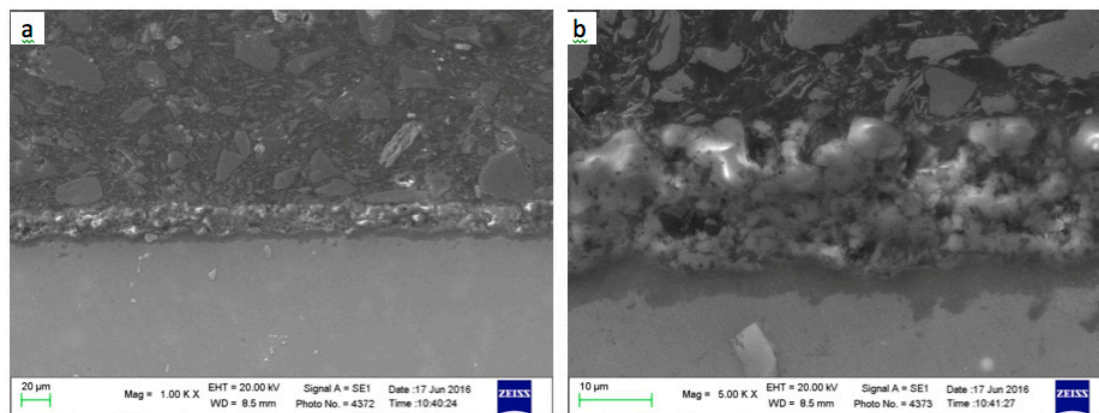
Figure 5. SEM images of PEO layer cross-section.

Representative SEM micrographs of the cross-section of the PEO-treated alloy are reported in Fig. 5 a-b. The conversion layer was about $23 \pm 3 \mu\text{m}$ in thickness and appears uniform and compact, with low density of pores and cracks, thus confirming that the sandblasting process was effective in removing the outer region of the PEO layer.

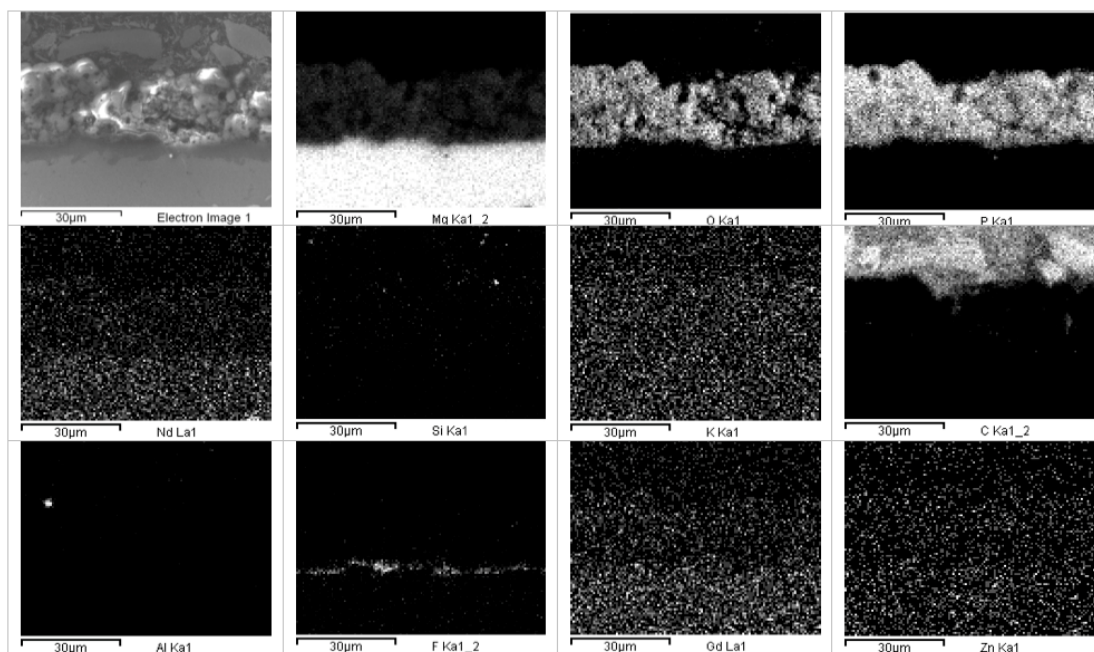
Figure 6. SEM-EDS cross section maps of the PEO layer.

SEM-EDS element maps on the cross-section, shown in Fig 6, revealed a homogenous distribution of phosphorous, potassium and oxygen due to the phosphate, silicate and potassium fluoride present in the electrolytic bath. A thin fluorine-rich layer at the interface between the PEO layer and substrate can also be detected. According to [37], this layer consists of MgF_2 and plays an important role during the PEO process, reducing electrolyte conductivity, thus decreasing the working voltage. Moreover, fluoride addition helps to obtain a more compact layer, reducing porosity and correspondingly improving mechanical performance, tribological behaviour and corrosion resistance [40].

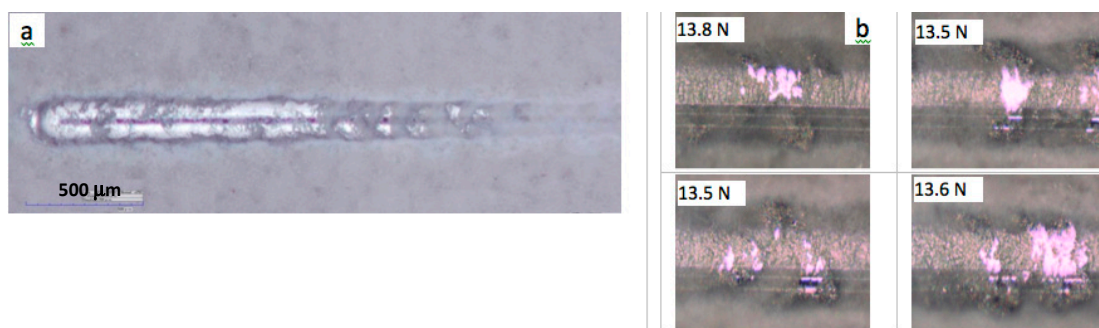
Figure 7. OM scratch test image (a); OM images of the failure area for different scratch tests with corresponding failure load (b).

PEO treatment on Mg alloys could be classified as a hard coating on a softer substrate material [41]. Scratch testing is a commonly used method to evaluate the adhesion of thin hard coatings. Failure depends on both substrate and coating properties, namely hardness and microstructural characteristics. A representative image of a scratch test performed on the PEO treated EV31A alloy is shown in Fig. 7a at a relatively low magnification, whereas more detailed images of the failure induced by the scratches are reported in Fig. 7b.

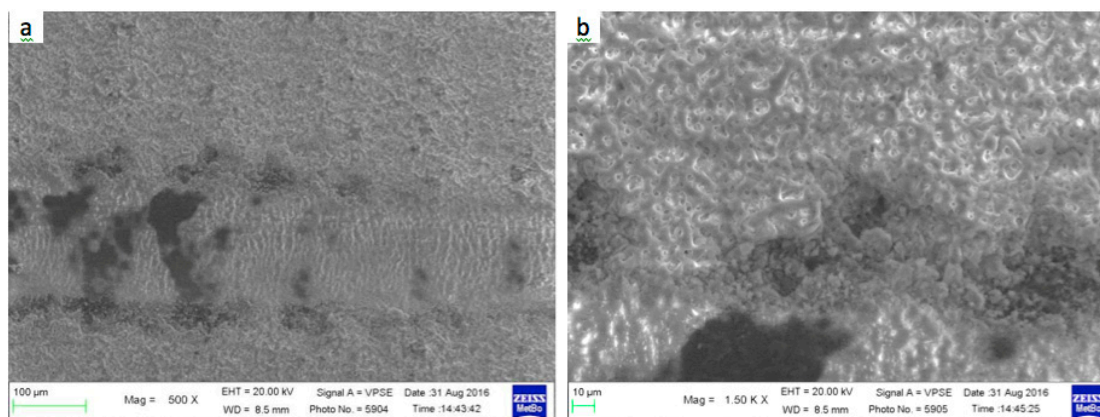
Figure 8. SEM images of the scratch test track at different magnification.

Reproducible results, in terms of failure mode and critical load, were obtained. SEM images at different magnifications of a representative scratch are shown in Fig. 8a-b, with corresponding EDS X-ray maps in Fig. 9. Buckling and spallation failure are both present in Fig. 8a-b, where coating detachment from the substrate can be clearly seen.

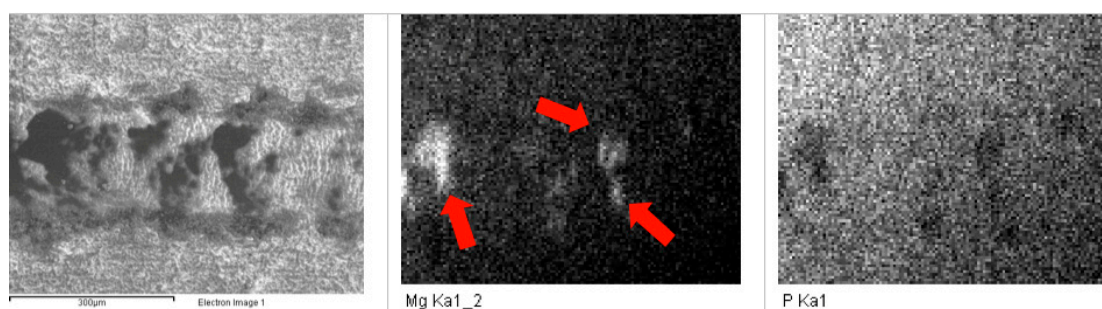
Figure 9. Representative SEM-EDS maps of the scratch tests, with the substrate highlighted by red arrows.

The EDS maps confirmed adhesion failure of the PEO coating, since the Mg substrate was detected at the bottom of the scratch, as shown in Fig. 9. Buckling failure occurs in response to the compressive stresses generated ahead of the moving indenter and typically occurs for a coating thickness less than 10 µm. Spallation occurs due to compressive shear stresses ahead of the indenter through the coating, resulting in crack nucleation that could propagate through the thickness. The continued forward motion of the indenter leads to an interfacial crack and consequent coating failure [41]. Also in this case, where the PEO layer is about 20 µm and the EV31A substrate is relatively soft, buckling and spallation are the main failure modes.

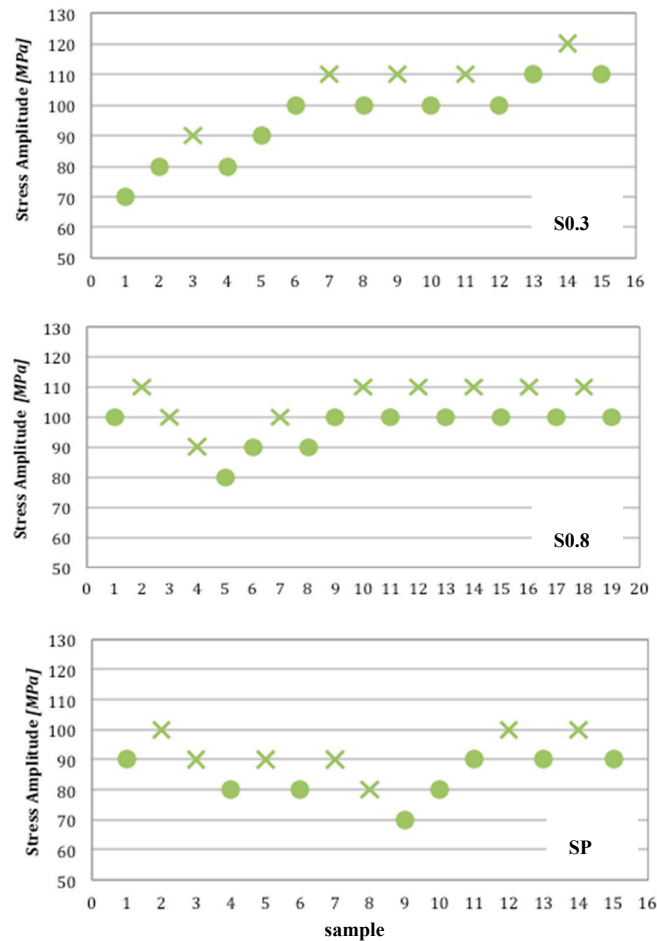
Figure 10. Stair case data for: S0.3, S0.8 and SP series (X Failures, O Survivals) . Tests were carried out according to UNI 3964 [33].

The results of the rotating bending fatigue tests carried out on the untreated sand cast EV31A Mg alloy with different surface roughness (S0.3 and S0.8 samples), and on the PEO-treated alloy are reported in Figure 10 and Table 2. It can be noted that the effect of surface roughness on the base alloy was negligible, since the difference in the mean fatigue strength values for the S0.8 and S0.3 samples was within 2% (103 and 101 MPa, respectively) and, as shown by the stair-case results in Fig. 10, the minimum stress level at which no failure occurred was 80 MPa.

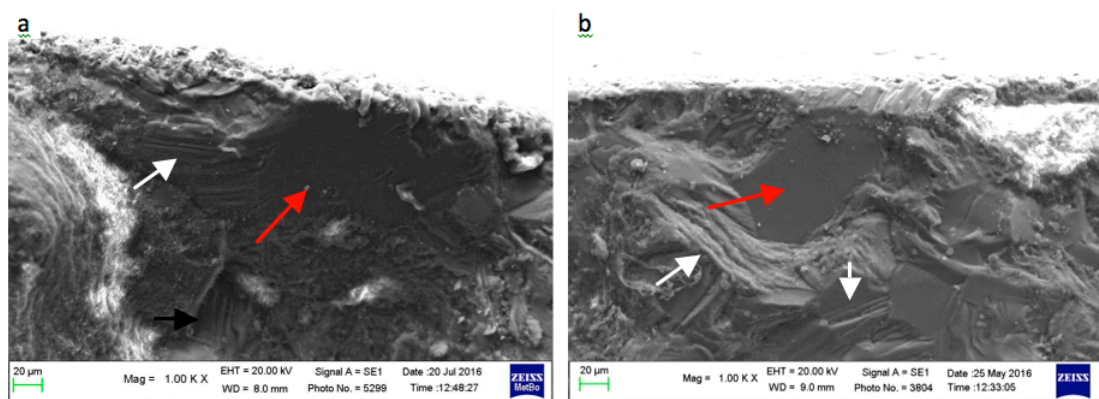
Figure 12. SEM images of crack initiation at isolated facets of cleavage planes (red arrow) surrounded by fatigue striations (white arrows) of two different PEO treated samples tested respectively at 90 MPa (a) and 100 MPa (b).

The PEO-treated samples showed the same crack nucleation mechanisms, as can be seen in Fig. 12 a-b, where cleavage facets and fatigue striations can be clearly identified.

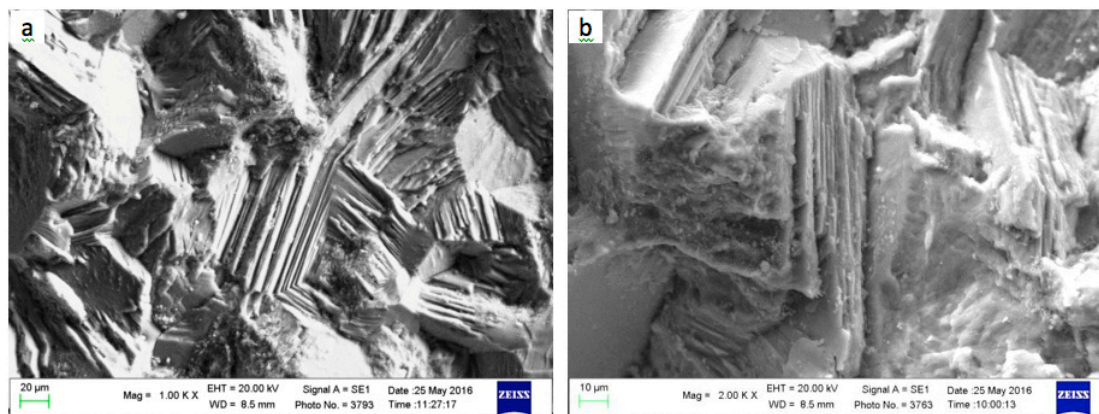
Figure 13. Representative SEM images of the crack growth region: SP sample tested at 100 MPa (a) and S0.2 sample tested at 110 MPa (b).

Representative SEM images of the crack growth region for the PEO treated and untreated samples are, instead, reported in Fig 13 a-b, showing the presence of classic fatigue striations. In Mg alloys their formation is generally associated with the dislocation slip and twinning mechanisms in the plastic zone ahead of the fatigue crack tip [4,6,48].

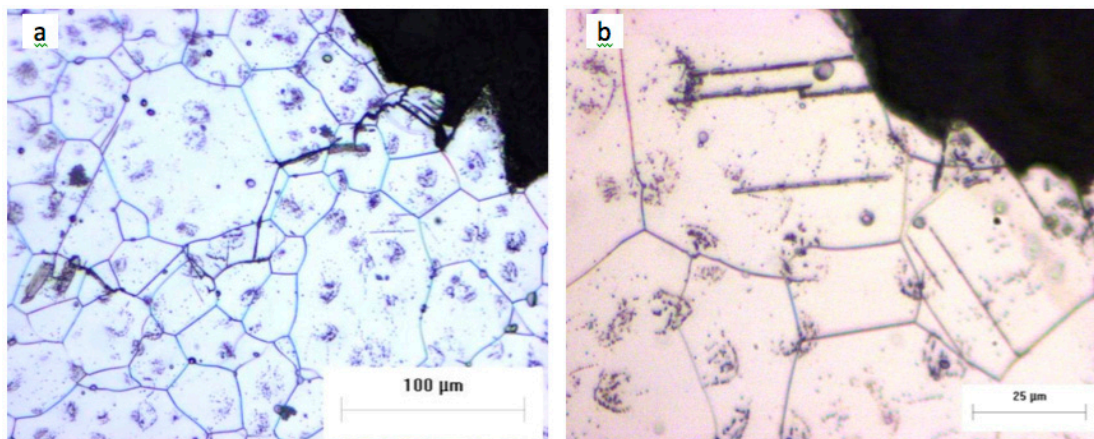
Figure 14. Representative OM images of longitudinal sections (parallel to the gauge length), of a S0.2 samples tested at 110 MPa: secondary transgranular cracks (a) and slip bands inside the grains (b).

In this region also secondary transgranular cracks are clearly visible, as shown by representative OM images on longitudinal sections of fatigue samples (Fig. 14 a); they originated from the main cracks, confirming a transgranular and intergranular mixed mode of crack propagation. Slip bands can be clearly seen inside the grains (Fig 14 b), confirming the previously discussed mechanism for fatigue striations formation.

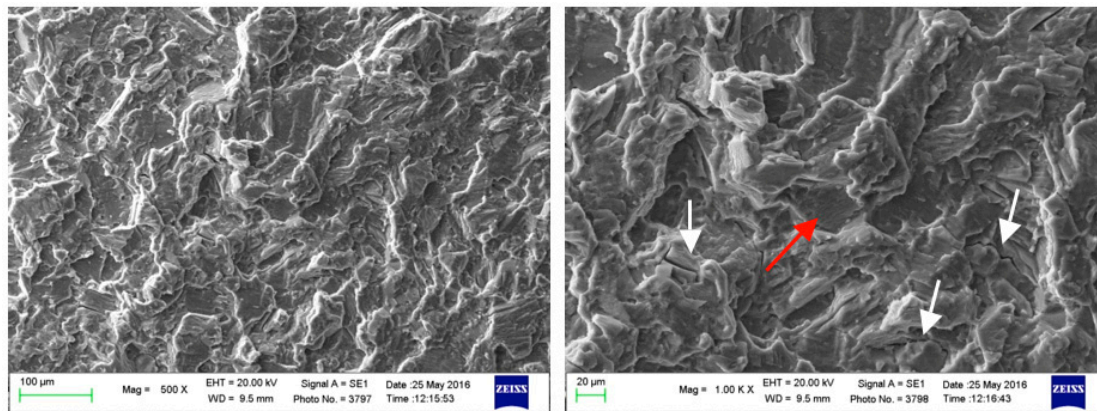
Figure 15. Representative SEM images in the overloading area at low magnification (a), and high magnification with cleavage planes (red arrow) and secondary microcracks (white arrows) (b).

Finally, representative SEM images of the overloading regions are reported in Fig 15, where a typical brittle morphology, with cleavage planes and secondary cracks, can be observed.
