Watching the Beach Steadily Disappearing – the Evolution of Understanding of Retrogressive Breach Failures

Dick R. Mastbergen^{1,*}, Konrad Beinssen² and Yves Nédélec³

Abstract: Retrogressive breach failures or coastal flow slides occur naturally in the shoreface in fine sands near dynamic tidal channels or rivers. They sometimes retrogress into beaches, shoal margins and river banks where they can threaten infrastructure and cause severe coastal erosion and flood risk. Ever since the first reports were published in the Netherlands over a century ago, attempts have been made to understand the geo-mechanical mechanism of flow slides. In this paper we have established that events, observed during the active phase, are characterized by a slow and steady retrogression into the shoreline, often continuing for many hours. This can be explained by the breaching mechanism, as elaborated in this paper. Recently, further evidence has become available in the form of video footage of active events in Australia and elsewhere, often publicly posted on the internet. All these observations justify the new term ‘retrogressive breach failure’ (RBF event). The mechanism has been confirmed in small-

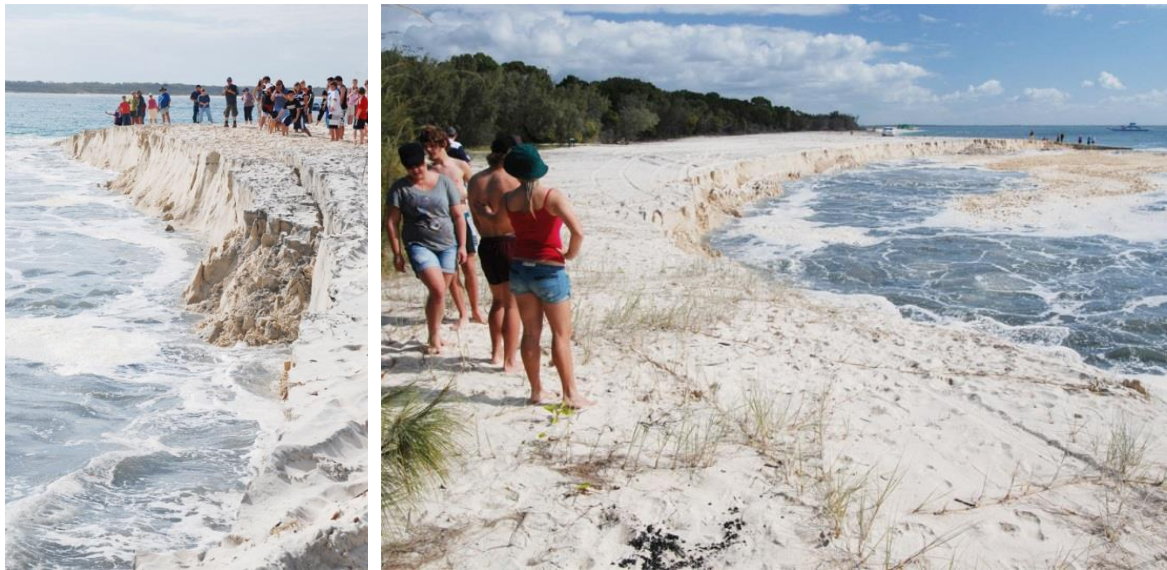
Figure 2. An active RBF even at Inskip Point, Queensland, Australia, 2011. Gympie Times / Jim Wyers / Youtube.

The first video of a large beach collapse that we now identify as an RBF event, was recorded with a cell phone at Inskip Point, Australia in 2011 and posted on the internet (Figure 2). This event was also reported by the TEN NEWS network. Large events at this location again took place and were recorded and posted in 2015 (with some damage to a camping area) and most recently 2018 (Figure 1). We found more examples of internet published footage of active events. In the USA, an event at Fort Popham, MN was recorded in 2011 and another at North Wildwood, NJ, in 2012 where on a previous occasion, reported by NBC10 Philadelphia, three bathers fell into the water and where dragged into the tidal current and drowned. Another event occurred in the Philippines at Candelaria, Zambales in 2013, reported by ANC news. Videos clearly reveal the slow retrogressive nature of the above RBF events, the sliding of blocks of sand and the steep scar. Typical RBF 'foot prints' often can be identified on Google Earth satellite images, Figure 8(a).

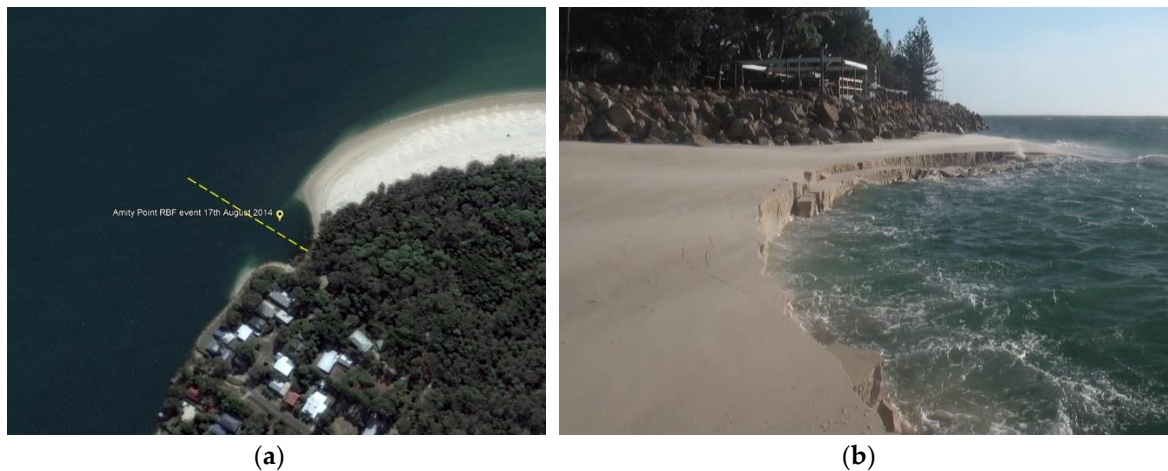
Figure 8. (a) Satellite image of an RBF crater at Amity Point captured on 18th August 2014 (Google Earth) (b) Image of this active event reaching the beach on 17th August 2014 viewed to the South, from [1].

Beinssen and Neil [2] describe how a collapsing riprap works to quench an active event. If an event encounters a rock wall defense and the base of the breach is higher than the rock wall foundations, the event terminates because it runs out of sand (Figure 8). If the base of the breach is lower than the rock wall foundations, the breach will undermine the rocks and the wall will slump or collapse (Figure 17).

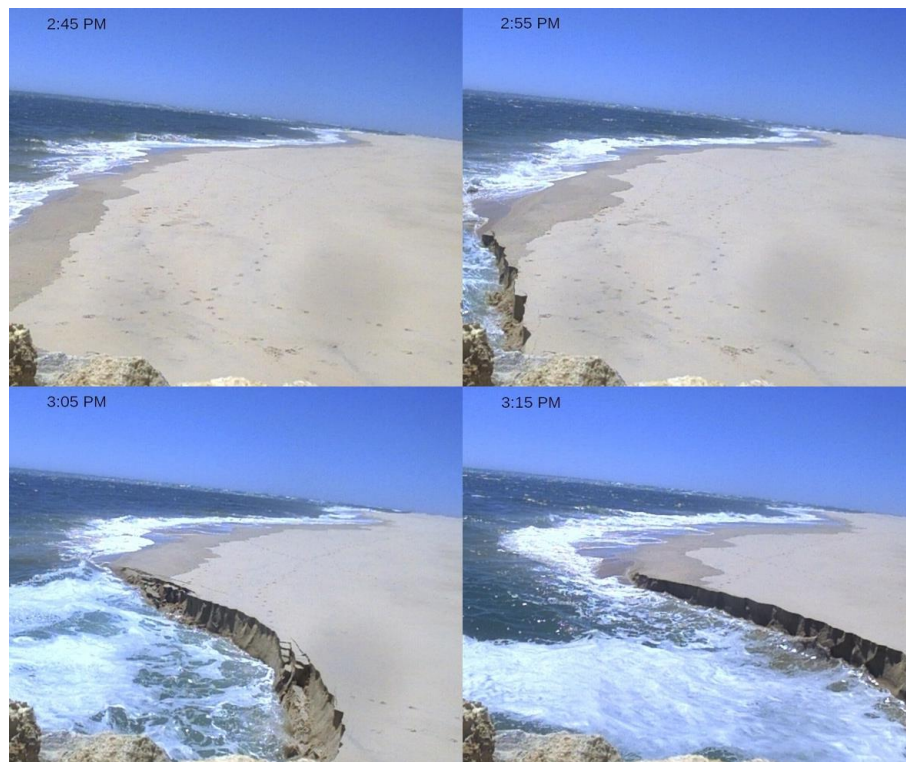
Figure 13. Beach collapse at Cap Ferret, dated June 2016. Time stamps 2:45, 2:55, 3:05 and 3:15 PM.

Figure 13 shows another event at Cap Ferret, seen over a timestamped sequence of static views. It shows a regression speed of about 10 meters over half an hour or about 5 mm/s.

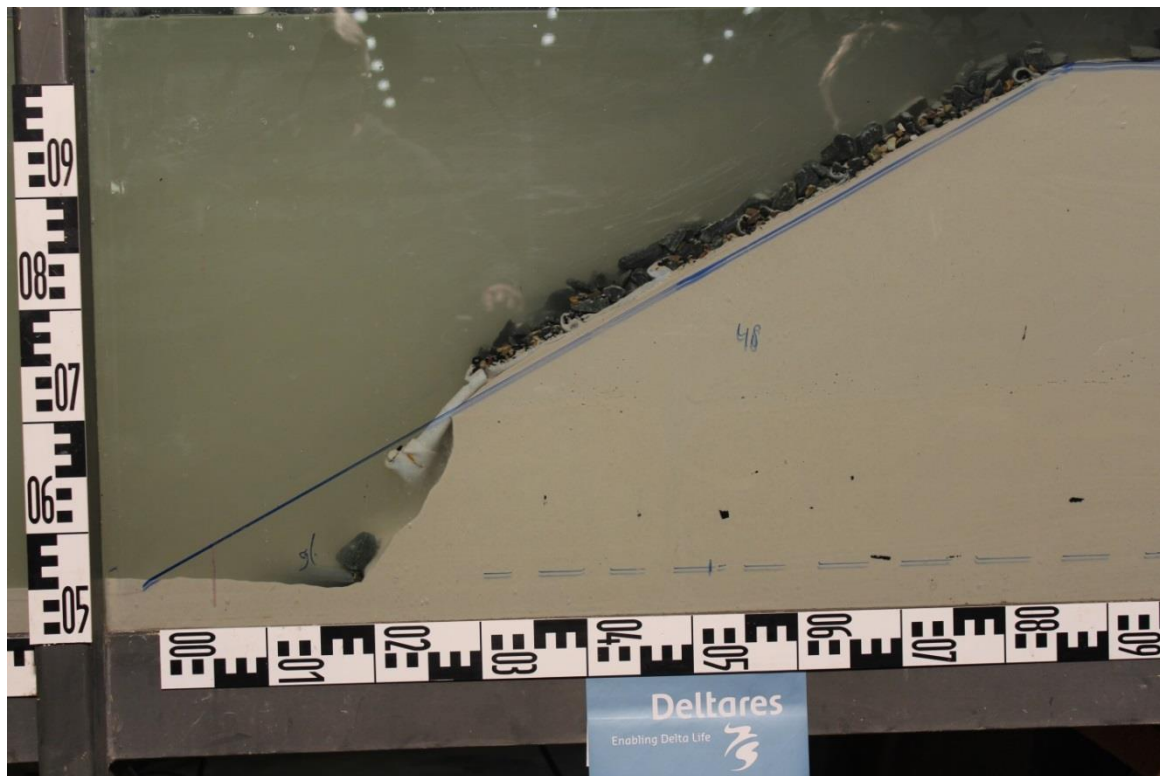
Figure 16. Model test of breaching under a slowly collapsing rock slope protection consisting of a filter layer of fine and coarse gravel on a permeable geotextile membrane [64]. Photo: M. Busink.

How stone protection against RBF events actually works has been demonstrated in a small-scale flume test with a 1:2 (26°) protected slope in fine sand (see Figure 16 and compare this with Figure 14). Two types of protection were used, a) a filter construction of fine and coarse gravel laid directly on the sand and b), the same protection layer but on top of a permeable geotextile membrane. In the test with the geotextile, undermining by breaching continued until finally the complete slope was degraded and the natural angle of repose was reached. In the test with loose gravel protection, the retrogression of the breach was immediately smothered by the loose rocks covering the breach. In both cases the retrogressing breach did not develop into a full RBF event, since in small scale experimental conditions a sufficiently strong density current cannot develop.

breach will be quickly covered and smothered, preventing further retrogression, as shown in flume tests, Figure 16.

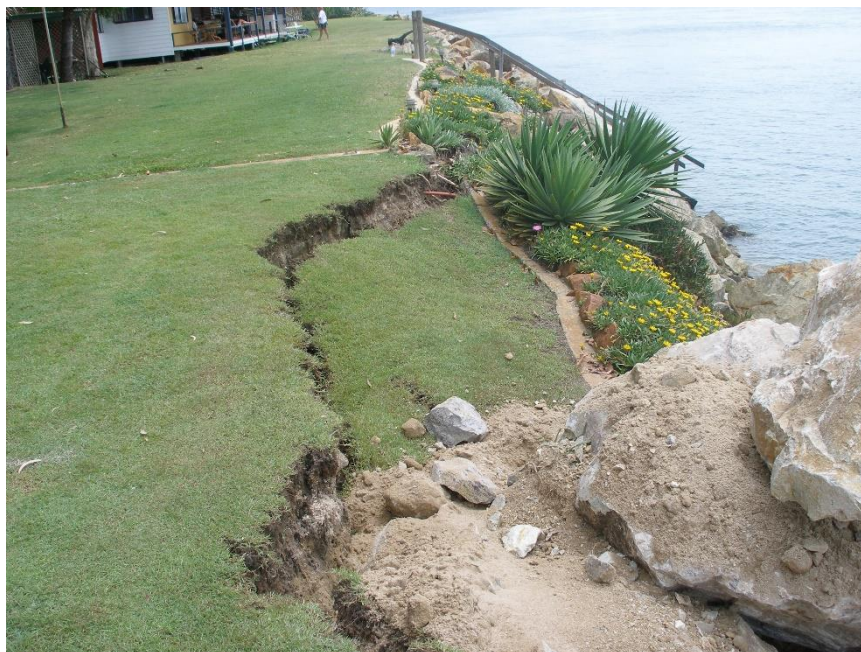
Figure 17. Damage to the 'Barrier' at Amity Point (2016) after an RBF event has partly undermined it. Repairs by adding new rock have started. Photo: Beinssen.
