Gradual Strengthening of Existing Masonry Houses with Ferrocement Bandaging

Abstract

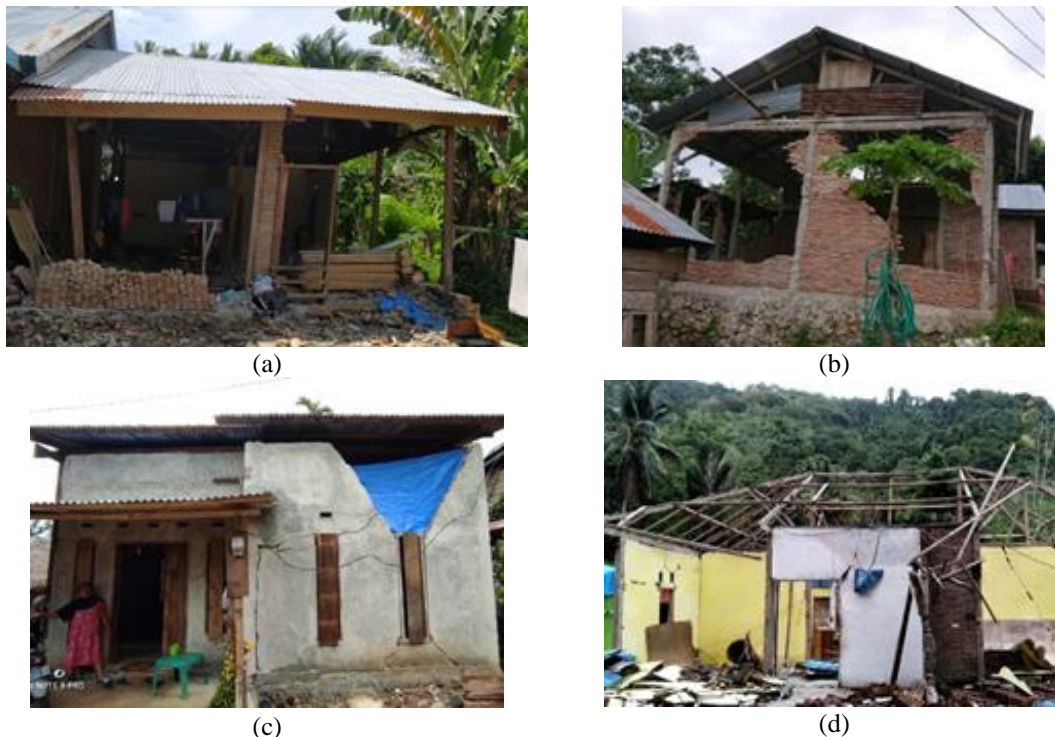
Figure 1. Examples of poorly built houses from the West Sulawesi Earthquake on January 15th, 2021

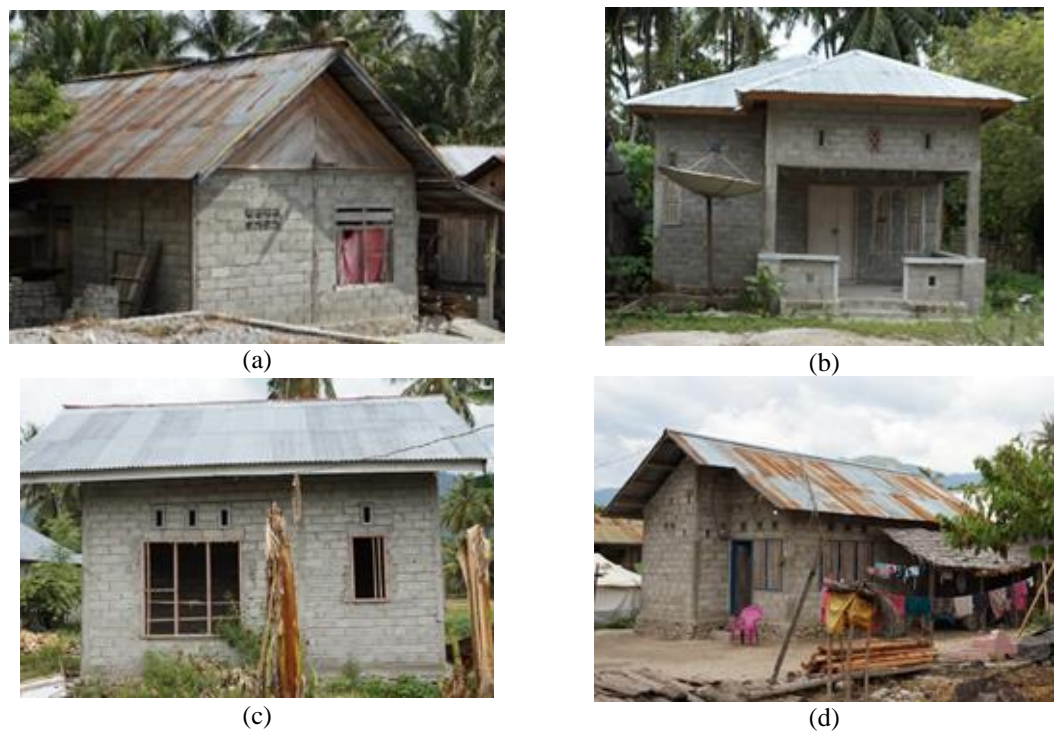
Figure 2. Examples of poorly built houses from the Palu (Central Sulawesi) Earthquake on September 28th, 2018

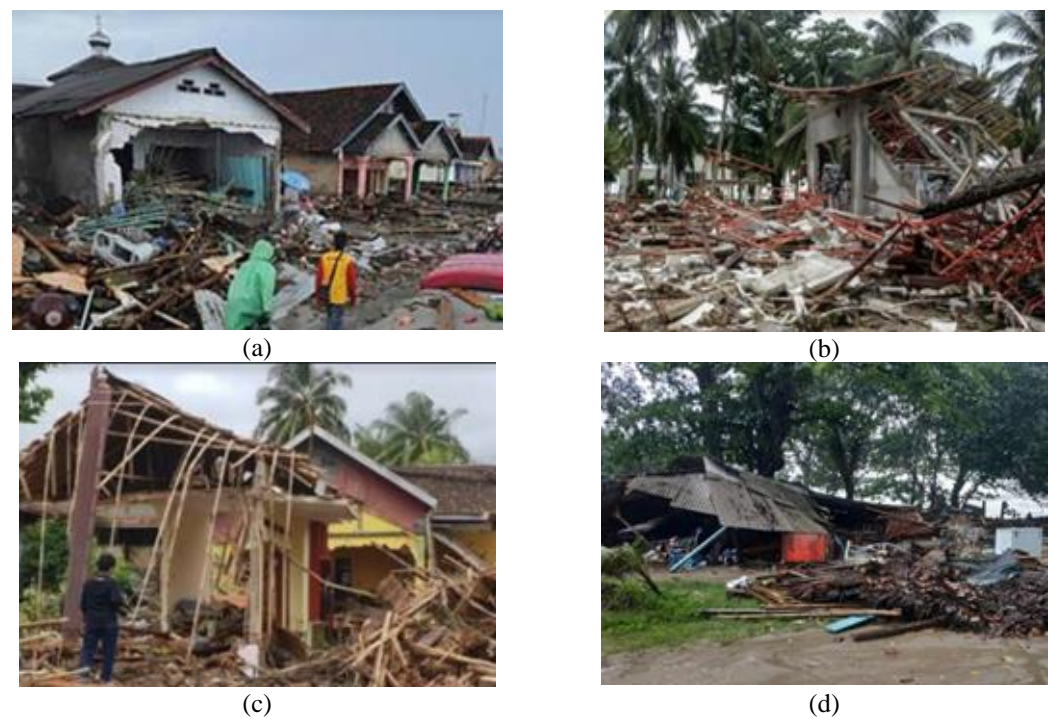
Figure 3. Examples of poorly built houses from the Selat Sunda Earthquake and Tsunami on December 22th, 2018

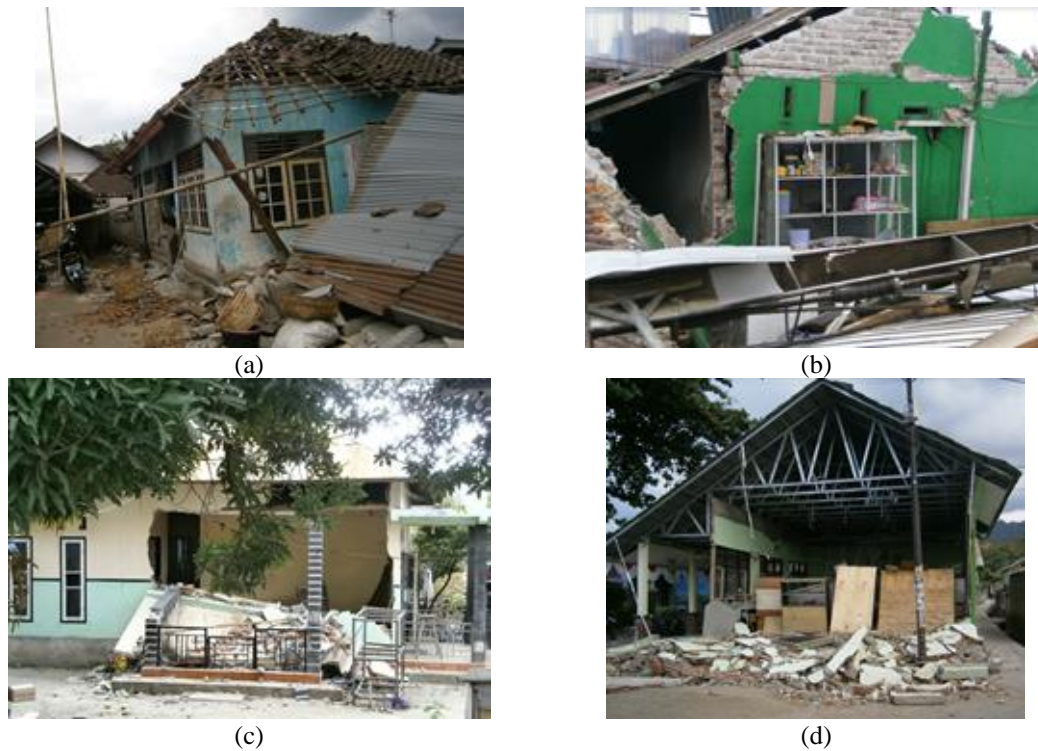
Figure 4. Examples of poorly built houses from the Lombok Earthquake on July 29th, 2018

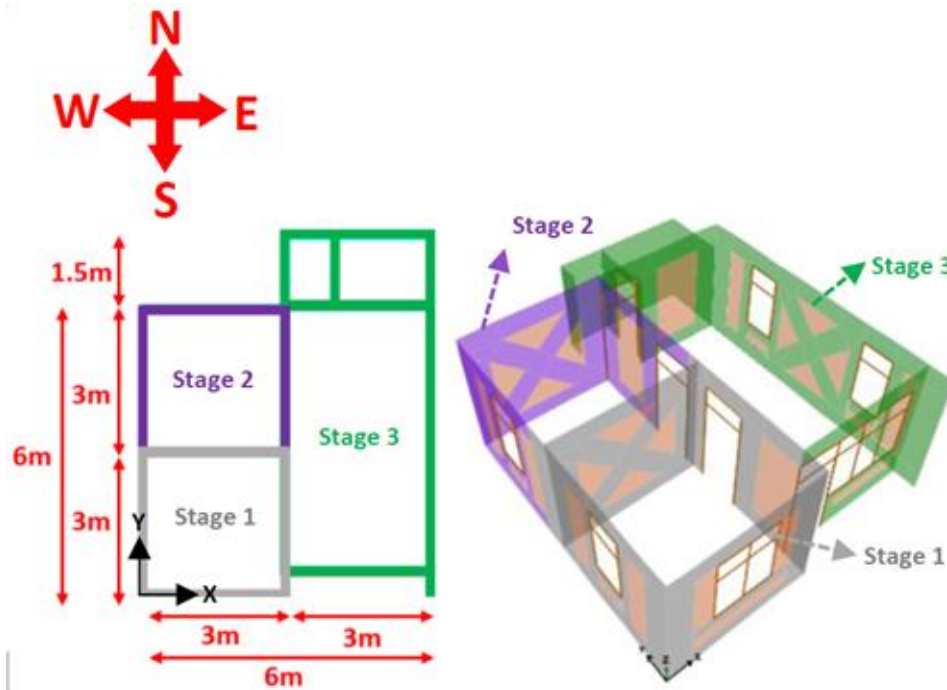
Figure 5. Sample layout of a gradual strengthening masonry house

strengthening does not mean that retrofitting can be delayed for years, but rather that reinforcement must be carried out as soon as possible to prevent collapse due to an upcoming earthquake. Three stages should be finished within one year, meaning the masonry house is fully strengthened by ferrocement bandaging (see Figure. 5).

The analysis model of sample house bandaged by ferrocement layers follow the same method as indicated in reference [14]. The gradual strengthening analysis is started from the first stage, one bedroom. Then it is continued to the next bedroom for the second stage and subsequently completed for the last step, which is bandaging the entire masonry house, as shown in Figure. 5.

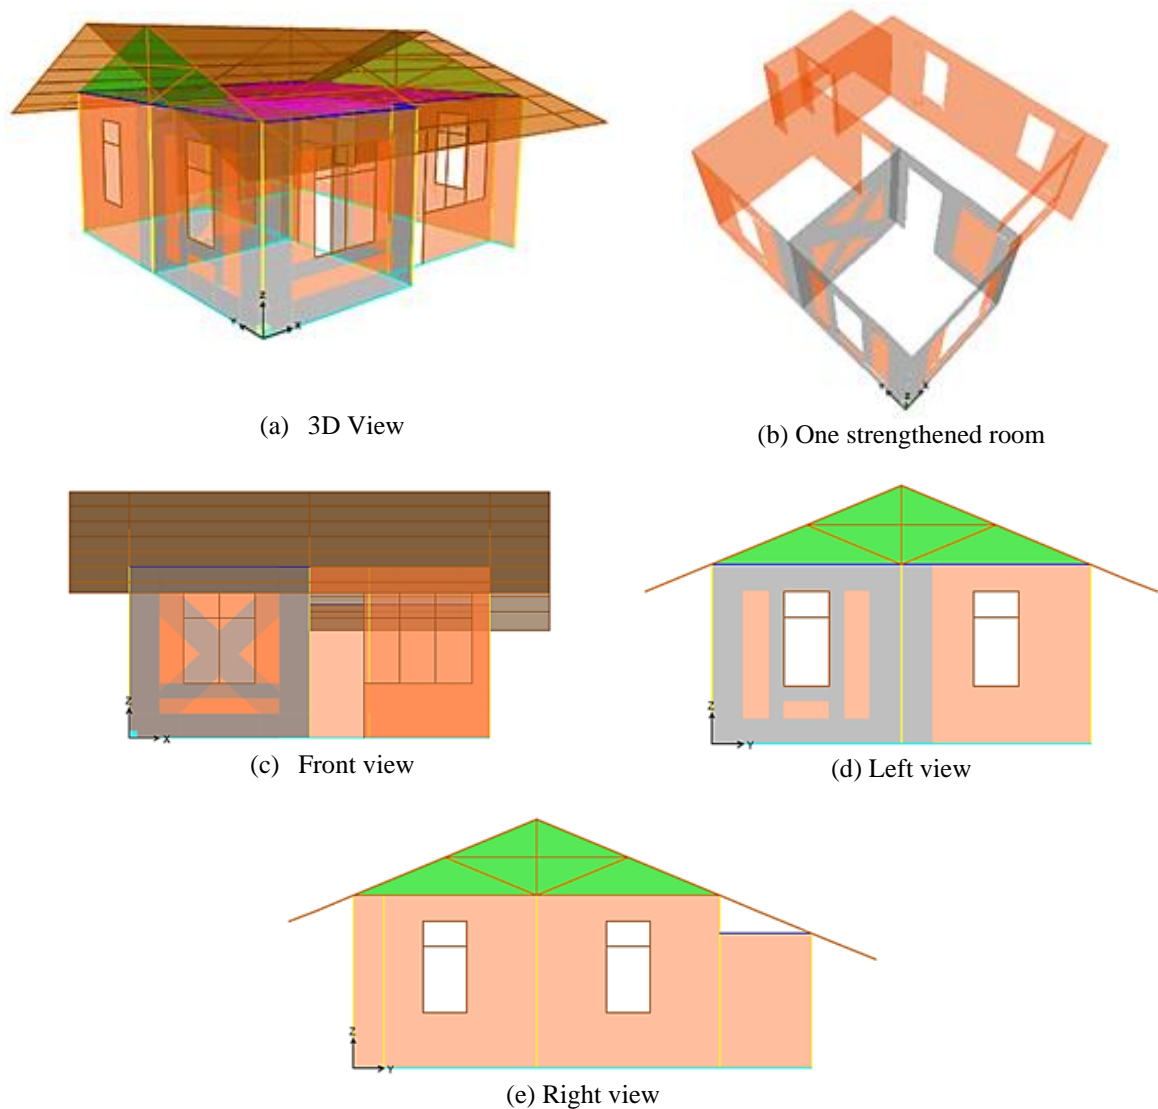
Figure 6. Model of sample house with one strengthened room

The modeling of an existing masonry house uses columns and beams of poor quality, as is the reality found in actual practice. Columns and beams do not need to be dismantled. Just restored and directly bandaged with ferrocement layers. Figure. 6 shows the model of the sample masonry house for the analysis, and Figure. 7 depicts the installation sketch of ferrocement layers.

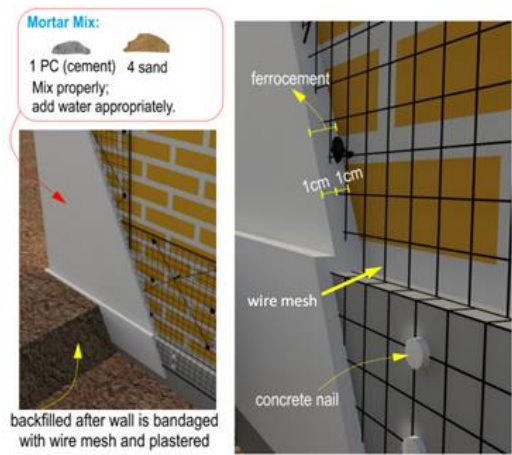
Figure 7. Sketch of ferrocement layer installation [15]

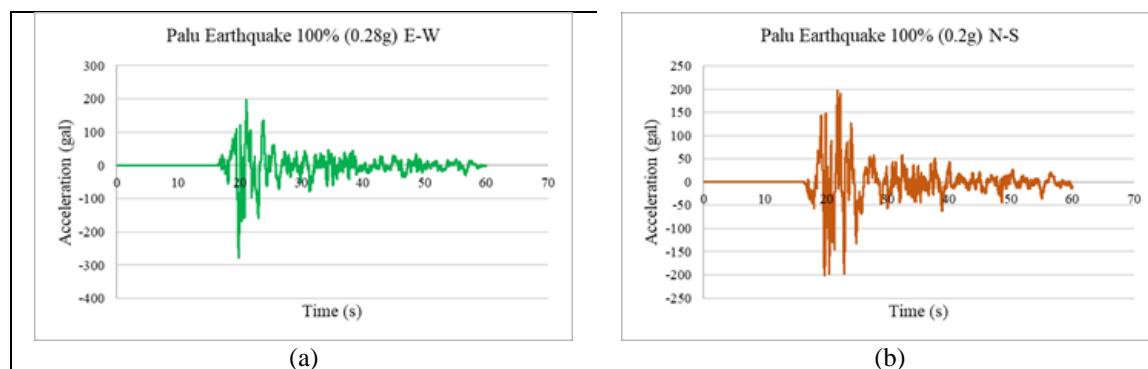
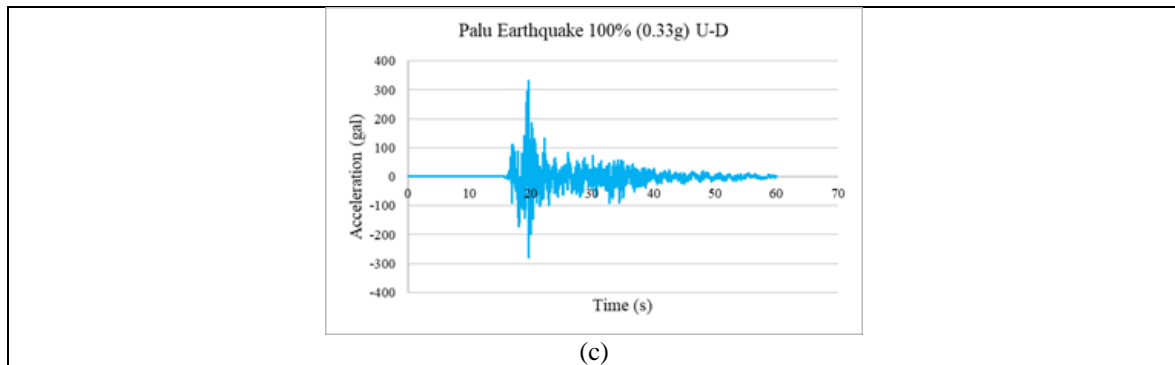
Figure 8. Palu (Central Sulawesi) earthquake records [17]

The earthquake records used in the analysis are the September 28th, 2018 Palu (Central Sulawesi) earthquake (0.33g) and the September 30th, 2009 Padang (West Sumatra) earthquake (0.3g) [17,18]. The Palu earthquake record represents a single pulse-type earthquake dominant in the U-D direction (see Figure. 8). Meanwhile, the Padang earthquake record represents multiple pulse-type earthquakes dominant in the N-S direction (see Figure. 9). The model analysis for both earthquake records is conducted by running earthquake loads in 3 directions simultaneously, namely the X, Y, and Z directions of the building, as shown in Figure. 6. The X-direction of the building is given an E-W direction of earthquake load, the Y direction of the building is given an N-S direction of earthquake load, and the Z-direction of the building is given a U-D direction of earthquake load.

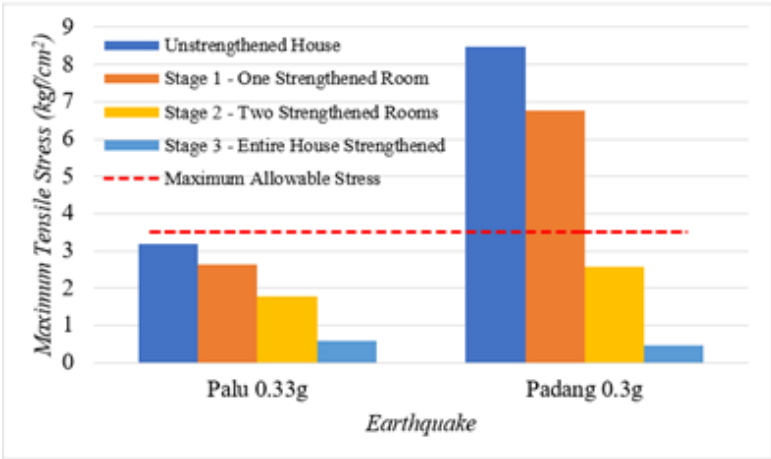
Figure 10. The maximum tensile stress of masonry wall

The results of gradual strengthening analysis started from stage 1 to stage 3 show a significant impact on the strength of masonry houses when bandaged using ferrocement layers. Below are the graphs to summarize the maximum tensile stress resulting from the Palu and Padang earthquake shaking (see Figure. 10 until Figure. 12). The result of each stage is elaborated deeply in part 5.1. until 5.4.

From the analysis, when shaken by the Palu earthquake, the tensile stress at a small part of the unstrengthened masonry wall (Figure. 14) exceeds the allowable stress limit (3.5 kgf/cm^2), whereas, for strengthened masonry wall, the tensile stress occurred is very small. When shaken by the Padang earthquake, the unstrengthened masonry wall suffered severe damage, marked by blue color in some parts. From Figure. 10, the maximum stress at the masonry wall is 6.77 kgf/cm^2 .

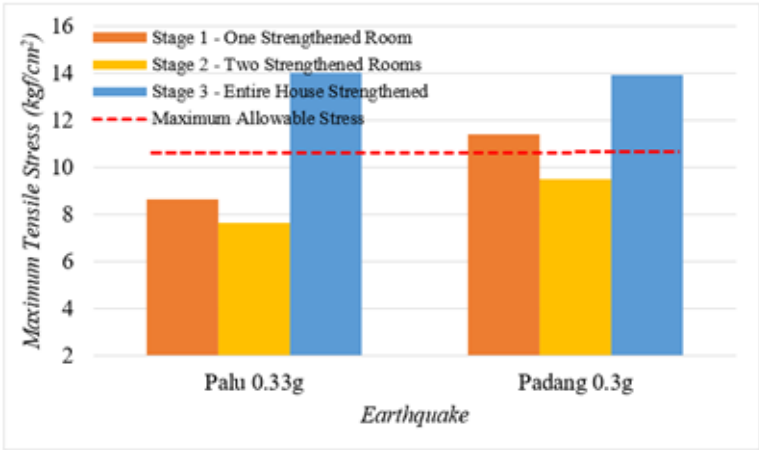
Figure 11. The maximum tensile stress of outer ferrocement layers

For one room strengthened by ferrocement layers, when shaken by the Padang earthquake, the tensile stress in the ferrocement layers slightly exceeds the allowable stress (the maximum stress that occurred was 11.4 kgf/cm² as can be seen in Figure. 11 and Figure. 12). This indicates that the ferrocement layers may experience a slight crack but not collapse (see Figure. 15 and Figure. 16).

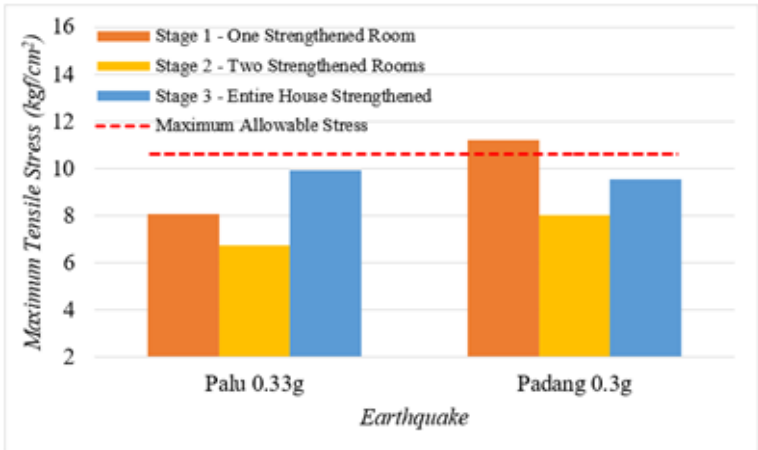
Figure 12. The maximum tensile stress of inner ferrocement layers

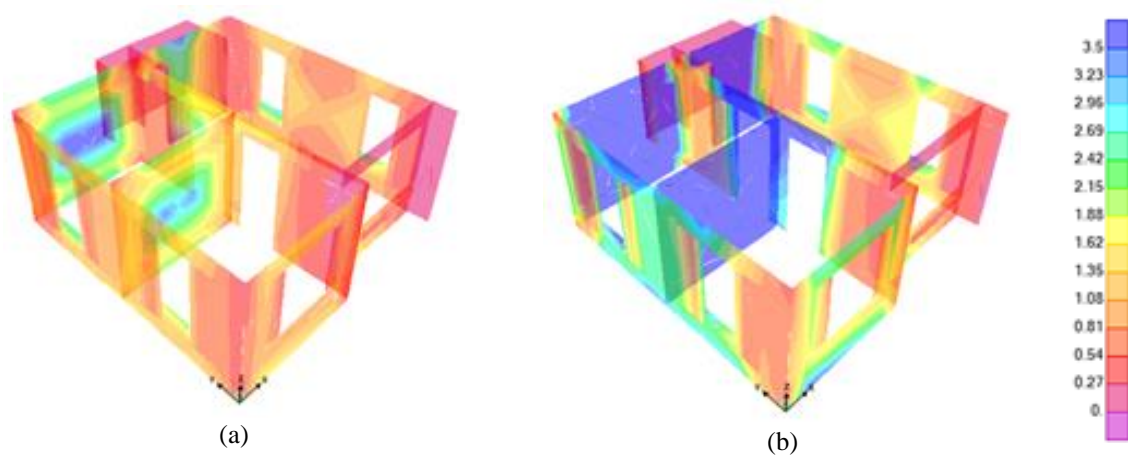
Figure 13. The maximum tensile stress pattern of masonry wall (unit in kgf/cm^2) due to (a) Palu earthquake and (b) Padang earthquake

The results of the analysis of unreinforced masonry houses when shaken by Palu and Padang earthquakes provide a significant difference due to the characteristics of the Padang earthquake, which is a multiple pulse type. In contrast, the Palu earthquake is a single pulse type. It proves that the masonry walls were quite strong when shaken by the Palu earthquake, while when they were shocked by the Padang earthquake, most of the wall tensile stress had exceeded the allowable stress limit (3.5 kgf/cm^2) as indicated in blue color. As shown in Figure. 10, the tensile stress in the walls reaches 8.48 kgf/cm^2 . It could be said that the walls were heavily damaged and might even collapse.

The damaged walls indicated in blue color are the result of the high level of the out-of-plane load caused by the N-S direction earthquake. Since Padang earthquake records in the N-S direction are more significant than E-W (see Figure. 9), the damaged masonry walls in Figure. 13 are perpendicular to the N-S direction. Based on the above finding, it is suggested that the strengthening of masonry houses should be prioritized and implemented.

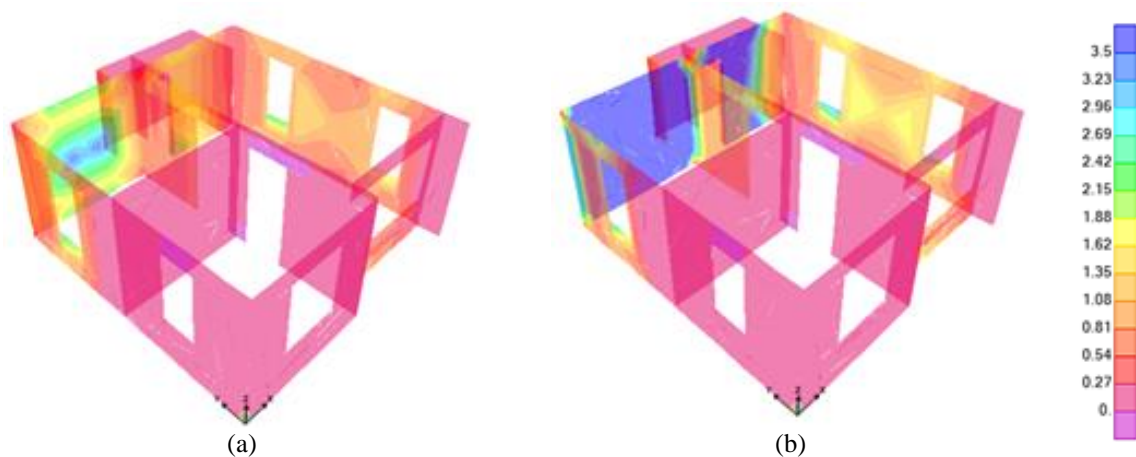
Figure 14. The maximum tensile stress pattern of masonry wall (unit in kgf/cm²) due to (a) Palu earthquake and (b) Padang earthquake

Compared to the prior analysis of one strengthened room (see Figure. 14), the previously unstrengthened second room is now earthquake-resistant due to the ferrocement bandaging.

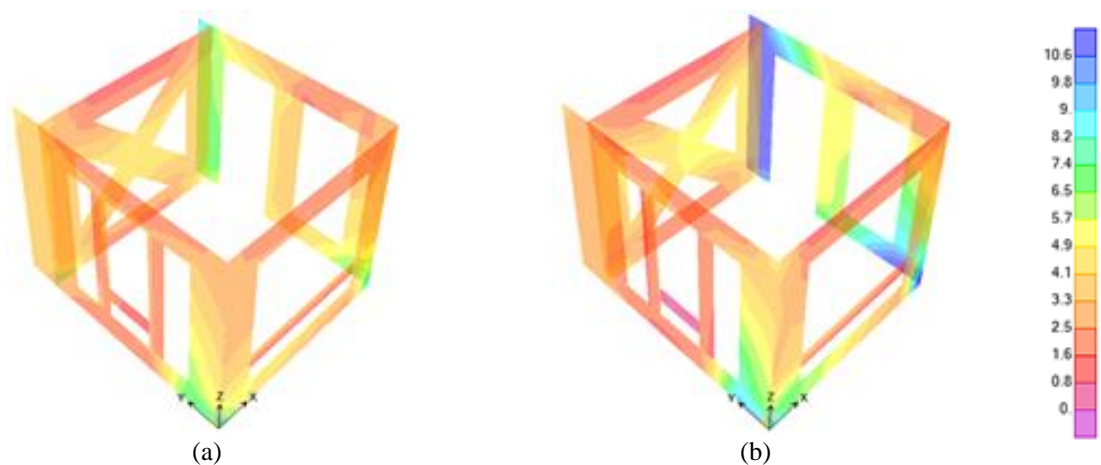
Figure 15. The maximum tensile stress pattern of outer ferrocement layers (unit in kgf/cm²) due to (a) Palu earthquake and (b) Padang earthquake

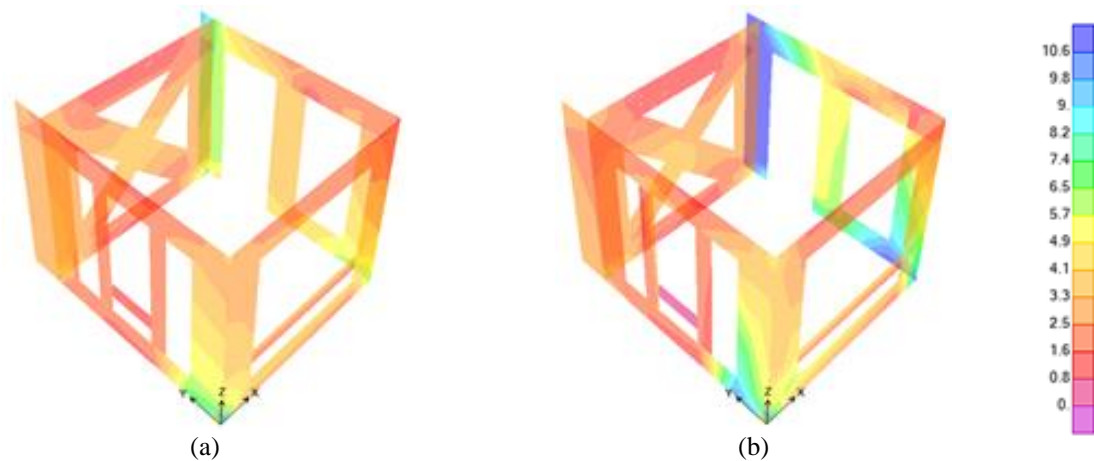
Figure 16. The maximum tensile stress pattern of inner ferrocement layers (unit in kgf/cm²) due to (a) Palu earthquake and (b) Padang earthquake

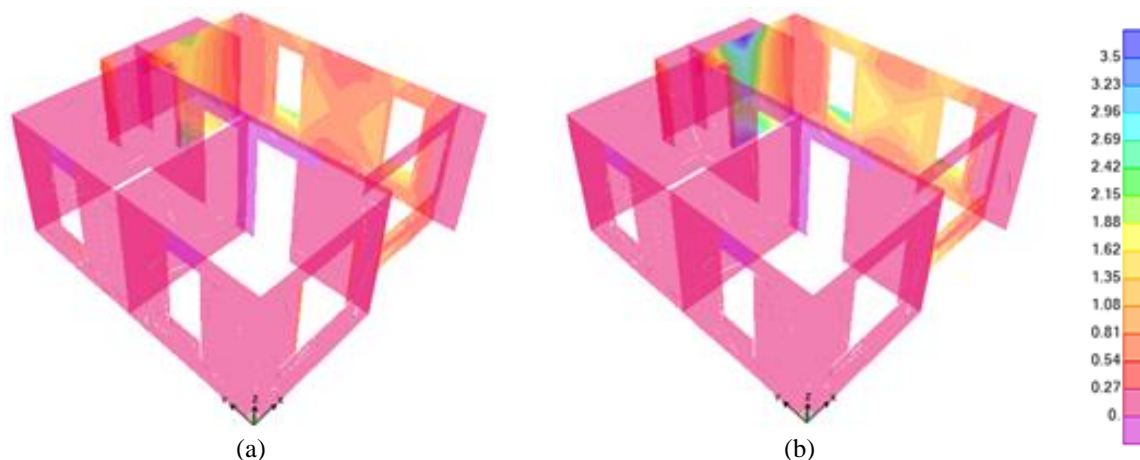
Figure 17. The maximum tensile stress pattern of masonry wall (unit in kgf/cm²) due to (a) Palu earthquake and (b) Padang earthquake

In the second stage, the strengthening is applied to 2 bedrooms. For the unreinforced masonry wall, the analysis results show that the maximum stress in the North wall did exceed the allowable stress limit when shaken by the Padang earthquake (see Figure. 17). This is influenced by the Padang earthquake's out-of-plane load, which is much more significant in the Y direction (0.3g) than in the house's X direction (0.25g).

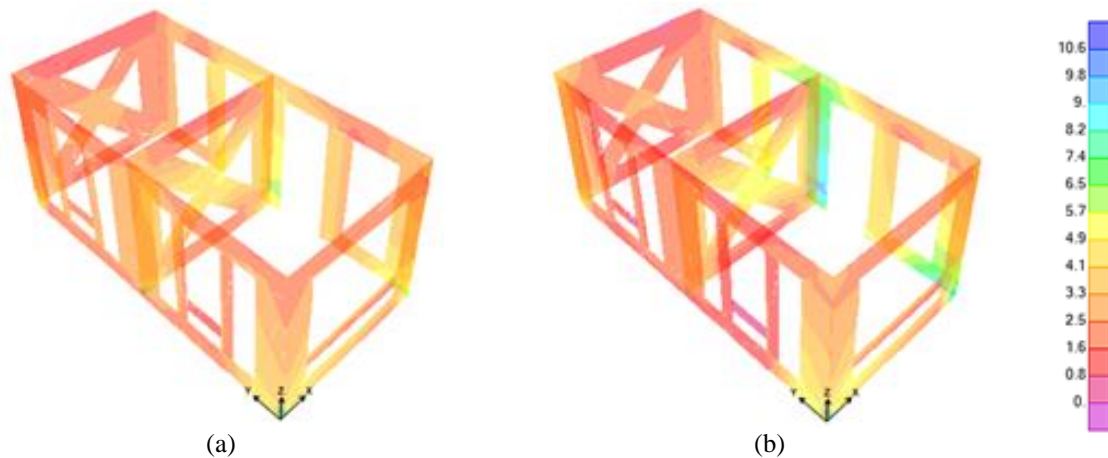
Figure 18. The maximum tensile stress pattern of outer ferrocement layers (unit in kgf/cm²) due to (a) Palu earthquake and (b) Padang earthquake

The earthquake can occur at any time. Therefore, it is better to strengthen the masonry house entirely up to stage 3. For both the inner and outer ferrocement layers, it can be seen clearly that the tensile stress that occurred in ferrocement layers is only around 3-6 kgf/cm² (see Figure. 18 and Figure. 19), below the allowable tensile stress limit (10.63 kgf/cm²).

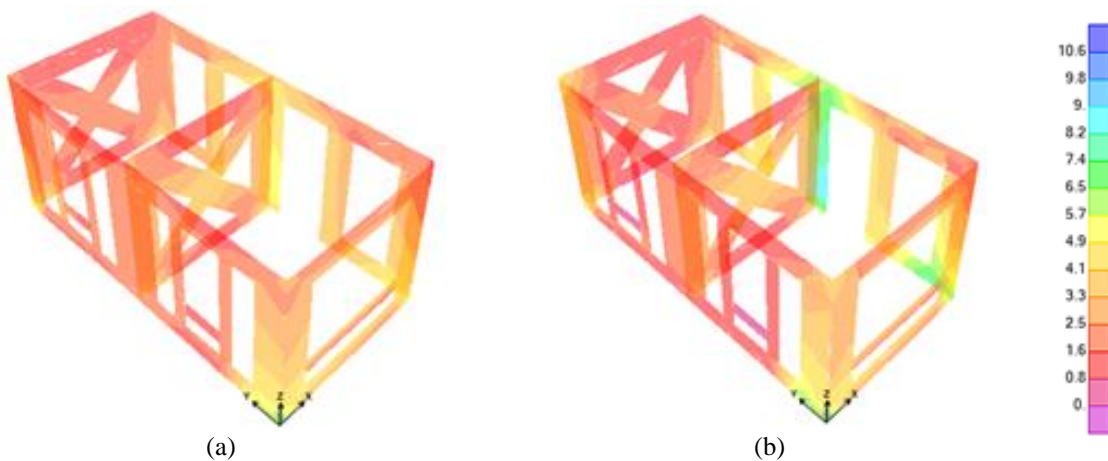
Figure 19. The maximum tensile stress pattern of inner ferrocement layers (unit in kgf/cm²) due to (a) Palu earthquake and (b) Padang earthquake

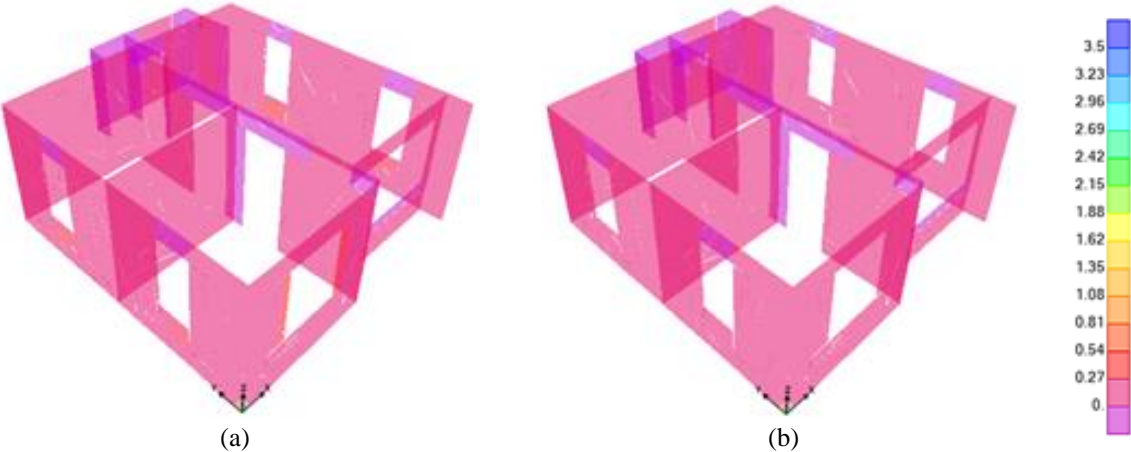
Figure 20. The maximum tensile stress pattern of masonry wall (unit in kgf/cm²) due to (a) Palu earthquake and (b) Padang earthquake

When all masonry walls are strengthened by ferrocement bandaging, the tensile stresses are become smaller, as shown in Figure. 20. In general, the tensile stress of ferrocement layers when shaken by Palu and Padang earthquakes was below the allowable stress (10.63 kgf/cm²), as shown in Figure. 21 and Figure. 22. For the right wall, where there is no room partition, the tensile stress of outer ferrocement layers slightly exceeds the allowable stress (see Figure. 11), which indicates the possibility of cracks. The analysis results of stage 3 show that the masonry house strengthened by ferrocement layers is earthquake resistant.

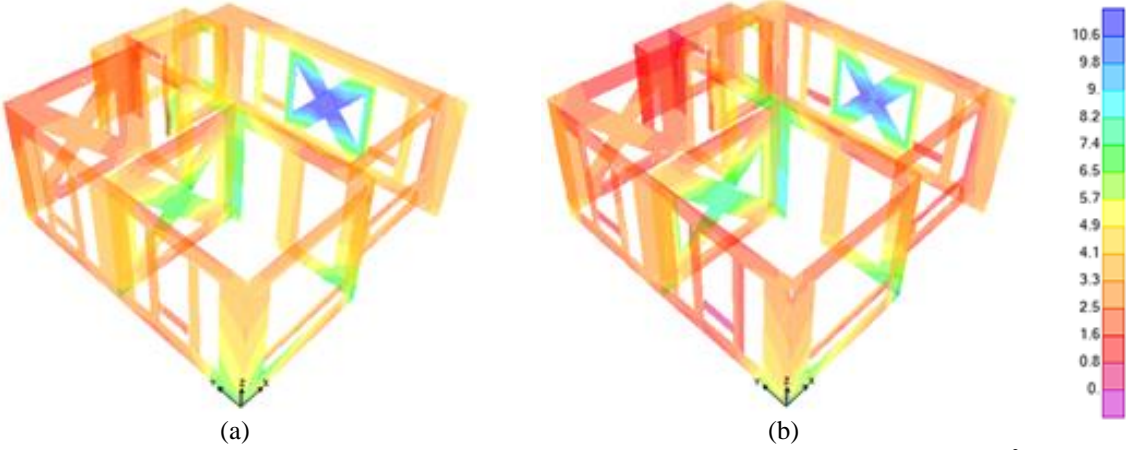
Figure 21. The maximum tensile stress pattern of outer ferrocement layers (unit in kgf/cm²) due to Palu earthquake (a) and Padang earthquake (b)

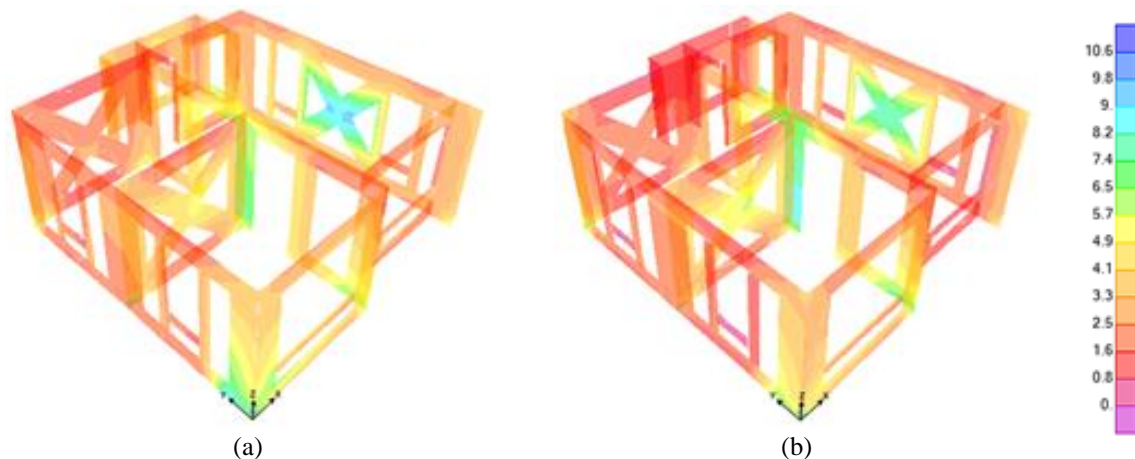
Figure 22. The maximum tensile stress pattern of inner ferrocement layers (unit in kgf/cm²) due to (a) Palu earthquake and (b) Padang earthquake
