Studying the water supply system of the Roman villa of Pisões (Beja, Portugal) using ground-penetrating radar and geospatial methods

Abstract: The Roman villa of Pisões (Beja, Portugal), was part of the Lusitanian colony of Pax Iulia. This place stands out for the predominance of the water element in several structures of the villa, highlighting the *balneum* and the large *natatio*, one of the largest known in Roman Hispania. The records of the initial excavations that took place since 1967 do not allow the establishment of clear functionalities of the villa. The University of Évora, owner of the site, conceived an action plan for the requalification and enhancement of the archaeological site. One of the tasks aims to investigate using Applied Geophysics. This work analyses the landscape directly related to the villa, given that it is in the flooded area of a river, with a Roman containment dam. It is uncertain whether the water supply comes from this structure or other nearby springs. The use of ground-penetrating radar, combined with unnamed aerial vehicles, all integrated in a geographic information system, allows us to know the location of underground water connections and cr

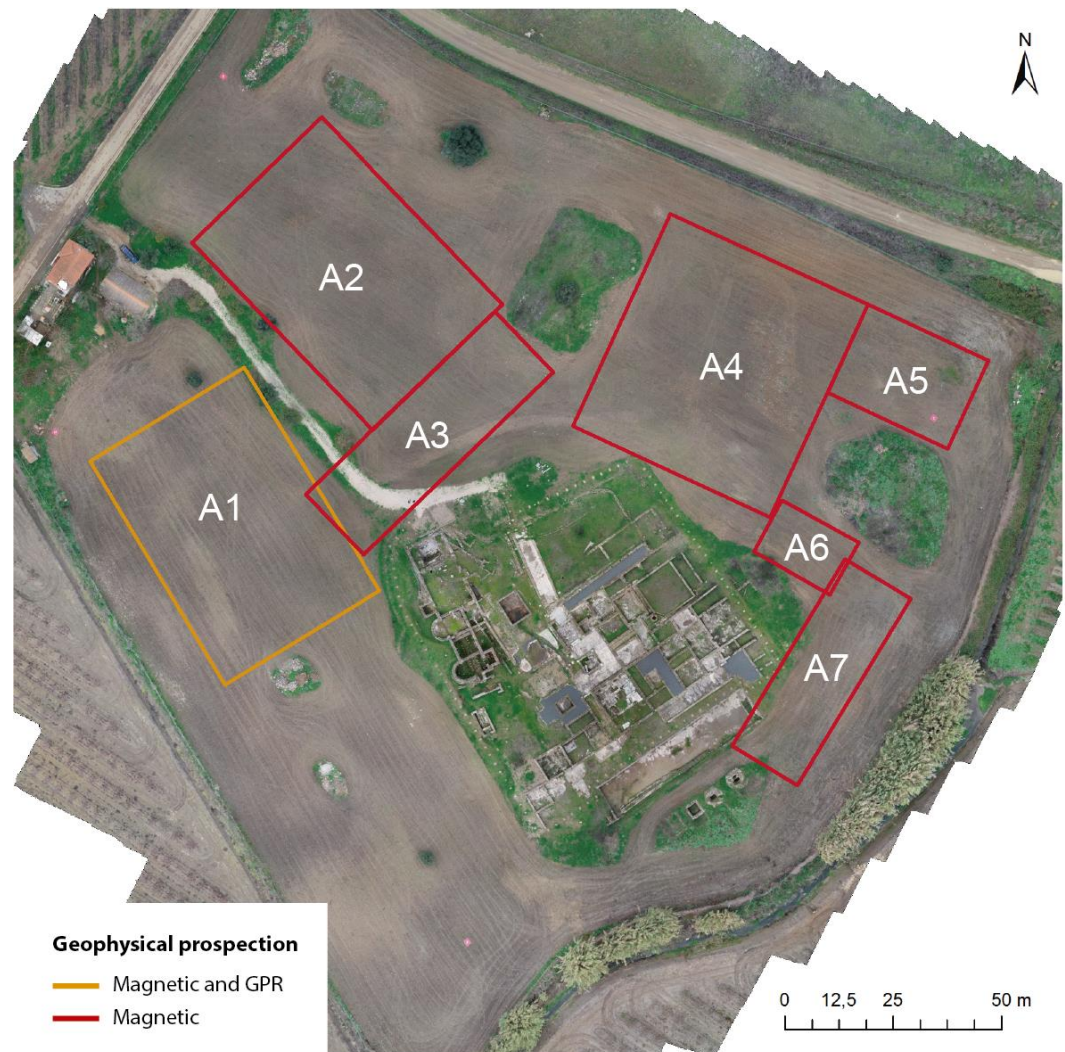
In 2017, several geophysical surveys have been carried out with different methods to prospect the subsurface and assess the state of conservation of some structures. Between 2018 and 2020 was carried out a magnetic survey (vertical gradient mode) and ground-penetrating radar (GPR) in several sectors around the *pars urbana* (Figure 2) [9–11].

Figure 2. Location of the geophysical surveys carried out at Pisões.

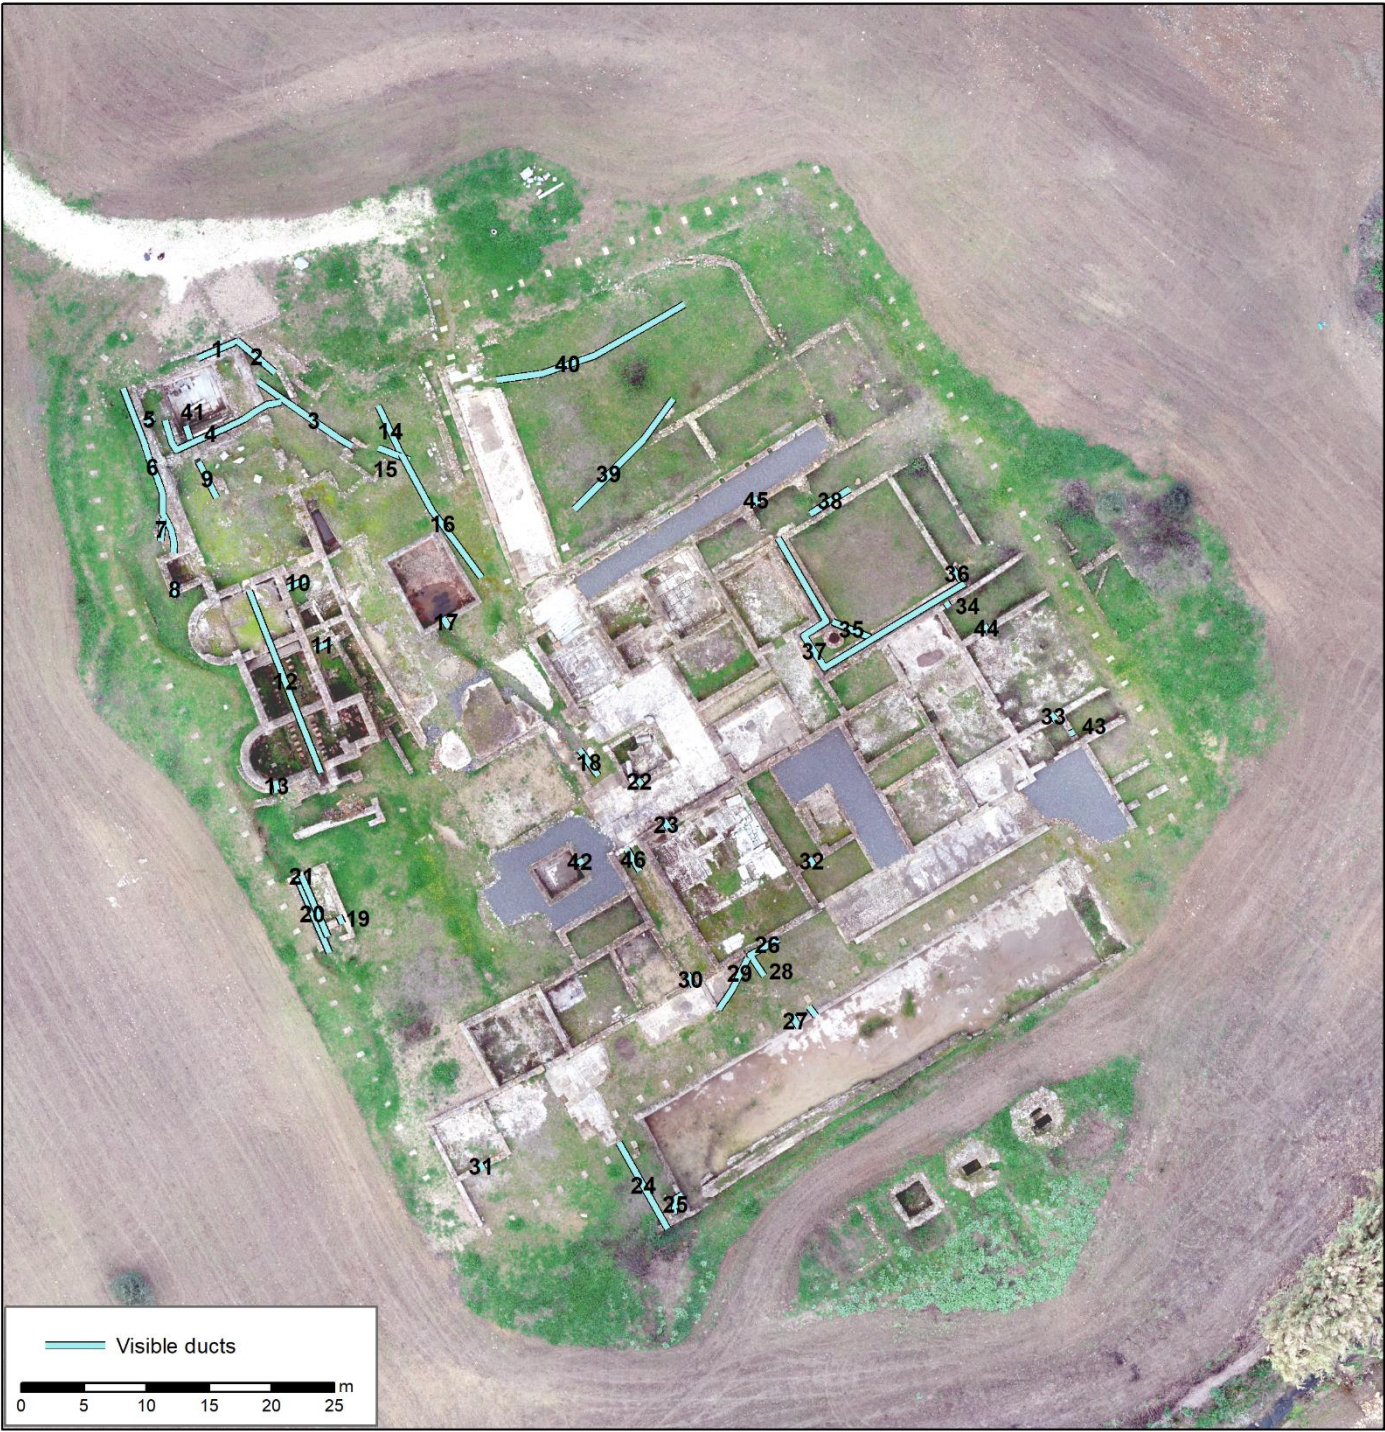
In the first stage of surface work, we have been able to discover a total of 46 water conduits in the villa, within which they serve different functionalities and may not be related to each other. Figure 3 shows the visible conduits, which are described below in groups according to their function. The altitude values of the visible ducts were measured with differential GNSS (Table 3).

Figure 3. Location of visible water conduits in Pisões on the orthophotography of the site.

Ducts 1 to 9 correspond to the original supply of the thermal building, where pipe 1 is at an elevation of 181.60 m, the highest topographical point in the whole villa. This part of the complex can be understood quite well, given that the water flows from pipe 1 and 2 to 6 and from there through 3, 4 and 5 to the *natatio* located there, the water exiting at pipe 9.

Figure 4 shows examples of the different elements that we have detected in the villa with a water conduction function, whose numbering corresponds to the structures identified in Figure 3. Conduit 4 would be under the pavement and would serve to conduct water within the enclosure itself, while conduit 6 is on the side of the *balneum*. Duct 9 is the water exit of one of the *natatio*, and duct 12 is where the water would have gone, which can be seen on the floor of the well-preserved *hypocaustum* with its brick basins. Element 13 is the only water exit that we have located on the side of the *balneum* for the hot water. Structure 18 is the water conduit that would have supplied water to the center of the villa, while the number 20 is from the latrines. Structure 23 is a strange element that seems to be to supply water to the room which could be a low *natation*. Finally, structure 25 would be the main sewage collector of the villa in a bad state of preservation.

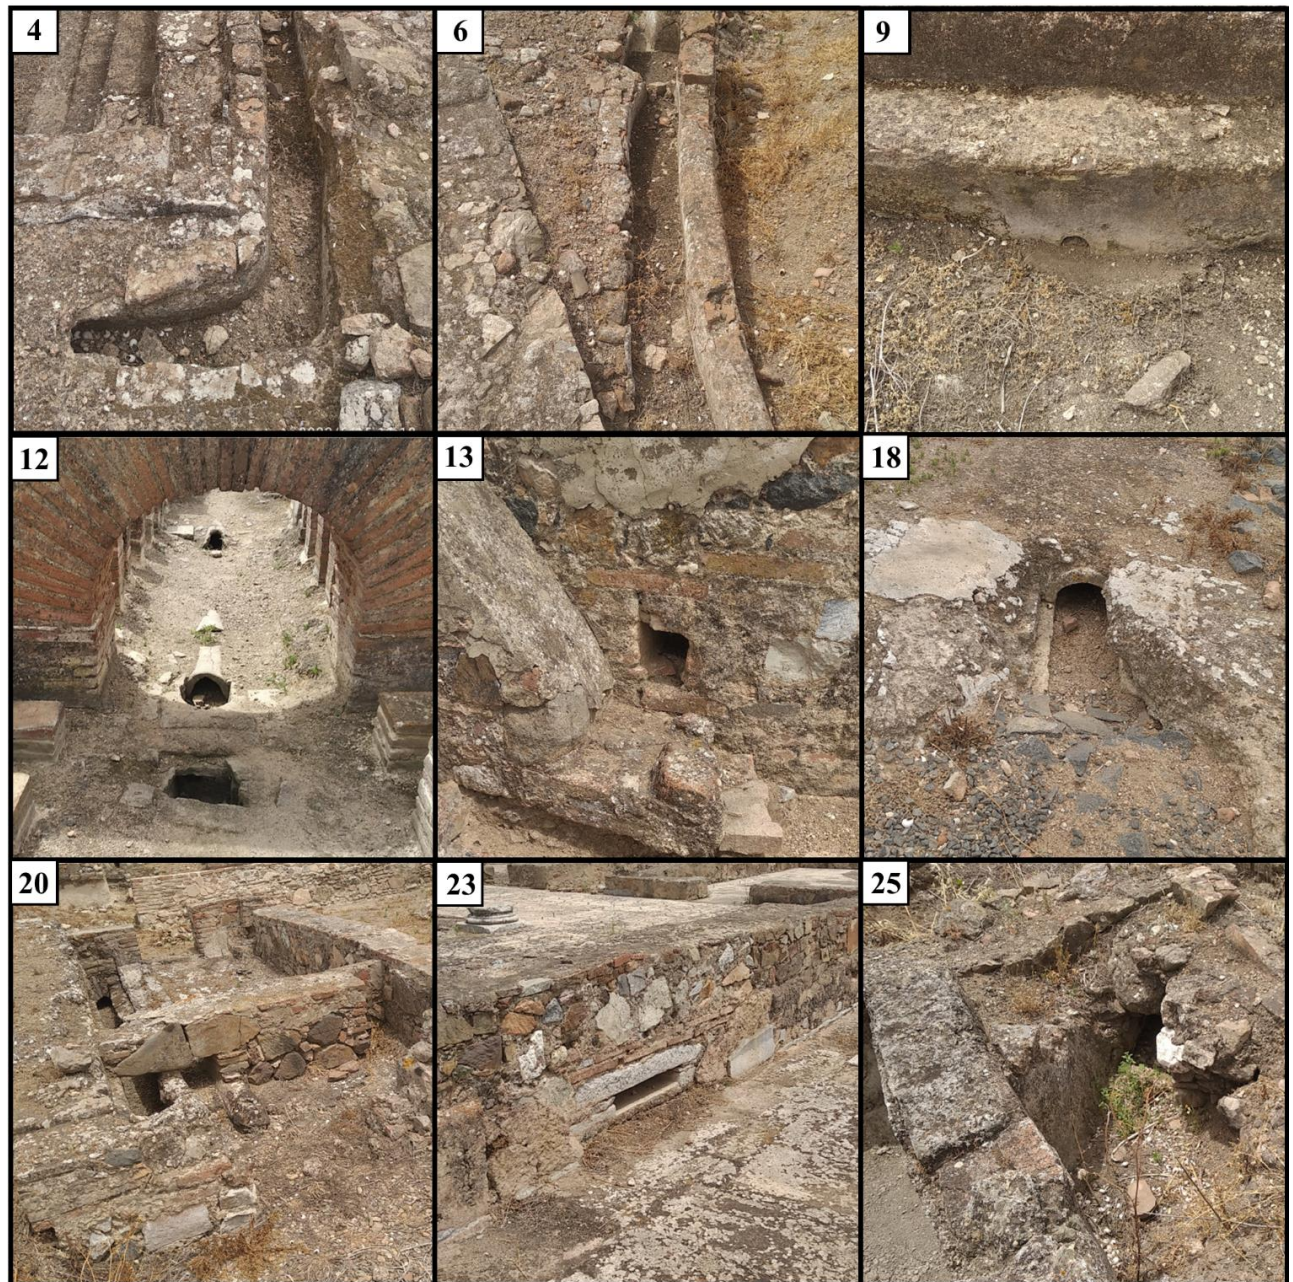
Figure 4. Examples of water conduits of Pisões. The numbering corresponds to the structures identified in Figure 3.

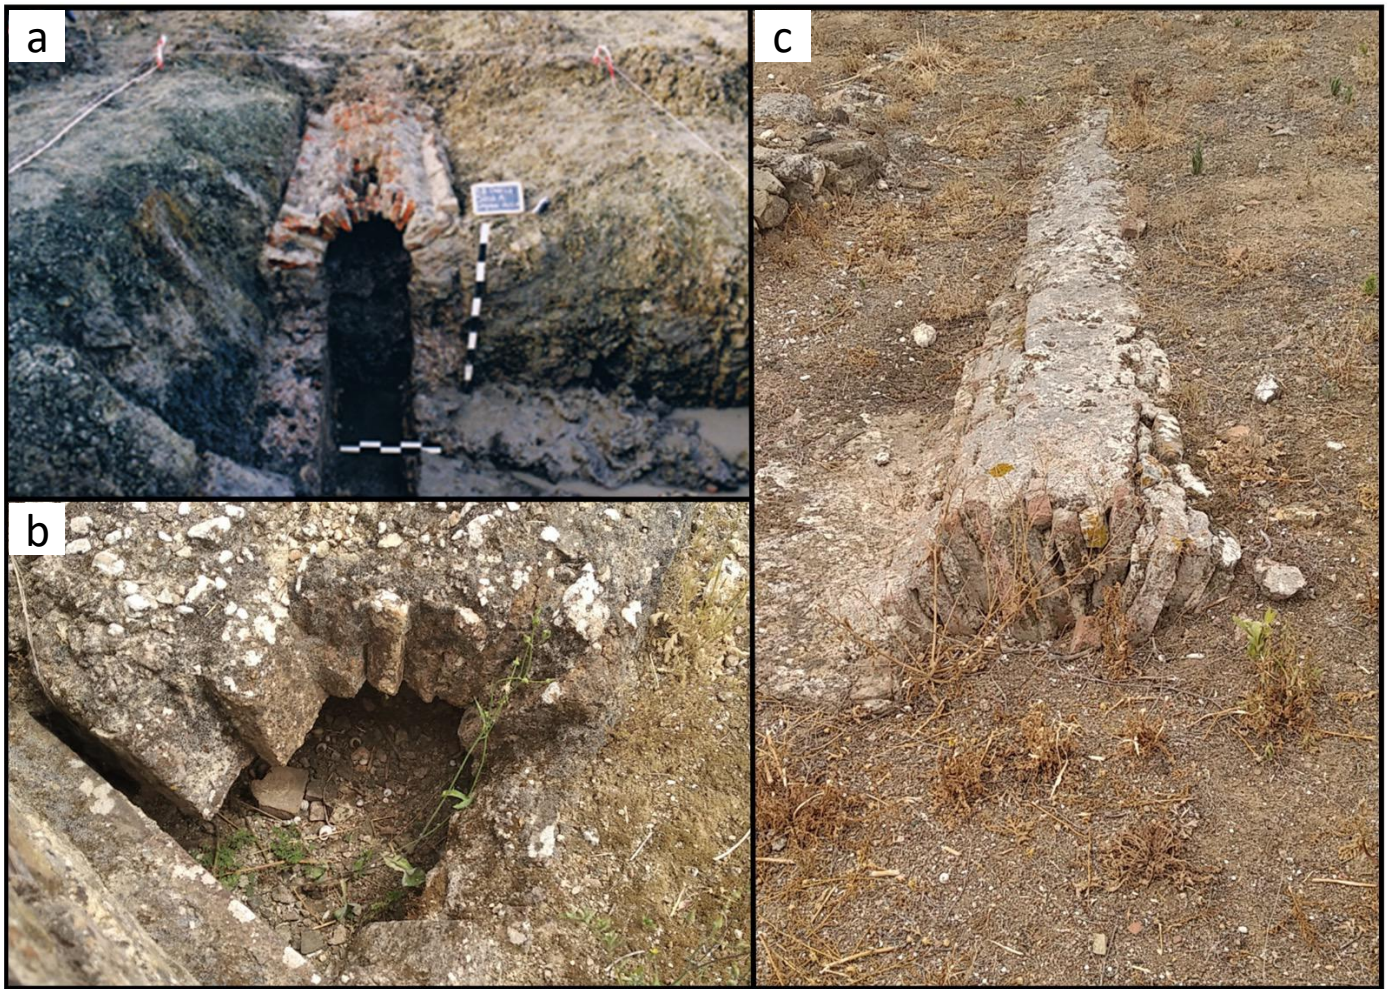
Considering all the elements analyzed, the only water supply point, i.e., where it may have come from, is the conduit 39. This is a small, partially collapsed brick vault in which small access and cleaning well is preserved, as well as part of its roof being visible. This

construction is very similar in shape to an aqueduct located at northeast of the villa [13–14] and which could be the access point for water from nearby springs. In addition, structure 39 is very similar in shape to number 11, so all three could be part of the same aqueduct, as can be seen in Figure 5.

Figure 5. (a) Underground aqueduct discovered in an archaeological survey carried out on the outside of Pisões [13]. (b) Upper part of duct 11. (c) Traces of upper part of duct 39.

We can discuss the water inlet in the villa. Undoubtedly, due to the appearance of the aqueduct referred to in Figure 5, this can be the main source coming from nearby springs. However, the continuation of this aqueduct up to the second *balneum* must be questioned, given that the roof of the aqueduct is at altitude 180.10 m and 179.80 m, i.e., with a difference in height of 30 cm at the two points where we have been able to document it. Bearing in mind the height of this type of vault-shaped aqueduct, it is possible that the water circulated at altitude 179.50 m, with the hydraulic elements of the *balneum* at 179.70 m at the lowest point and 180.40 m at the highest point. It is unlikely that the water was distributed from these elements, especially since the access to the water for the northernmost *natatio*, which is well preserved, is at 180.30 m. Moreover, *natatio* 3 is right in the middle of the conduction, the bottom of which is at 179.30 m, i.e., it is impossible for the aqueduct to pass under this pool. It could go around it, but we have found no traces of this hydraulic element in the prospections planned precisely for this purpose.

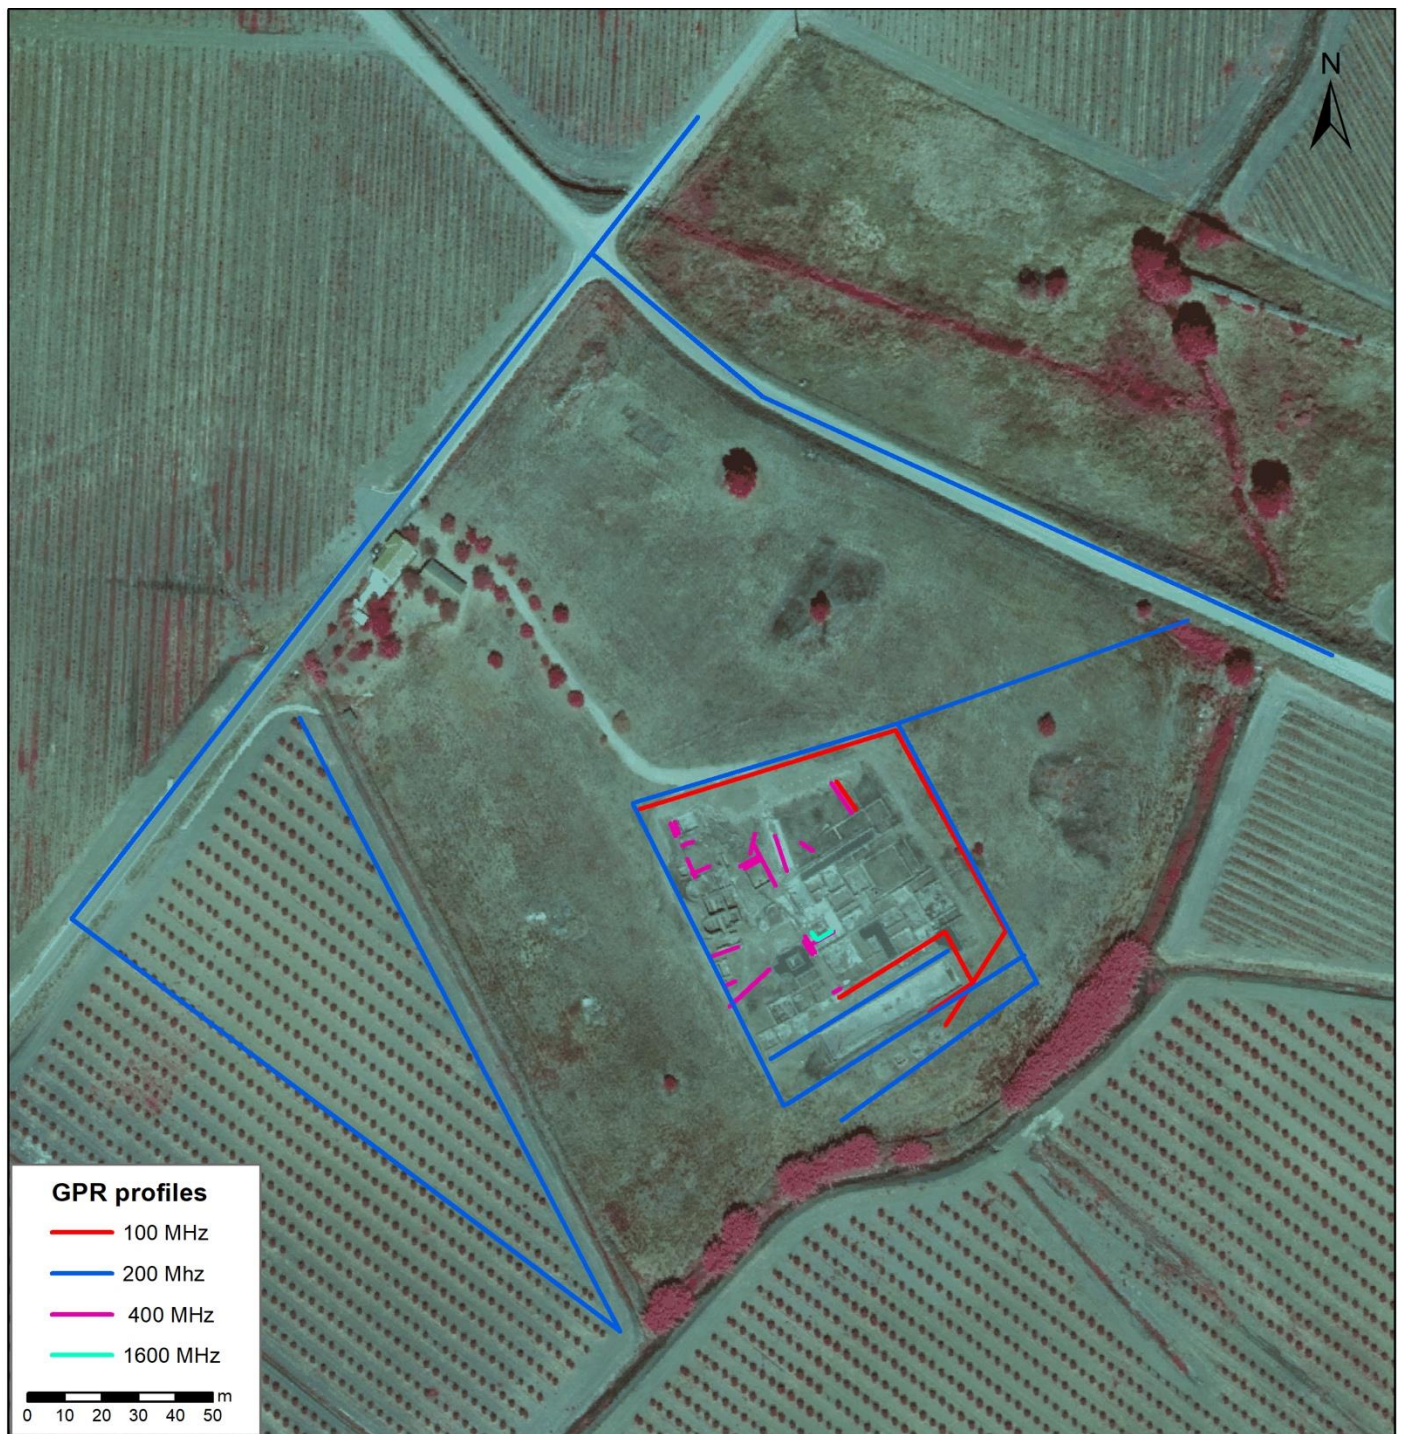
Therefore, the study carried out consisted of the acquisition of 38 B-scans around and inside the *pars urbana*, using antennas with the following central frequency values: 100, 200, 400 and 1600 MHz. The best antennas to prospect buried structures in archaeological context is the 400 and 200 MHz. However, at Pisões site, only the 200 MHz antenna allowed to see reflections compatible with structures, but near the border of the *pars urbana* we cannot detect any reflections. In the inner part of the *pars urbana*, the 400 and 1600 MHz antennas worked well, allowed the detection of buried structures. The location of all registered B-scans is shown in Figure 6.

Figure 6. Location of GPR B-scans carried out inside and outside Pisões site.

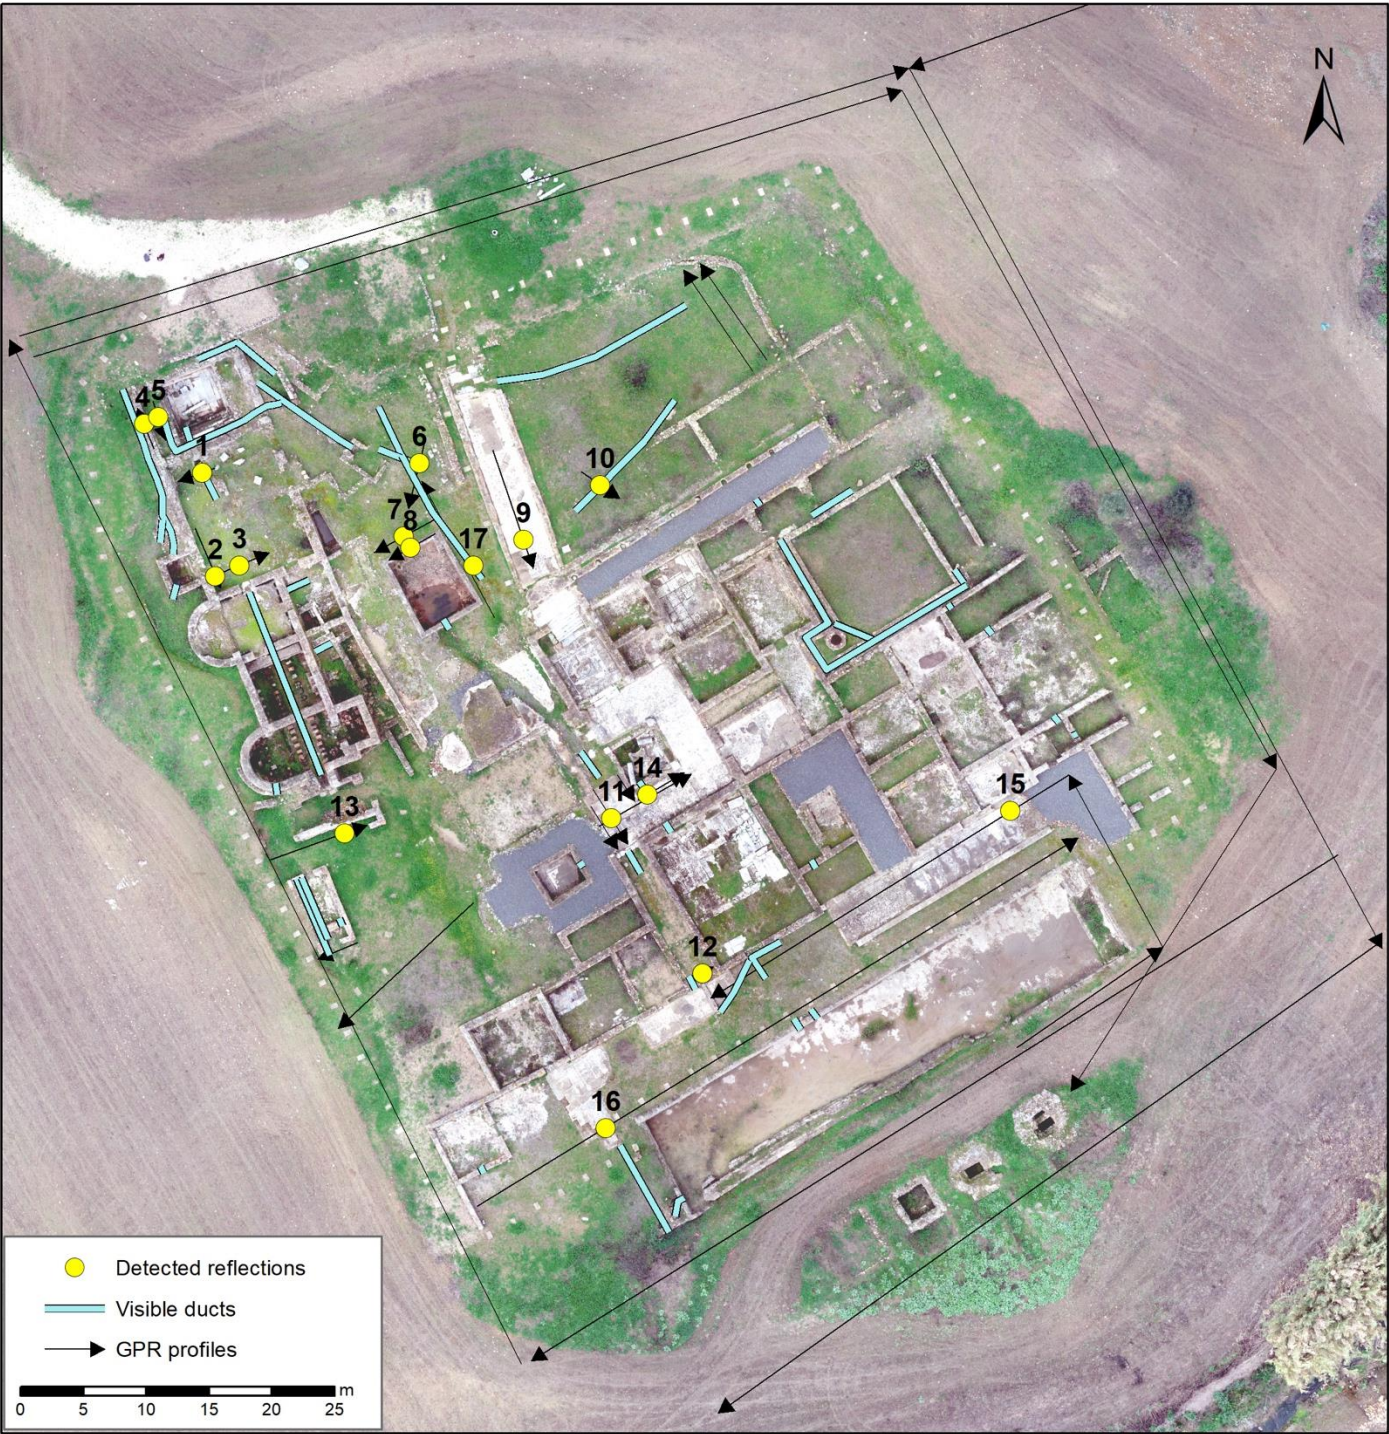
Thus, in the inner part of the *pars urbana* 17 reflection patterns were identified in the B-scans, all compatible with water conducts, and at expected locations, near visible conducts or structure holes. The location of these patterns is shown in Figure 7.

Figure 7. Location of GPR reflection patterns compatible with water conducts.

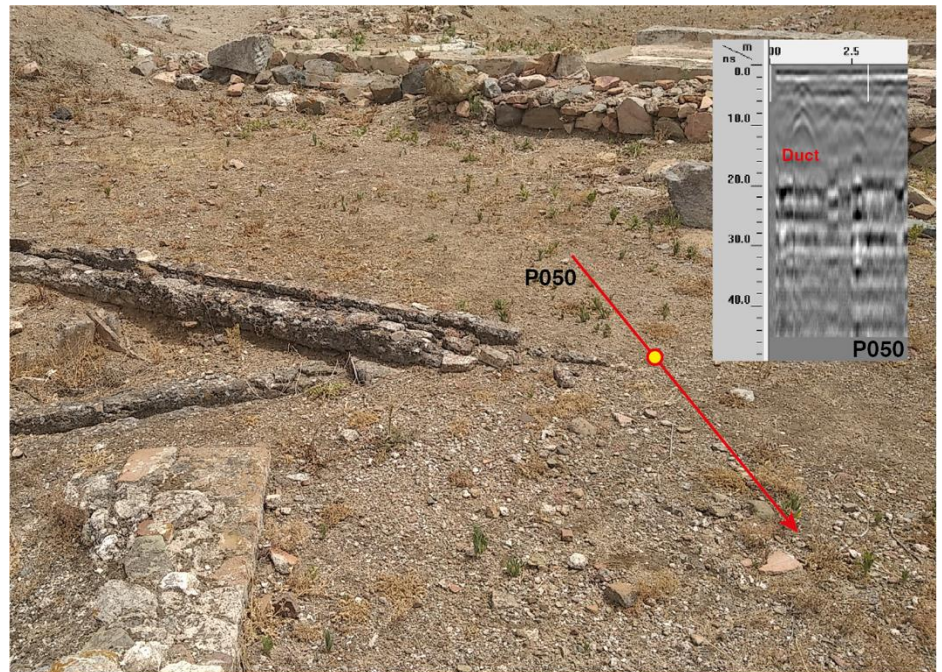
In Figure 8 is shown a B-scan acquired near the remains of 2 conducts. However, just one is possible to observe and make the correspondence with the observed in the field. As these tubes are quite degraded, it is possible that part of them no longer exist.

Figure 8. Representation of the B-scan P050 and location in the field.

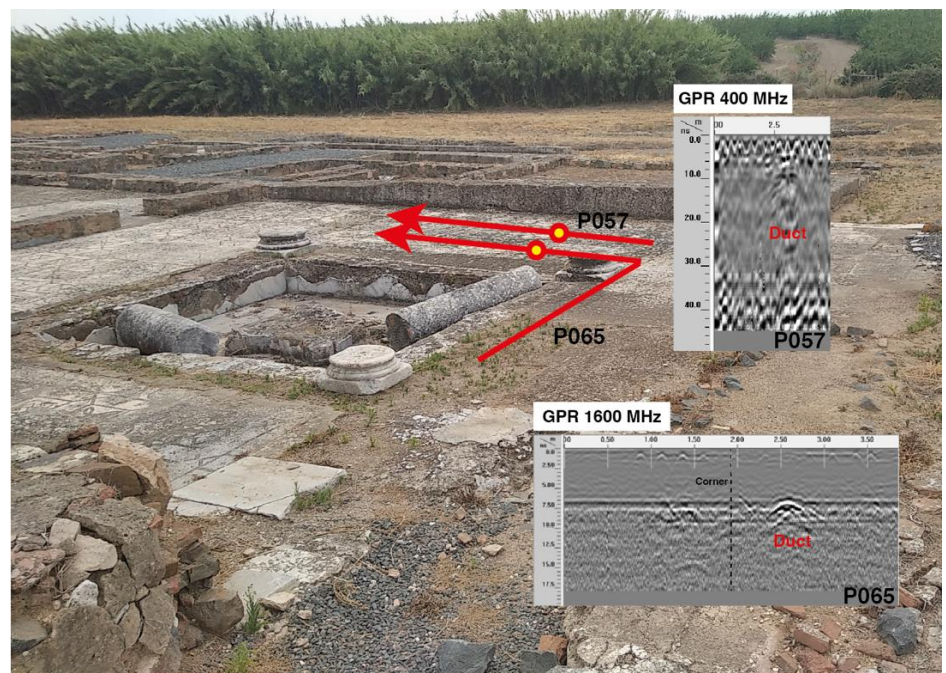
In Figure 9 is shown 2 B-scans carried out with 400 and 1600 MHz antennas. Both profiles were acquired partially in the same location and shows a reflection pattern compatible with a duct, in the expected location of the *peristilum* drainpipe. For small structures, 1600 MHz antenna allowed to observe more details.

Figure 9. Representation of the B-scans P057 and P065 and location in the field.

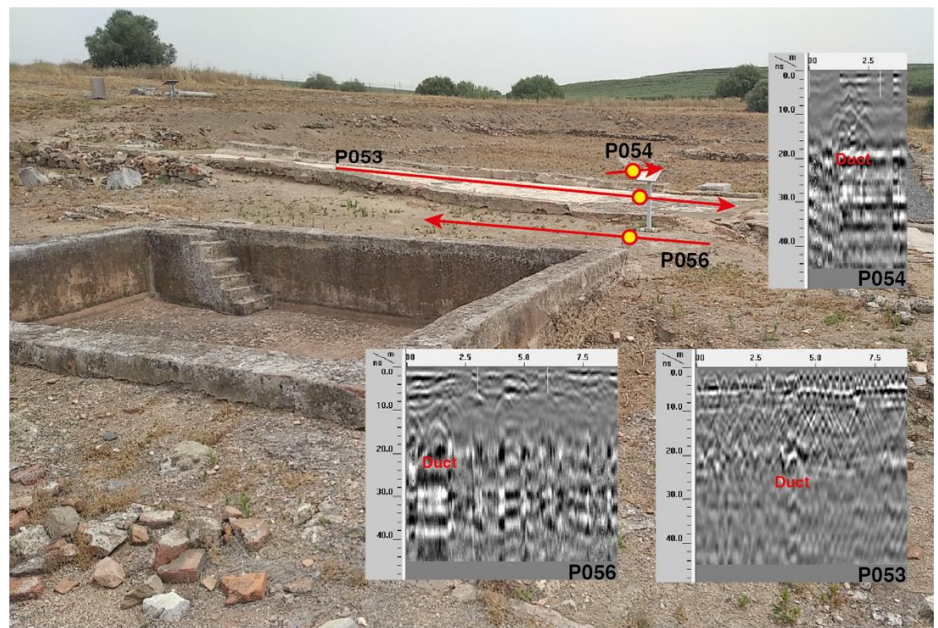
Figure 10 shows the spatial distribution of an underground aqueduct. Near P054 B-scan we can observe the top part of the structure. The results show reflections compatible

with a great conduct, which passes under the mosaic floor, continues towards the small pool towards the thermal baths.

Figure 10. Representation of the B-scans P053, P054 and P056 and location in the field.

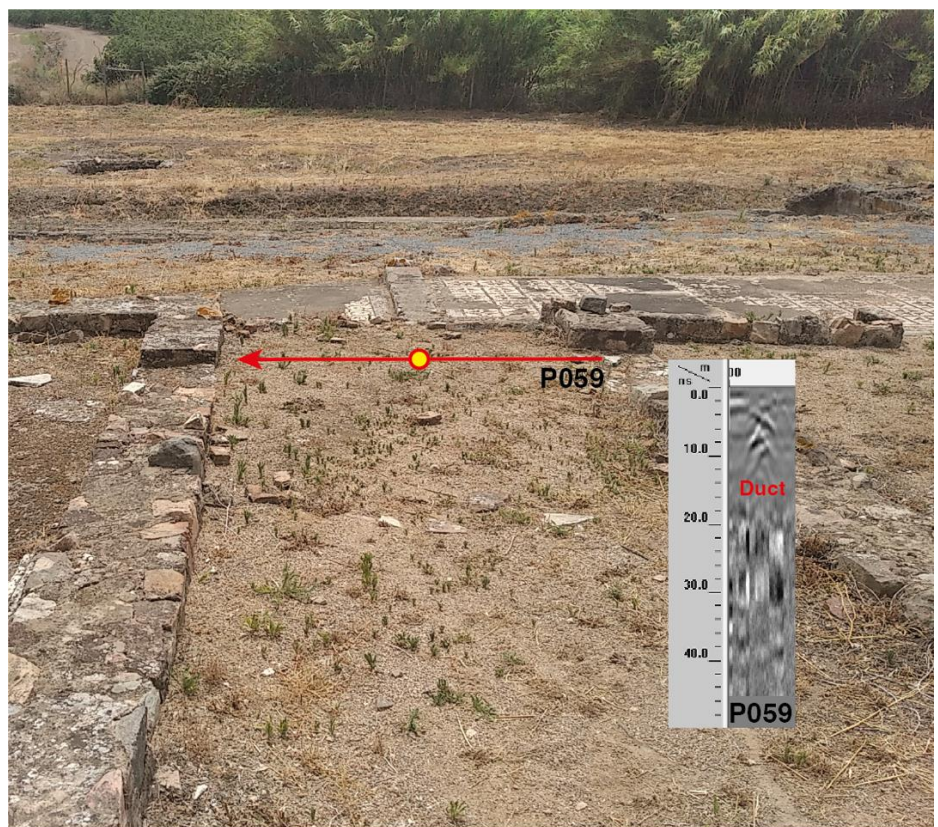
Figure 11 and Figure 12 shows the B-scan reflections in the continuation of a drainage conduits.

Figure 11. Representation of the B-scan P059 and location in the field.

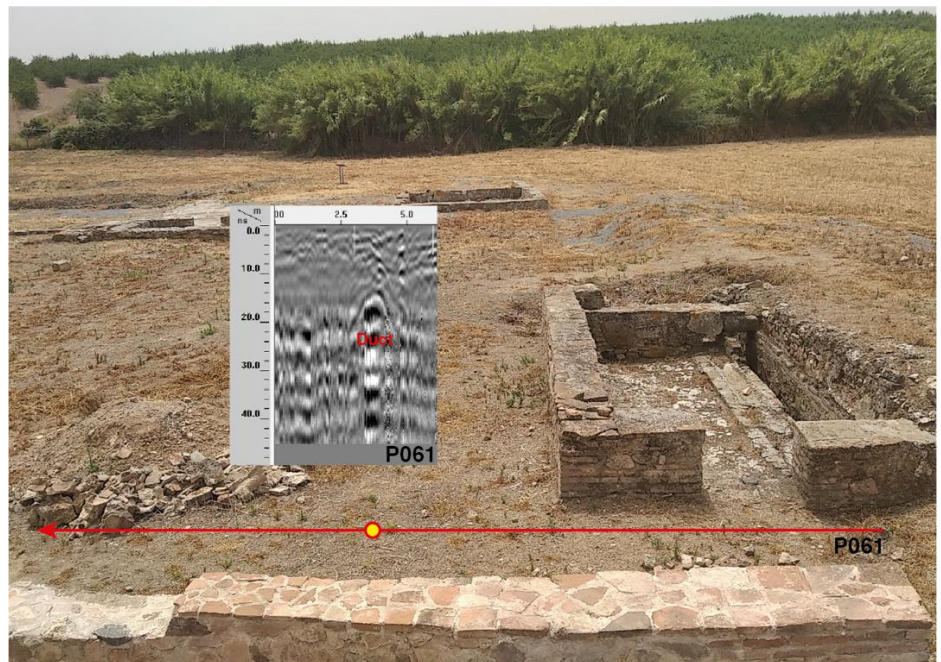
Figure 12. Representation of the B-scan P061 and location in the field.

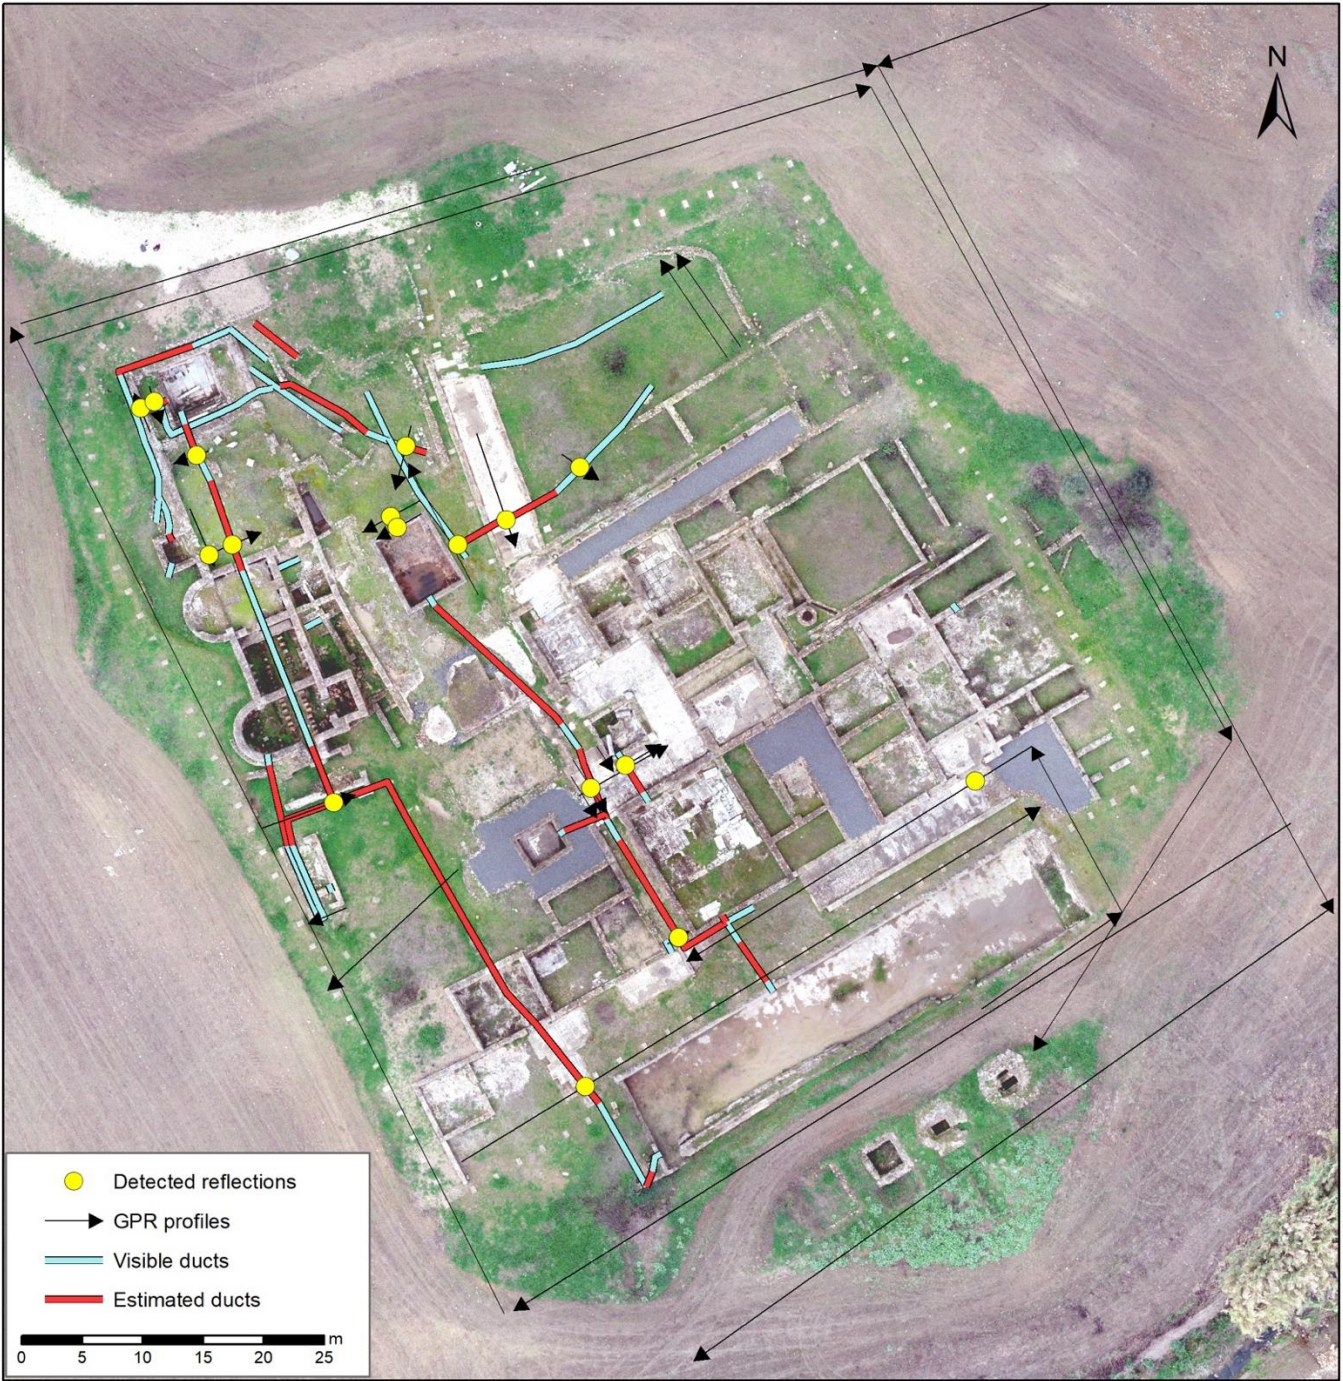
Excluding from the initial analysis several conduits that are not related to the main entrance, such as some small ones in the rooms and others related around the well, we propose a series of conduits that should have existed, based on the combination of all the data (Figure 13). The tracing drawn was made by considering the connections between the visible and preserved elements that explain the water circulation of the main system. There is a high possibility that many of these features are not preserved on the surface, either because of the history of the site, such as the agricultural works. These problems may also have been detected in previous excavations, but the lack of technical information at that time does not allow us to know if this happened. Therefore, we can describe the water communications that seem to have worked at the time of greater expansion of the villa, when the main hydraulic elements were in operation. Added to this, is a series of elements located in the northwest that have no direct connection, and which may date from another phase, as will be discussed later.

Figure 13. Location of estimated ducts, combining archaeological and GPR information sources.

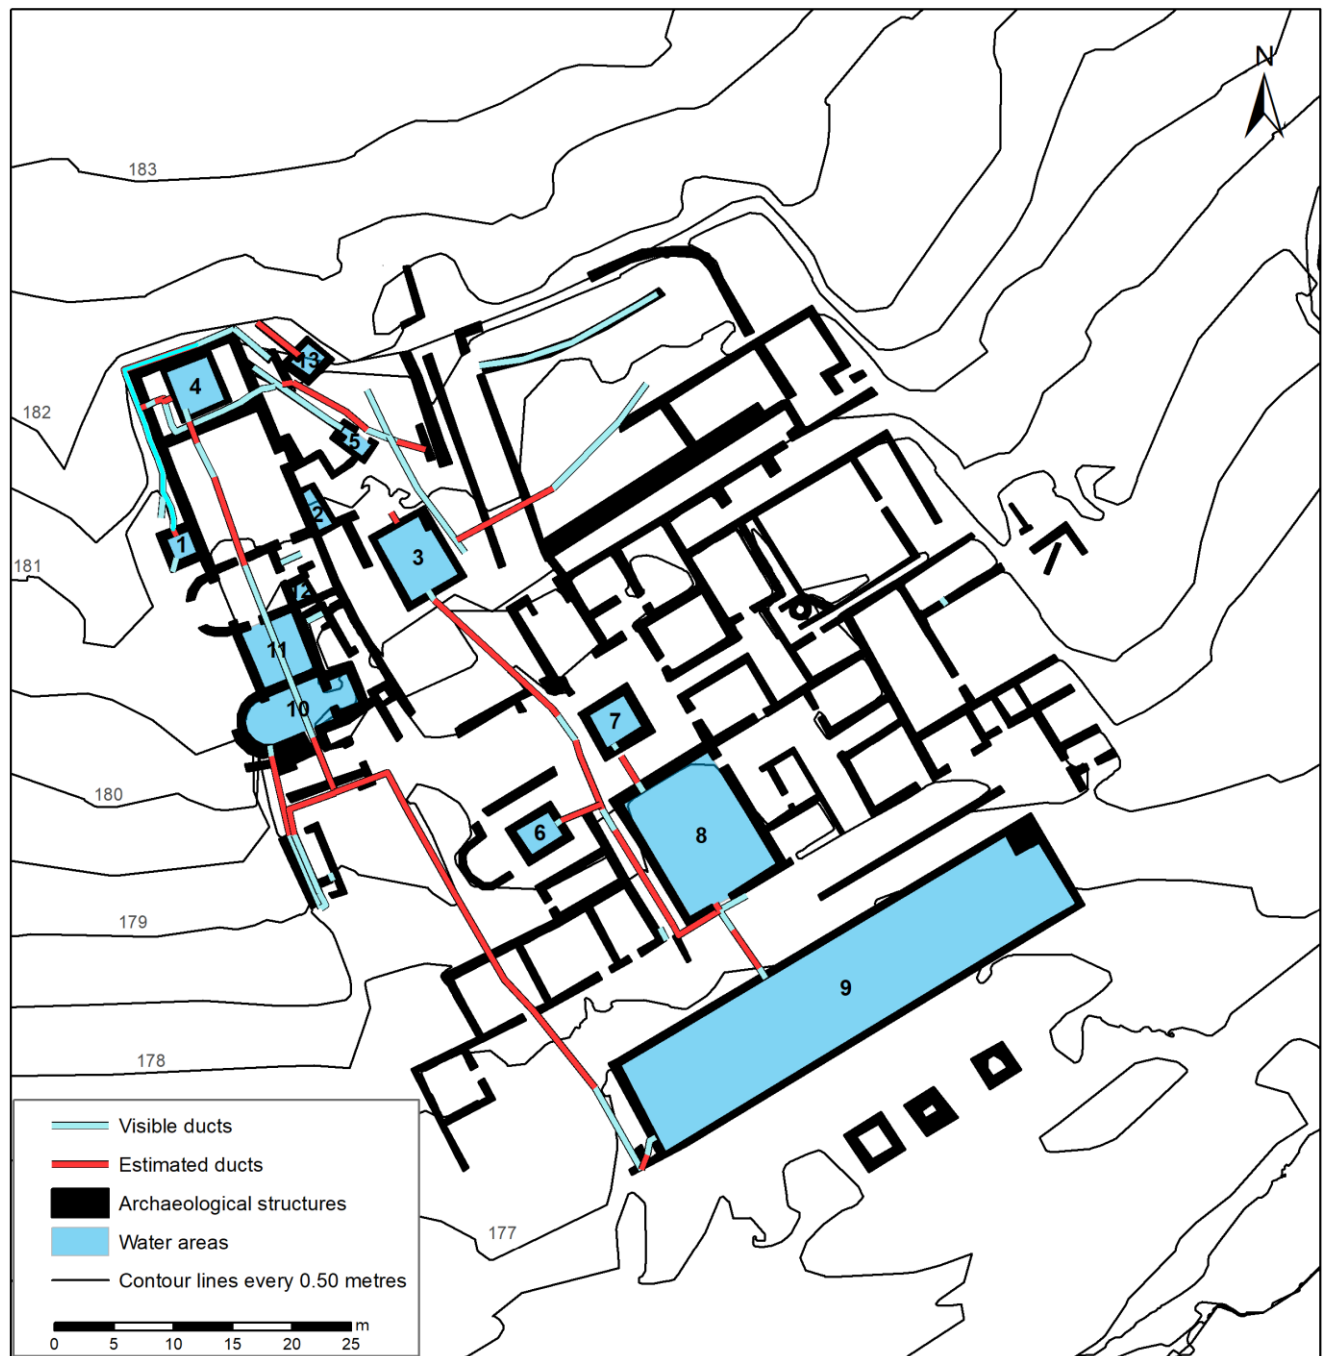
The detailed study between the visible water pipelines and those estimated by geophysics allowed us to reconstruct almost all the missing sections. The estimated sections are about twice the length of the parts that are currently preserved. The reconstruction of the main water connections can be observed in Figure 14.

Figure 14. Location of the estimated water connections between the existing conducts (visible and detected by geophysics).

Considering the altitude values of the bottom part of conducts and water receptacles, we can suggest that the water access is located at the northwest corner of the *pars urbana*, with altitude value of 181.60 m, the highest value measured in Pisões. The lowest value is in the large *natatio* to the south part of the villa, with altitude value of 175.90 m. The villa is therefore distributed on a hill that slopes down in a south-easterly direction with a change in elevation of more than 6 m in total. The water supply must necessarily come from the northwest. Therefore, the main water access can be well reconstructed to supply the main hydraulic elements of the *balneum*, corresponding to the elements 1 and 4 (Figure 14). The first one would correspond to a *labrum* supplied from outside the building, while the second would be a cold-water *natatio*. This little pool has a hole that crosses the wall that supplies water to this structure, but there is a second conduit in continuation, confirmed by GPR method, but we have no further information about its distribution in space. It may be connected to *natatio* 3, which we know that could have a water conduit to supply

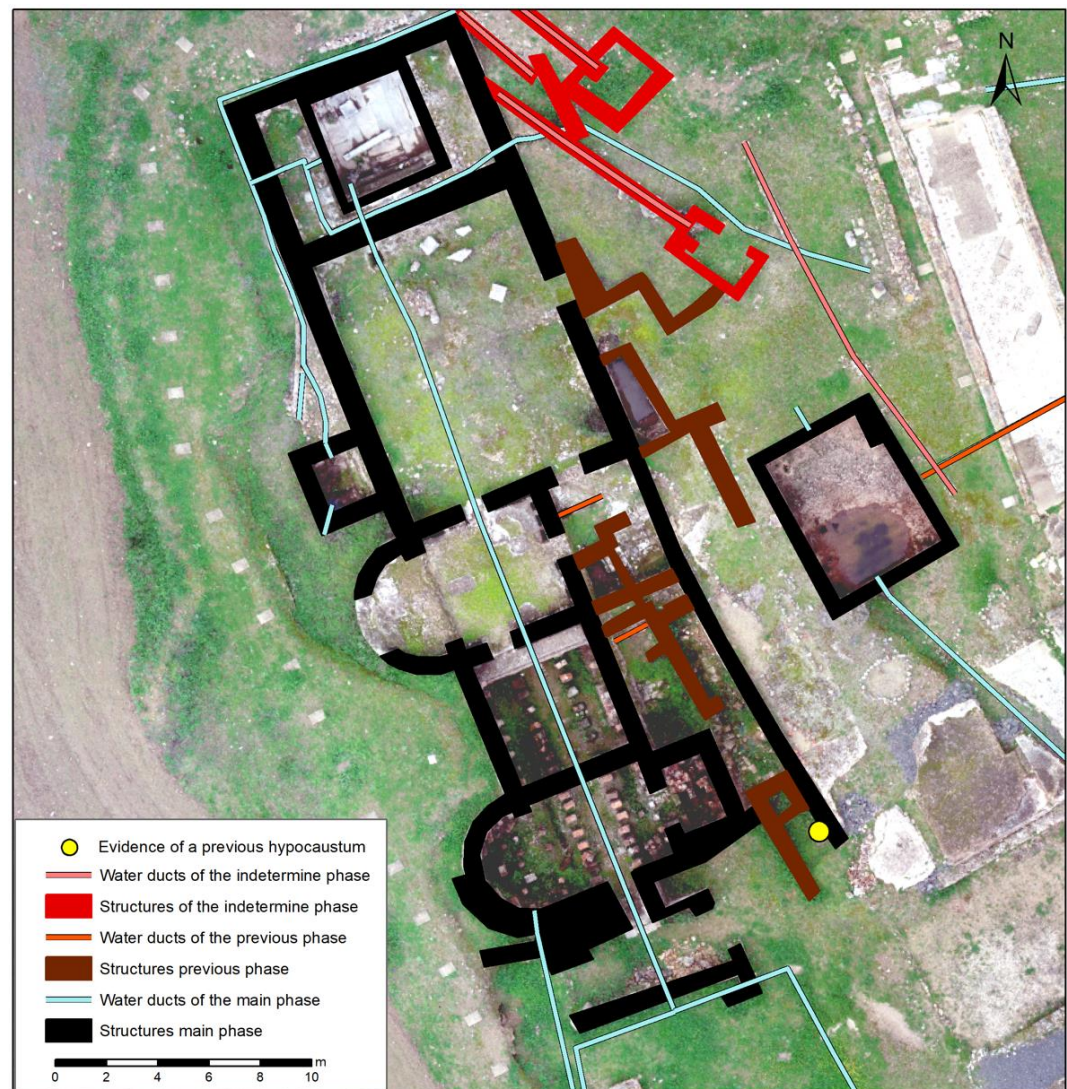
Above this element, we have a series of pools that have been interpreted as part of the previous villa, specifically structures 2, 5, 12 and 13, and therefore there are two superimposed thermal complexes (Figure 15). This hypothesis includes the *natatio* 3 within these elements, where there would also be a *hypocaustum* below some archaeological elements at a much lower level than the second one, something we have been able to verify given that several pools are found in a profile approximately one meter below those of the second thermal complex. We also verified that the direction of the two generations of bath complex has slightly rotated directions from each other.

Figure 15. Possible different archaeological phases detected with this study.
