Characterization and Analysis of the Mortars of the Church of Santo Domingo in Quito (Ecuador)

Abstract: The religious art of the Dominican order is reflected in the church of Santo Domingo, built between 1541 and 1688. This work of heritage architecture, one of the first to be built in the colonized city, was affected by multiple earthquakes, interventions, and constructions that do not have a clear record. A total of 13 samples were taken from the mortar inside the cloister, central nave, and side chapel, following the minor destruction testing protocols and standards suggested by the research team. The analysis included mineral characterization studies and quantitative analysis by X-ray diffraction, petrographic, and scanning electron microscopy with microanalysis of the samples. The results showed the presence of volcanic aggregates and lime mortars, mortars of rustic composition and coarse manufacture. The results of mineralogical data and texture have allowed us to corroborate the historical information described by the chroniclers and to date relatively studied sites and to establish a hypothesis of constructive stages.

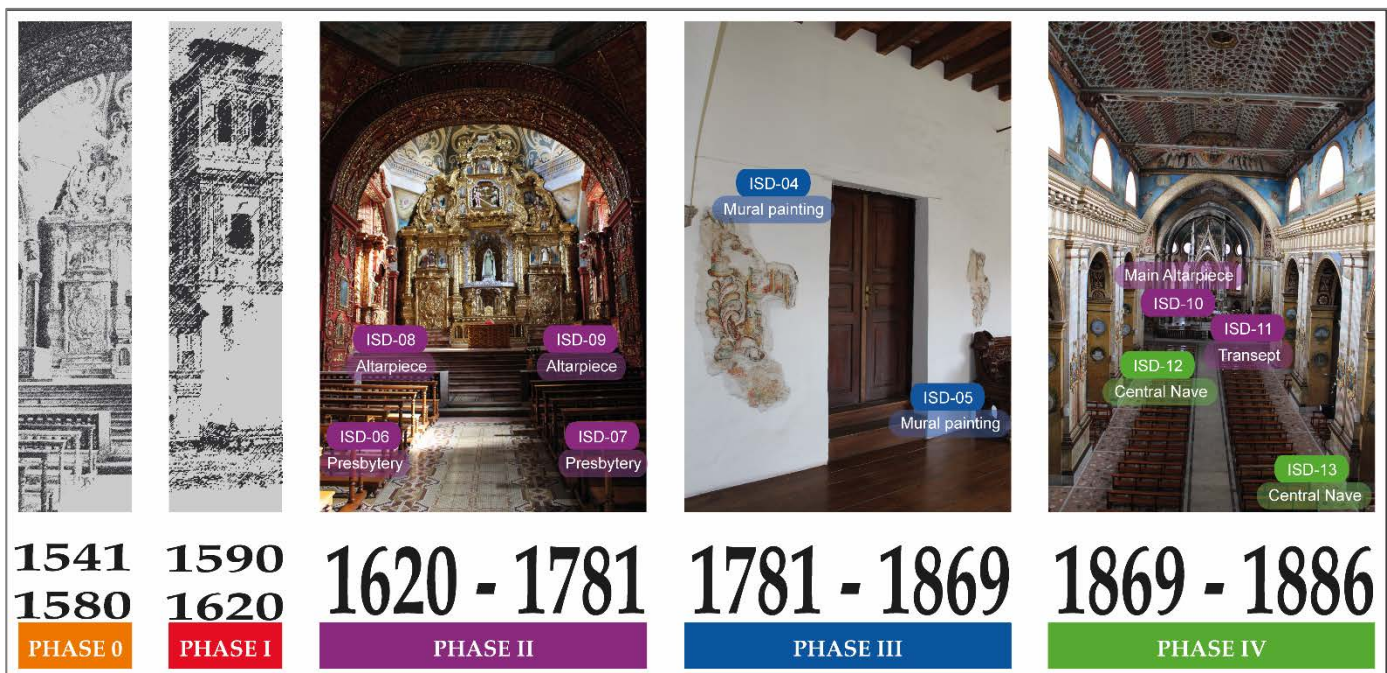
Figure 2. Image of the five chronological phases of the construction of the Santo Domingo church in 345 years. (1541-1580) Earth construction; (1590-1620) Phase I; (1620-1781) Photography of the Chapel of the Rosary; (1781-1869) Photography of the mural in the convent corridor; and (1869-1886) Photography from the central nave to the main altar, with the location of the places where the mortar samples were extracted.

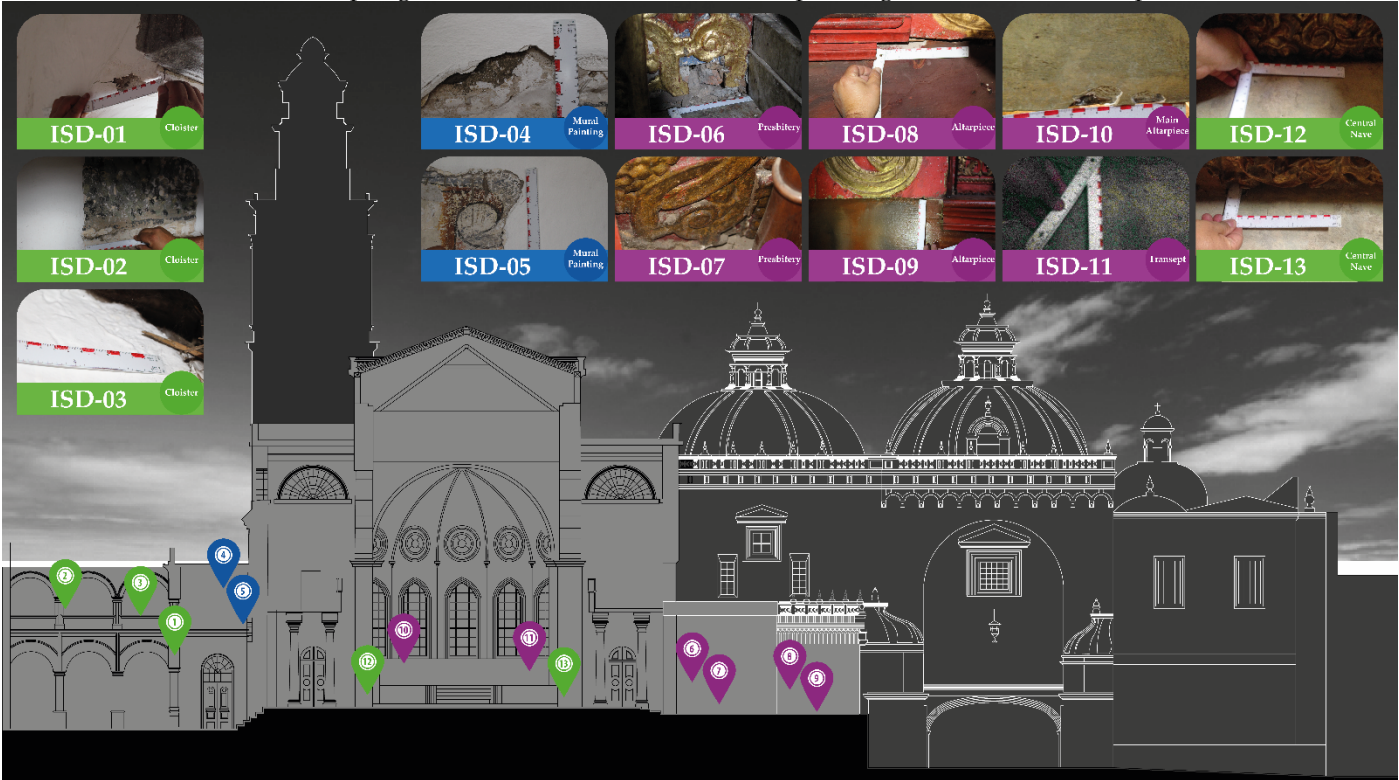
Figure 3. Blueprints of the church of Santo Domingo of Quito with the location of the analyzed samples; the figure describes the 13 samples with its location.

In this work, 13 mortar samples (according to Figure 3), extracted from the Santo Domingo church, considering the indications made by temple technicians about the places that presumably have not been altered in the rehabilitation stages. To carry out the sampling, three sectors were identified depending on the construction phase.

Phase II (1620-1781), samples ISD-06, ISD-07, ISD-08, ISD-09, ISD-10, and ISD-11. Samples 6, 7, 8, 9 were extracted from the Chapel of the Virgin of the Rosary, while sample 11 was extracted from the south surface of the transept, and sample 10 is part of the nineteenth century reconstruction of the novitiate.

Phase III (1781-1869), samples ISD-04 and ISD-05. These samples were extracted from the surface of the wall of the convent cloister adjacent to the north wall of the temple.

Phase IV (1869-1886), samples ISD-01, ISD-02, ISD-03, ISD-12, and ISD-13. These samples are simultaneous to those of the Italian Reformation that intervened in the cloister of the convent, samples 1, 2, and 3; and the Central Nave of the Temple, samples 12 and 13.

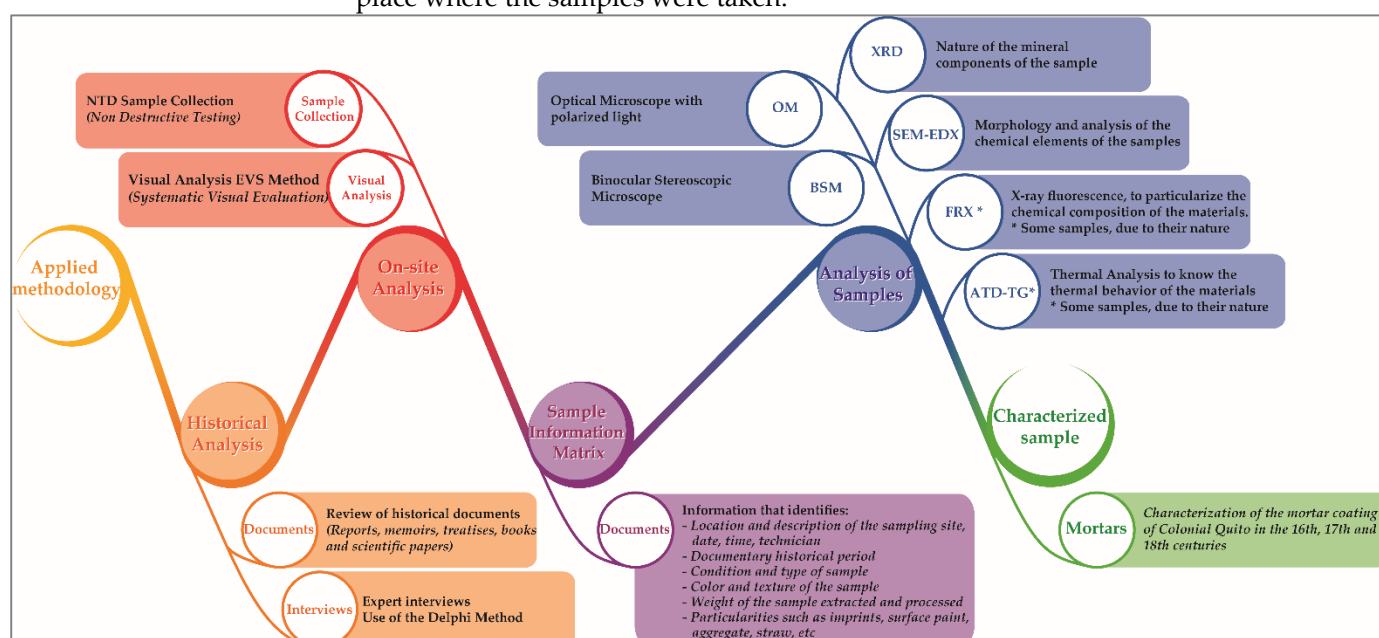
Figure 4. Description of the methodological process generated for the analysis of samples from general research. *Analyses performed for some of the samples due to their nature.

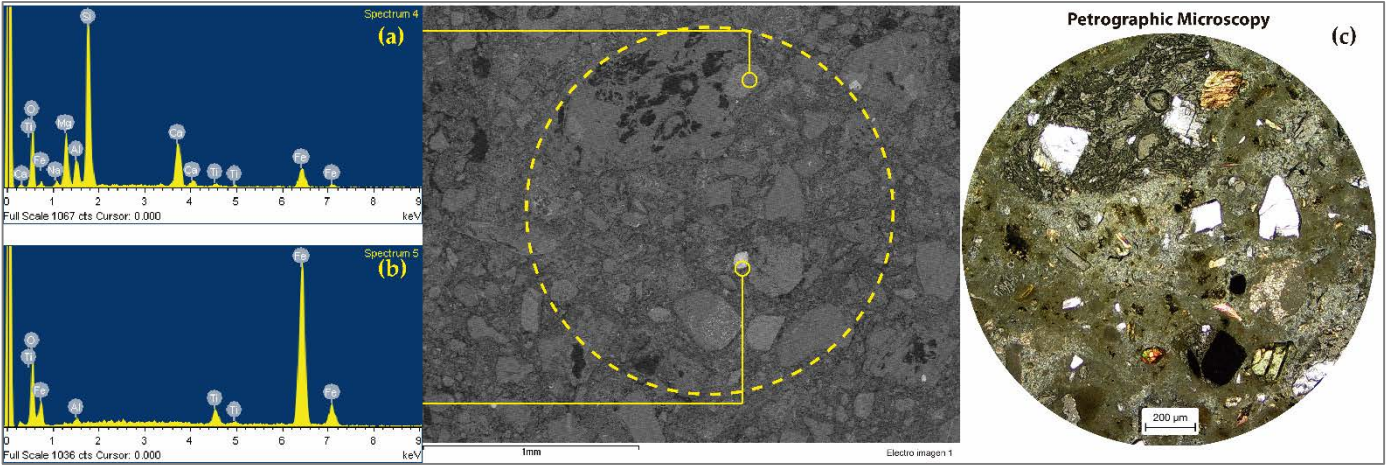
Figure 5. Sample ISD-08 (a) and (b) chemical analysis by EDX-SEM supported by a BSE image of lime mortar with volcanic aggregates; and (c) thin section image at 50x magnification under PM with X polarizer.

To identify the morphology, we used polarized optical microscopy (POM) and SEM to understand the different mineral phase textural relationship. XRD was used for the mineralogical identification. The samples ISD-08, ISD-11 from phase II (Figures 5 and 6), ISD-05 from phase III (Figure 7), and ISD-12 from phase IV (Figure 8) were chosen as representative samples of the use of volcanic aggregates in different ornamental situations. It is worth mentioning the use of these in stucco-type finishes [39,40].

As shown in (Figure 5) of sample ISD-08, this EDX analysis was performed at nine different points of the main chemical elements; we have identified two relevant points, (a)

spectrum 4 with Si, Mg, Ti, Ca, Al, and Fe; (b) spectrum 5 with Fe, Ti, and Al; (c) image obtained at 200x magnification by the petrographic microscope that allows visualizing the properties of double refraction or crystallographic directions of the sample of the Chapel of the Rosary by controlling the contrast of the image and color variation.

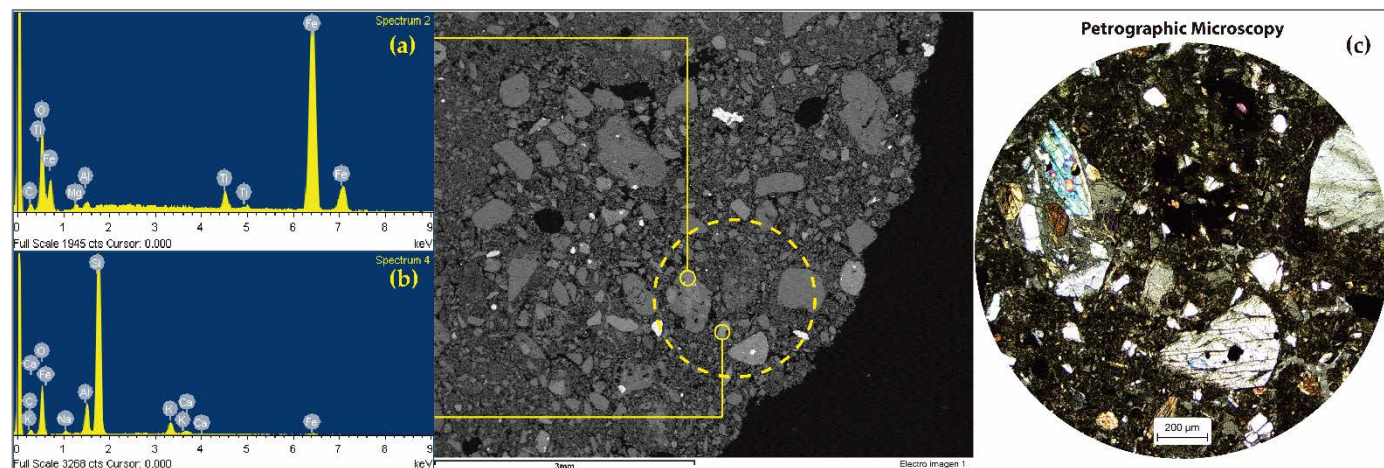
Figure 6. Sample ISD-11 (a) and (b) chemical analysis by EDX-SEM supported by a BSE image of lime mortar with volcanic aggregates; and (c) thin section image at 200x magnification under PM with X polarizer.

In the case of sample ISD-11 (Figure 6), this EDX analysis was performed at six different points of the main chemical elements, and we have pointed out two relevant points, (a) spectrum 2 with Fe, Ti, Al, and Mg; (b) spectrum 4 with Si, Al, Ca, K, and Na; (c) image obtained at 200x magnification by the petrographic microscope that allows visualizing the properties of double refraction or crystallographic directions of the sample from the lower part of the transept by controlling the contrast of the image and color variation.

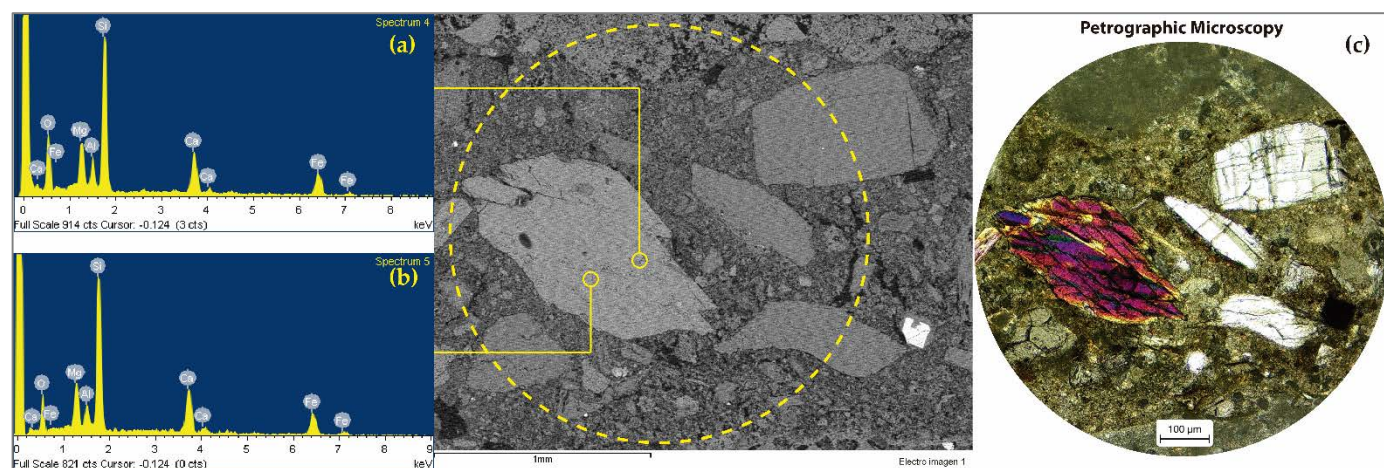
Figure 7. Sample ISD-05 (a) and (b) chemical analysis by EDX-SEM supported by a BSE image of lime mortar with volcanic aggregates; and (c) thin section image at 150x magnification under PM with X polarizer.

EDX analysis of sample ISD-05 (Figure 7), was performed at nine different points of the main chemical elements, we have pointed out two relevant points, (a) spectrum 4 with Si, Mg, Ca, Al, and Fe; (b) spectrum 5 with Si, Mg, Ca, Al, and Fe; (c) image obtained at 500x magnification by the petrographic microscope that allows visualizing the properties of double refraction or crystallographic directions of the sample of coating of mural painting by controlling the contrast of the image and color variation.

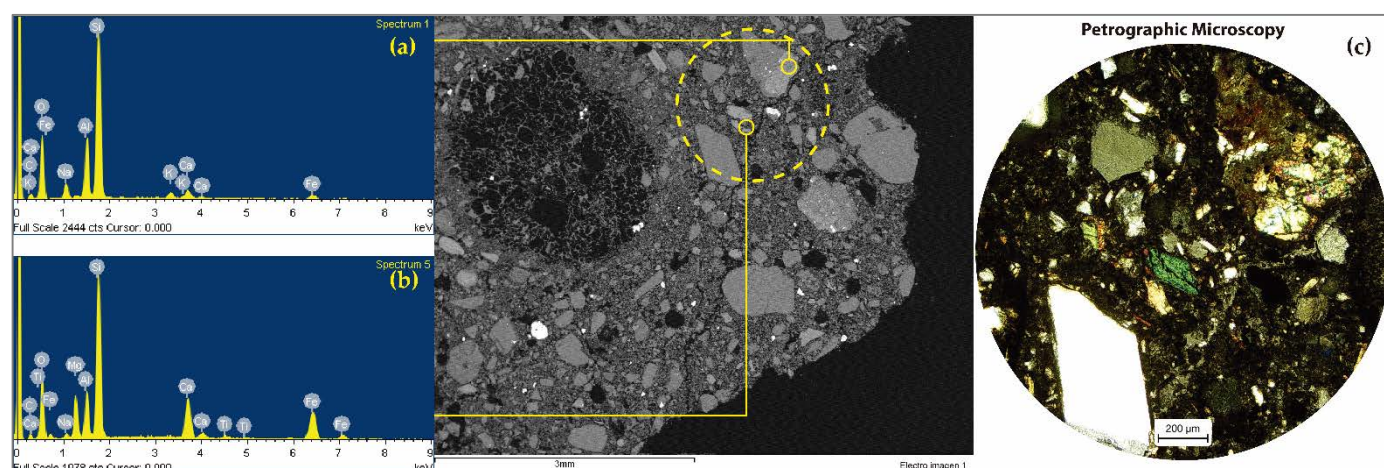
Figure 8. Sample ISD-12 (a) and (b) chemical analysis by EDX-SEM supported by a BSE image of lime mortar with volcanic aggregates; and (c) thin section image at 50x magnification under PM with X polarizer.

Finally, EDX analysis of sample ISD-12 (Figure 8), was performed at nine different points of the main chemical elements, we have pointed out two relevant points, (a) spectrum 1 with Si, Fe, Al, Ca, Na, and K; (b) spectrum 5 with Si, Mg, Ti, Al, Fe, Na, Ca, and Ti; (c) image obtained at 200x magnification by the petrographic microscope that allows visualizing the properties of double refraction or crystallographic directions of the sample of the central nave of the temple by controlling the contrast of the image and color variation.
