Analysis of Deterioration Characteristics of Service Aged XLPE Cables according to Installation Location of Combined Heat and Power Plant

Keywords: service aged XLPE cable; VLF Tan δ ; dielectric breakdown; insulation diagnosis; BFP; cooling tower; deaerator booster pump

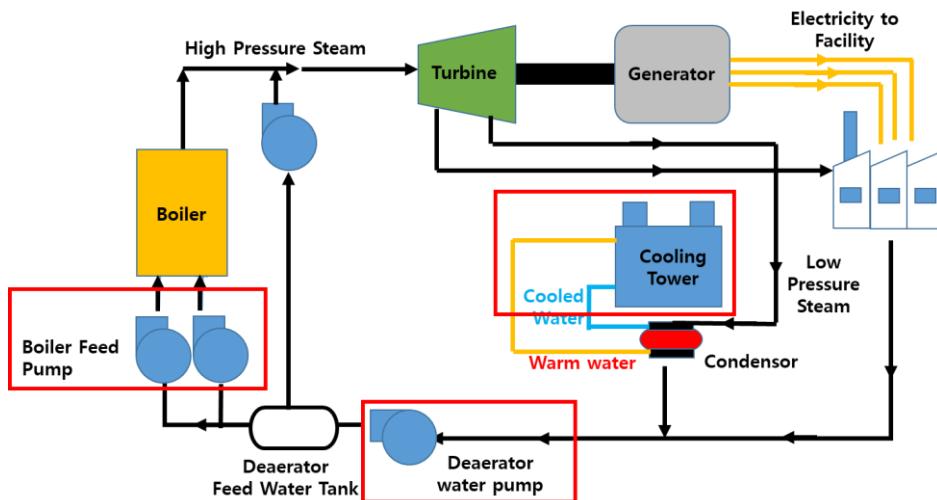
The combined heat and power plant is shown in Figure 1. The BFP is one of the important auxiliary devices because it supplies feedwater to the boiler [19]. Fundamentally, it transports hot water from the BFP to the boiler, creating steam that then powers the turbine. Consequently, it is exposed to environments of high temperature, high pressure, and steam. The deaerator booster pump ensures the quality of feedwater by removing oxygen and other non-condensable gases before supplying it to the boiler [20]. If the supplied feedwater contains oxygen or other gases, it can cause corrosion of the metals in the boiler and turbine. Cooling tower cools the steam used to rotate the steam turbines, condensing it back into water, and then recirculates it to the boiler. During the process of condensing high-temperature steam into water, a significant amount of water vapor is released, exposing the cooling tower to a continuous steam environment [21].

Figure 1. Location of cables installed in combined heat and power plant.

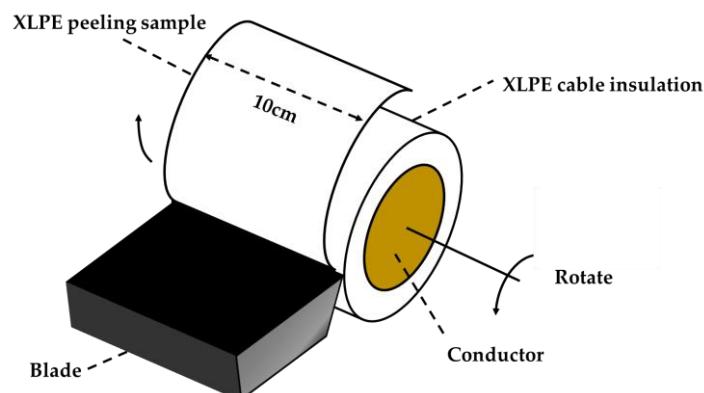
After measuring $\tan \delta$ and conducting dielectric breakdown evaluations of XLPE cables, specimens were processed into ribbon-shaped tape samples from the XLPE insulation layer for the measurement of mechanical, chemical, and electrical evaluations, as illustrated in Figure 2. The size of the specimen is $100\text{mm} \times 100\text{mm}$, and the thickness is $80 \pm 10 [\mu\text{m}]$.

Figure 2. Peeling of 10 cm wide XLPE specimens.

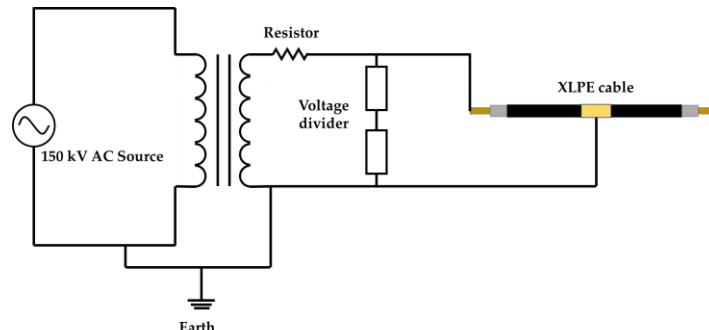
After the VLF $\tan \delta$ measurement was completed, dielectric breakdown test of the XLPE cable was performed. The experimental setup consists of a 150 kV AC voltage source and 6m XLPE cable as shown in Figure 3. The voltage was gradually increased to 50% of the anticipated breakdown voltage and then applied for 10 minutes. If dielectric breakdown did not occur, the voltage was raised to 10 kV and continued for 10 minutes. This process was repeated until dielectric breakdown occurred. When dielectric breakdown occurred, the location of the XLPE cable breakdown was confirmed as shown in Figure 4. If dielectric breakdown occurred in the XLPE insulation as depicted in Figure 4a, the cable was replaced with another XLPE cable. Cutting the section with dielectric breakdown and terminating the XLPE cable results in a shortened length, preventing further experimentation. However, if dielectric breakdown occurred at the semi-conductor layer-XLPE interface, as shown in Figure 4b, the cable was cut and terminations were made to facilitate additional re-experimentation.

Figure 3. Schematic diagram of cable dielectric breakdown.

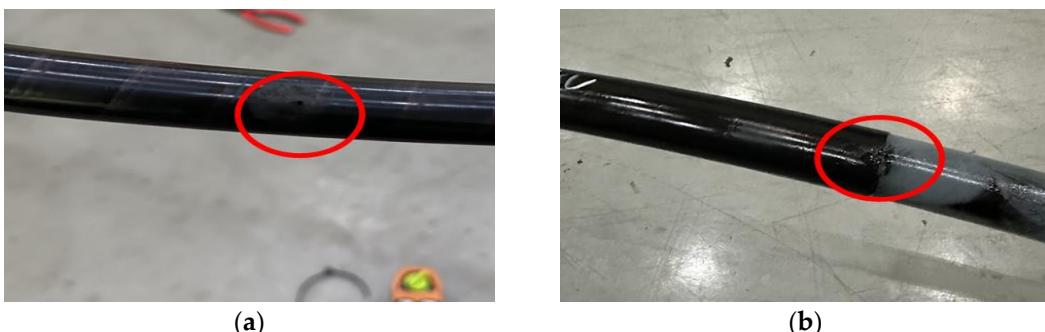
Figure 4. Location of dielectric breakdown occurred: (a) dielectric breakdown in XLPE insulation; (b) dielectric breakdown occurs at the semi-conductor layer-XLPE interface.

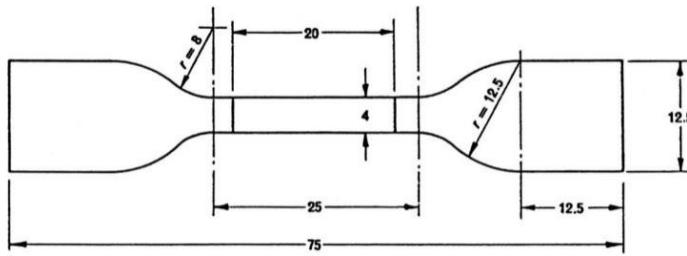
Upon completion of the dielectric breakdown experiment on the XLPE cable, the cable was cut and processed into ribbon-shaped tape samples. According to IEC 60811-1, the thickness of the specimens must be selected between 0.8 mm and 2.0 mm. Therefore, after verifying the thickness of the prepared specimens, dumbbell-shaped samples were fabricated as illustrated in Figure 5. Before measuring mechanical evaluations, it is necessary to measure the average thickness of the prepared dumbbell specimens to ensure reliable analysis results. The thickness at both ends and the center of the 4mm wide section was measured, and the average of these measurements was defined as the thickness of the dumbbell specimen. Afterwards, the tensile strength and elongation at break were measured using a tensile tester. The tests were conducted at room temperature with an elongation rate of 250mm/min. Tensile strength and elongation at break were determined based on the average of three tests conducted using the same method.

Figure 5. Dumbbell shaped specimen.

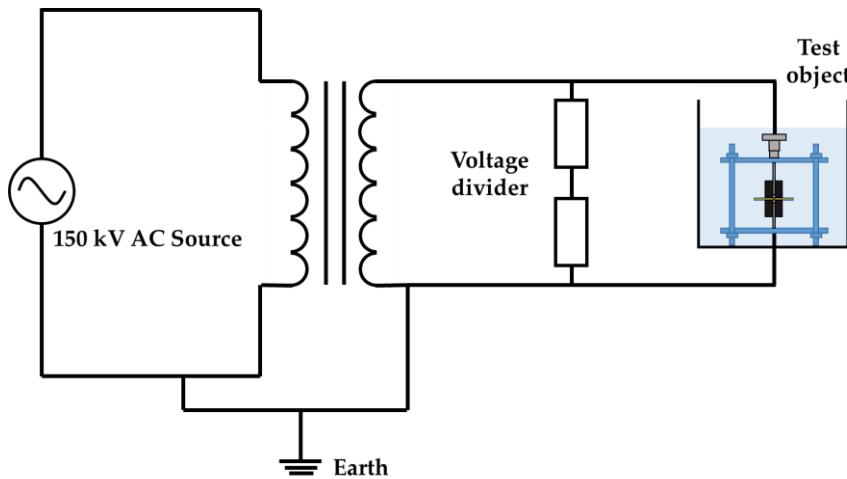
When performing a dielectric breakdown test on a 6m XLPE cable, it is possible to measure only one breakdown voltage. Therefore, a specimen was produced to reduce deviation through repeated experiments. The experimental setup consists of a 150 kV AC voltage source, a water tank, mineral oil, XLPE specimen, jigs, and epoxy molding electrodes, as shown in Figure 6. Mineral oil was used to prevent surface discharge of the XLPE specimen. Mineral oil was used to prevent surface discharge of the XLPE specimen. The jigs and epoxy molding electrodes are as shown in Figure 7. The applied electrode was made of a 10mm diameter sphere electrode molded with epoxy. This design minimizes surface discharge and ensures that dielectric breakdown occurs at the shortest distance between electrodes, enhancing the reliability of the dielectric breakdown test.

Figure 6. Schematic diagram of dielectric breakdown of XLPE specimen.

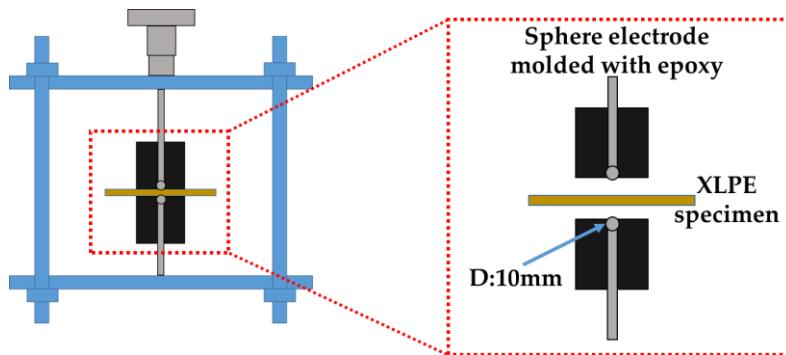
Figure 7. Jigs and Electrodes.

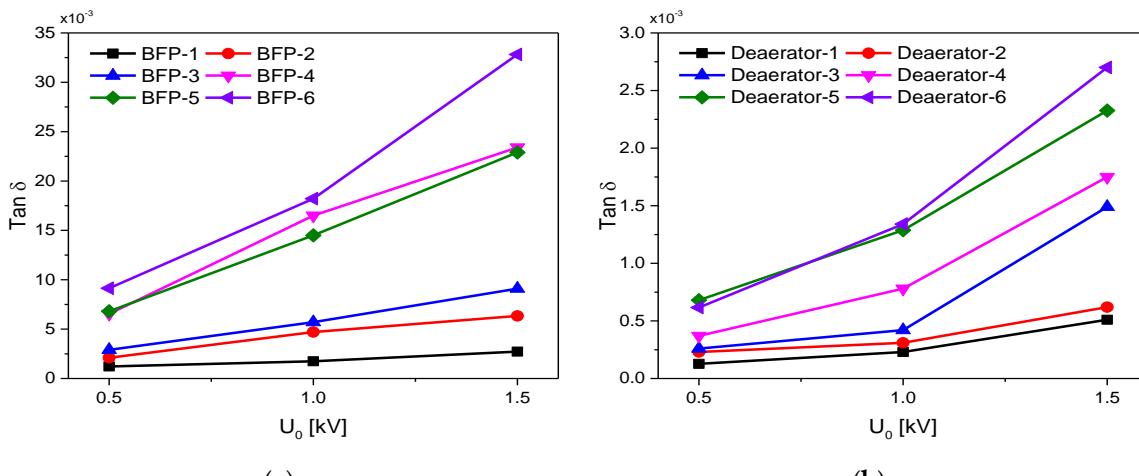
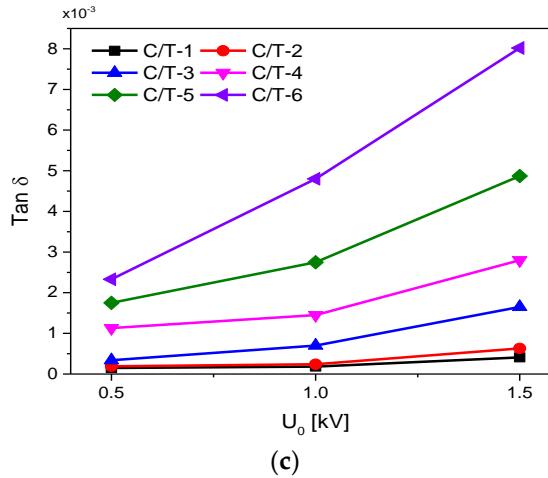
The VLF $\tan \delta$ of the XLPE cables installed in the combined heat and power plant was measured, as shown in Table 2 and Figure 8. When comparing the BFP, deaerator booster pump, and cooling tower, it was observed that the $\tan \delta$ deviation of the BFP was significantly large. The cooling tower also showed deviation, and the deviation of the deaerator booster pump was the smallest. It was observed that the $\tan \delta$ of the XLPE cable installed in the BFP increases linearly as U_0 increases. The rise in $\tan \delta$ with the increment in U_0 signifies an increase in losses within the insulator. The DTD ($1.5 U_0 - 0.5 U_0$) was also calculated to determine whether the high $\tan \delta$ is due to insulation degradation. If DTD is low while both $0.5 U_0$ and $1.5 U_0$ are high, it is due to environmental effects. Upon comparing the $1.0 U_0$ and DTD values, it appears that insulation degradation is more likely than environmental effects. The $\tan \delta$ of the XLPE cable installed in the deaerator booster pump is as shown in Figure 8b. Unlike the BFP, the graph for the deaerator booster pump showed a larger increase in $\tan \delta$ when the voltage was raised from $1.0 U_0$ to $1.5 U_0$. Since the DTD value was also high, it is confirmed that the cable is undergoing degradation. Deaerator-6 was identified as the XLPE cable

installed in the deaerator booster pump that has experienced the most significant degradation. However, it is similar to the $\tan \delta$ of the cable with the best insulation condition in the BFP. Figure 8c shows the $\tan \delta$ of the XLPE cable installed in the cooling tower. Unlike the cables installed in the BFP and deaerator booster pump, the $\tan \delta$ is distributed with a consistent deviation. For the cooling tower cable as well, the increase in $\tan \delta$ was larger when the voltage was raised from $1.0U_0$ to $1.5U_0$. Since the DTD value is also high, it indicates that the cable has undergone degradation.

Figure 8. VLF $\tan \delta$ depending on installation location: (a) BFP; (b) deaerator booster pump; (c) cooling tower.

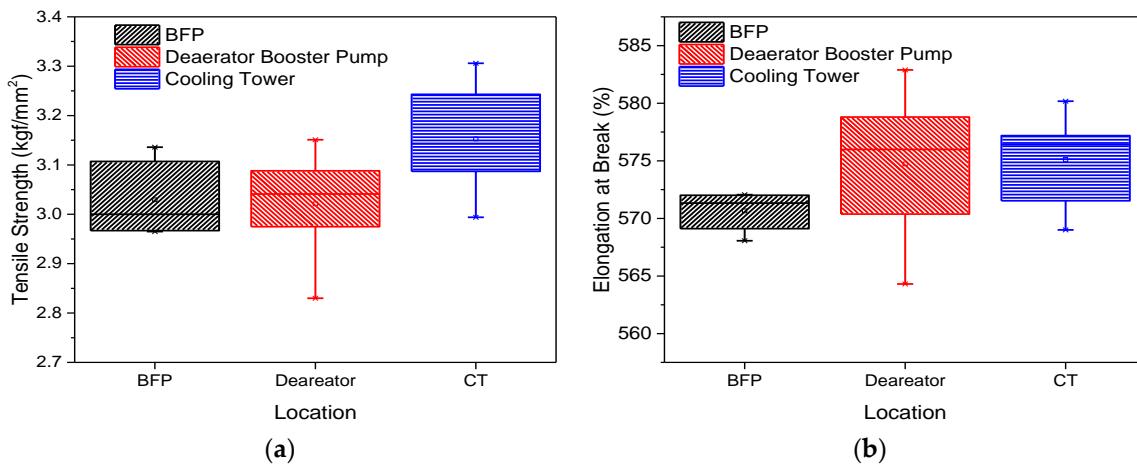
Figure 9 shows the graph of tensile strength and elongation at break according to installation location. The tensile strength is highest in the cooling tower and lowest in the deaerator booster pump, with approximately a 15% deviation. Excluding the highest and lowest values for comparison, it becomes difficult to distinguish differences in tensile strength according to the installation location. The deviation between the maximum and minimum values of elongation at break is around 4%. Therefore, similar to tensile strength, it is challenging to compare differences in elongation at break according to the installation location.

Figure 9. Mechanical evaluation according to installation location: (a) tensile strength; (b) Elongation at break.

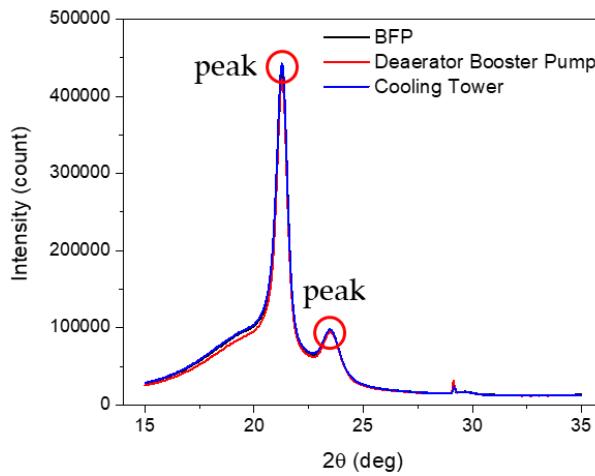
The XRD measurement data of XLPE specimens according to the installation location is as shown in Figure 10. The XRD analysis identified peaks at 21.3° and 23.4°. There was no difference in the peak angles of Intensity according to the installation location. For further analysis, each area is calculated through normal distribution as shown in Figure 10. Afterwards, the crystallinity was calculated using Equation 1.

In equation 1, $\chi(\%)$ is the crystallinity, Area 1 is amorphous area, Area 2 is the area of first peak and Area 3 is the area of the second peak.

Figure 10. XRD depending on installation location.

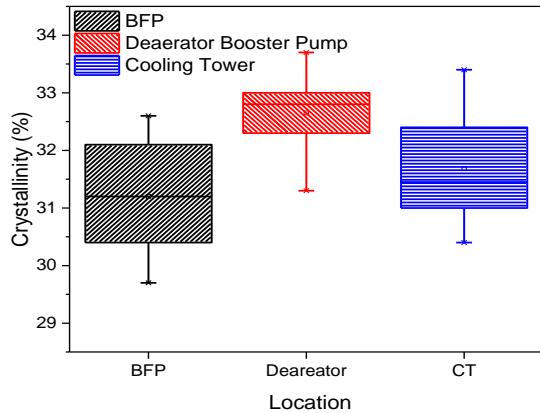
The derived crystallinity is shown in Figure 11. When analyzing the crystallinity according to the installation location, the BFP and cooling tower were similar. The difference between the highest and lowest values of crystallinity at each installation location was the largest for the cooling tower and BFP. However, excluding the highest and lowest values, the greatest deviation was observed in the BFP. This confirms that there is a significant variation in degradation. The crystallinity was highest for the XLPE cable installed in the deaerator booster pump. Additionally, the variation in data was relatively low. This means that the deterioration progressed less than in other locations.

Figure 11. Crystallinity of XLPE specimens depending on installation location.

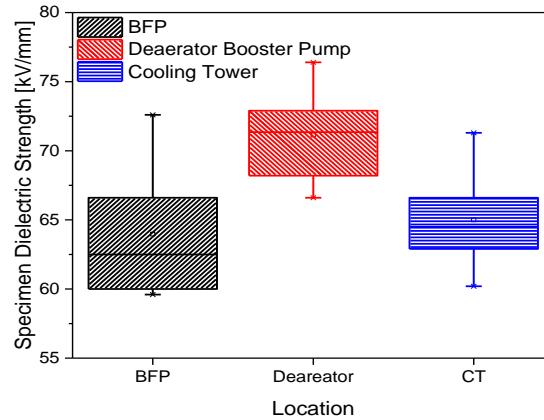
The dielectric strength of the specimens is as shown in Figure 12. The dielectric strength distribution of the XLPE cable specimens installed in the BFP is the lowest. However, it was confirmed that the variation in dielectric strength was the largest. The dielectric strength of the specimens in the cooling tower was similar to that of the BFP, but slightly higher. The variation in dielectric strength was also similar to that of the BFP, but the deviation in the data, excluding the highest and lowest voltages, was the smallest. Deaerator booster pump shows the highest dielectric strength distribution, with about 10% higher insulation performance.

Figure 12. Dielectric strength of XLPE specimens depending on installation location.

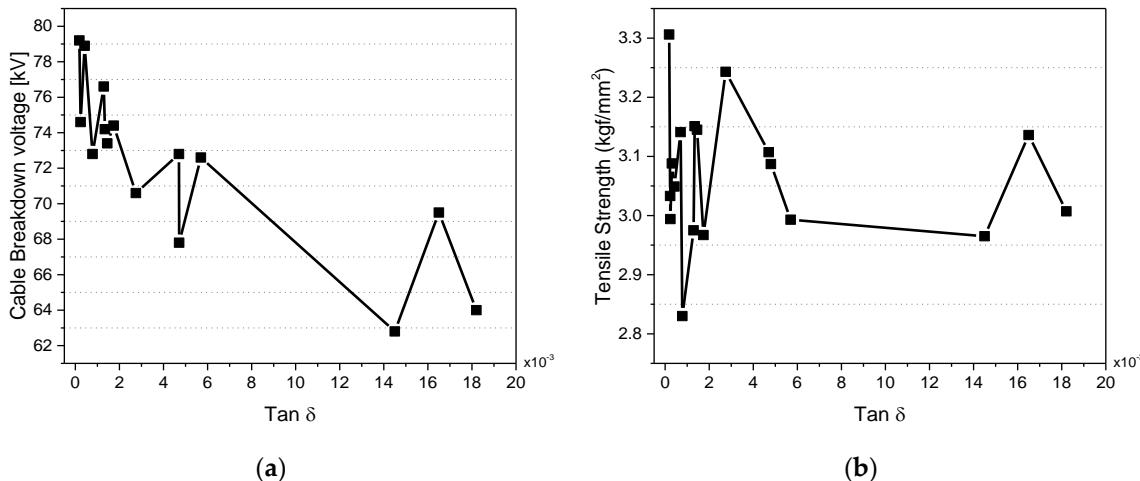
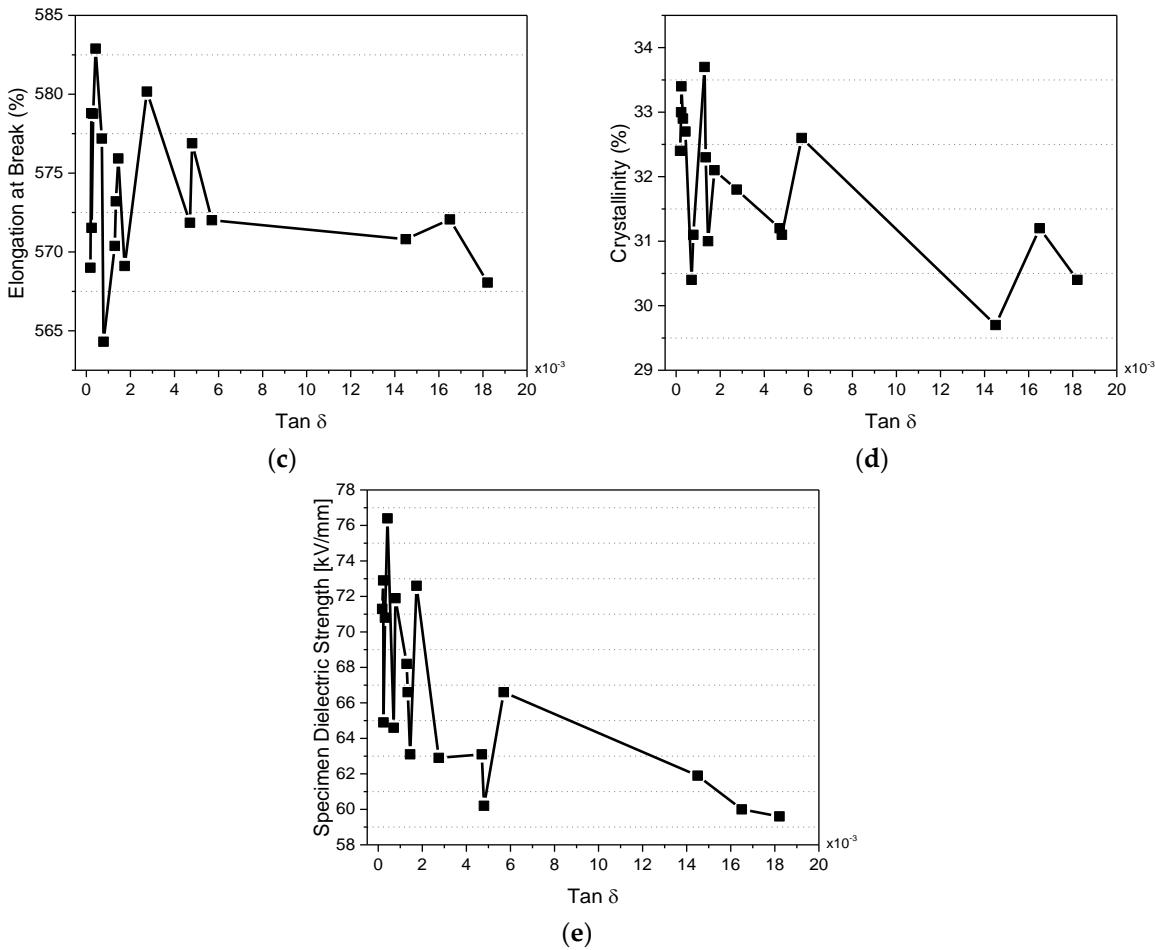
The correlation between VLF $\tan \delta$ and the dielectric breakdown of the cable is shown in Figure 13a, and the correlation between VLF $\tan \delta$ and the characteristic evaluation of the specimen is shown in Figure 13b–e. In Figure 13a, data for Deaerator-1, Deaerator-2, and C/T-3 were excluded. The $\tan \delta$ values for the excluded data are 0.23, 0.31, and 0.7 based on 1.0 U_0 . The reason for exclusion is that during the cable dielectric breakdown test, flashovers occurred, or dielectric breakdown happened at the interface between the semi-conductor layer and the XLPE insulator. It was observed that as $\tan \delta$ increases, the breakdown voltage of the cable decreases. The highest breakdown voltage was 79.2 kV, and the lowest voltage was 62.8, a decrease of about 20%. $\tan \delta$ at each voltage is 0.18 and 14.5. If the $\tan \delta$ data are distributed between 0.183 and 1.74, the breakdown voltages range from 72.8 to 79.2 [kV]. For $\tan \delta$ values within the range of 2.75 to 5.7, the breakdown voltages were measured between 67.8 and 72.8 [kV]. The remaining $\tan \delta$ is 14.5~18.2, and the breakdown voltage is 62.8~69.5 [kV]. Although repeated dielectric breakdown tests could not be performed due to the insufficient number of cables with high $\tan \delta$, it was possible to observe the distribution of dielectric breakdown voltage according to $\tan \delta$. This confirmed that there is a correlation between $\tan \delta$ and the breakdown voltage of the cable.

Figure 13. Correlation with Tan δ : (a) Tan δ and cable insulation breakdown; (b) Tan δ and tensile strength; (c) Tan δ and elongation at break; (d) Tan δ and crystallinity; (e) Tan δ and specimen dielectric strength.

The tensile strength and elongation at break according to Tan δ are as shown in Figures 13b,c. Even as Tan δ increases, the tensile strength and elongation at break show a consistent distribution. The tensile strength was mostly measured around 3.0 to 3.2 [kgf/mm²]. The elongation at break is also distributed between approximately 568% to 580%, but unlike tensile strength, it ranges from about 568 to 572% as Tan δ increases. Therefore, the elongation at break showed a tendency to decrease as Tan δ increased. However, it was found that Tan δ has a minor correlation with both tensile strength and elongation at break.

The crystallinity according to Tan δ is as shown in Figure 13d. When Tan δ is below 2, the crystallinity is distributed around 31 to 33%. However, a crystallinity of approximately 31 to 32% was derived when Tan δ ranges from 2 to 6. If Tan δ was 14 to 18, the crystallinity was calculated to be around 30 to 31%. Among the 18 Tan δ values, 11 are distributed within values below 2. Although the number of crystallinity measurements at higher Tan δ values is limited, it was observed that as Tan δ increases, there is a trend of decreasing crystallinity.

The dielectric strength graph of the specimens is as shown in Figure 13e. As Tan δ increased, the dielectric strength of the specimen decreased. When Tan δ is low, the dielectric strength of the specimens was distributed between approximately 63 to 73 [kV/mm], but as Tan δ increases, it was measured between 59 to 62 [kV/mm]. When Tan δ is 0.23 and 18.21, the dielectric strengths are 72.9 and 59.6 [kV/mm], respectively, showing a difference in dielectric strength of approximately 19%. Through this, it was confirmed that there is a correlation between Tan δ and the dielectric strength of the specimen.
