Experimental Investigation of Damage to Polymer Glass and Carbon Composites Used in Wind Turbine Blades as a Result of Four-Point Bending Test

[Senai YALÇINKAYA](#) , [Mehmet Fatih YOLDAS](#) ^{*} , [Dudu MERTGENÇ YOLDAS](#)

Posted Date: 29 July 2025

Keywords: adhesively bonded joints; composite materials; four-point bending test; mechanical properties; young's modulus

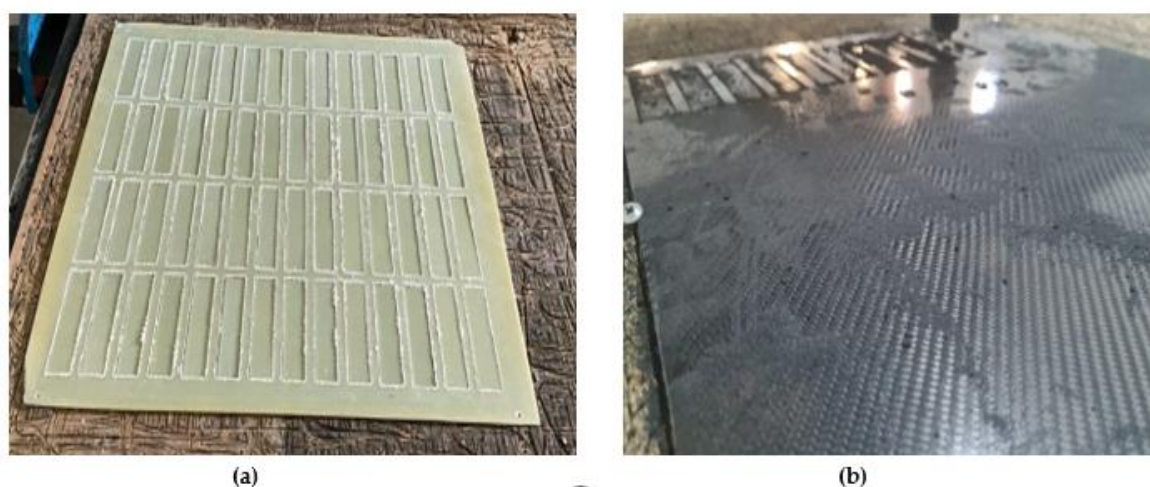
Figure 1. Shaping of GFRP (a) and CFRP (b) Plates with CNC Router.

complete the gelation process. Composite laminates were then produced using the hot press method; this process was carried out at 120°C and 8–10 bar for one hour. The GFRP and CFRP composite sheets produced were designed to measure 500 mm × 500 mm, and a CNC router was used for precision cutting (Figure 1). The mechanical properties of the composite structures obtained after curing were determined to be tensile strength 80 MPa and tensile modulus 3300 MPa. Flexural strength was 125 MPa and flexural modulus 3200 MPa.

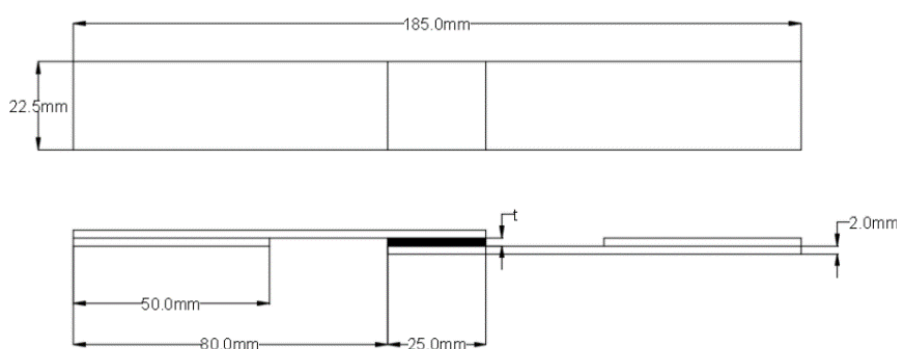
Figure 2. Geometric configuration of GFRP and CFRP specimens

The GFRP and CFRP specimens were prepared in accordance with ASTM D5868–01 [18], the standard test method for evaluating lap shear strength in fiber-reinforced plastic (FRP) adhesively bonded joints (Figure 2). Accordingly, the test specimens were cut to appropriate dimensions and shaped to allow for the examination of both moisture absorption and adhesive bond performance. During the preparation phase for the bonding process, reference points located 25 mm from the ends of the GFRP and CFRP specimens were determined, and the corresponding markings were made (Figure 3).

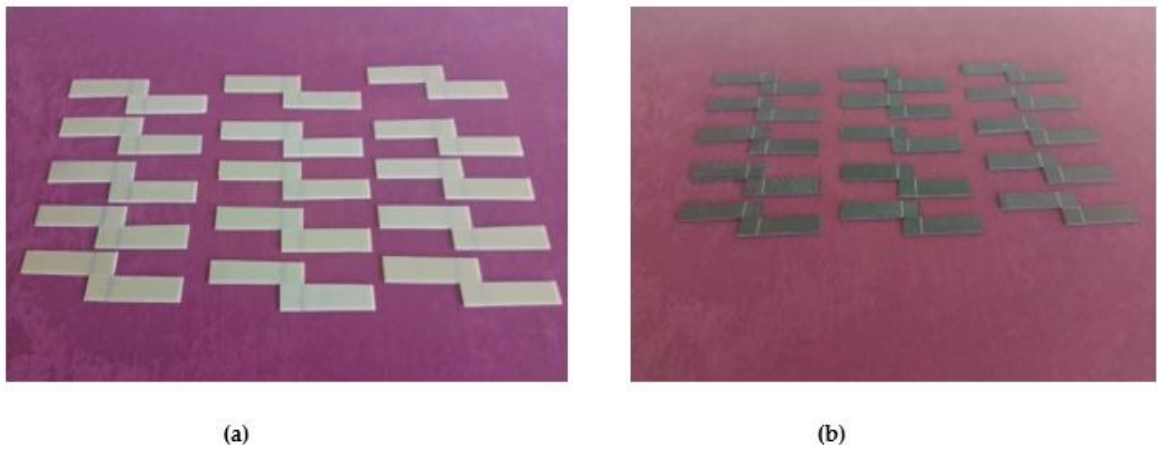
Figure 3. Marking of GFRP (a) and CFRP (b) specimens for alignment and placement before bonding.

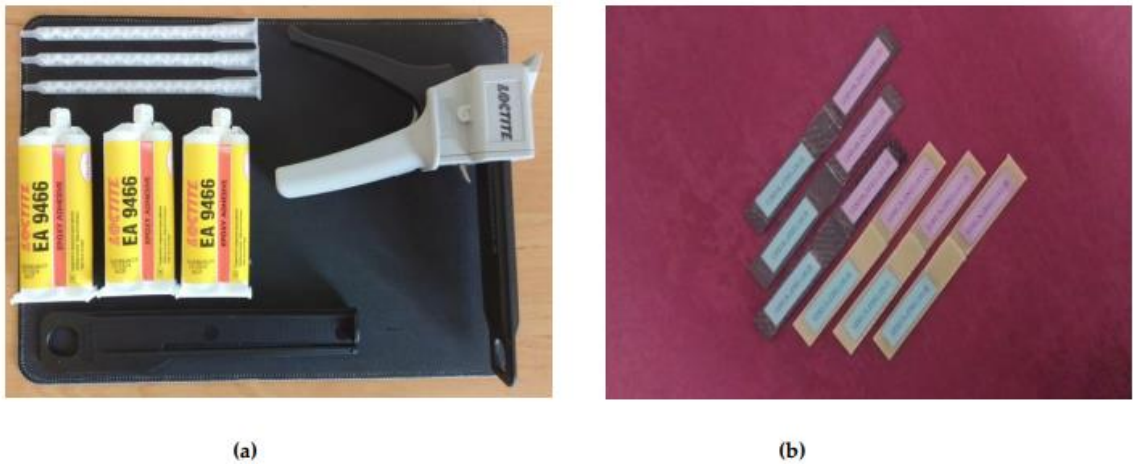
Figure 4. General appearance of the surface after application of Loctite Hysol-9466 epoxy adhesive (a) on the samples (b).

The samples were prepared by bonding solvent-cleaned surfaces using the adhesive bonding method. The bonding was performed using Loctite Hysol-9466 (Alpanhidrolik, Eskişehir, Turkey), a two-component epoxy adhesive that cures at room temperature and is mixed at a 2:1 ratio in the application gun (Figure 4a). Literature indicates that maintaining the adhesive thickness between 0.1 and 0.3 mm provides optimum bond strength, while thicknesses exceeding 0.6 mm result in a decrease in mechanical strength. This is explained by the fact that thin adhesive layers can utilize mechanical strength more efficiently [19]. Therefore, the adhesive layer thickness was set at 0.2 mm, and application was carried out under a constant pressure of 0.1 MPa. The homogeneity of the adhesive layer was checked with a digital caliper. The samples were allowed to cure at room temperature for 7 days in accordance with the product technical data sheet (Figure 4b).

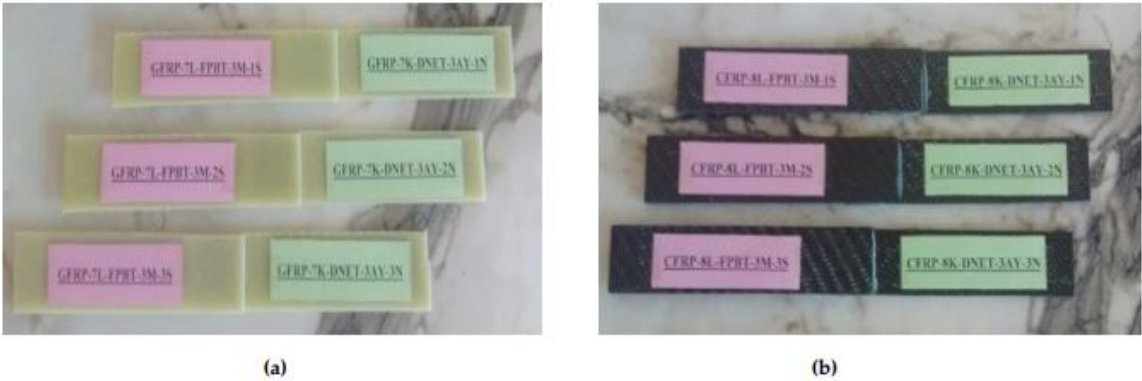
Figure 5. Sample codings of GFRP (a) and CFRP (b) samples.

To prevent confusion during the experimental process, the samples were assigned distinctive codes in both Turkish and English. The English code structure was organized to include information on the material type, number of layers, test method, environmental conditions, and sample order. For example, the code GFRP-7L-FPBT-2M-1S represents a seven-layer (7L) glass fiber-reinforced plastic (GFRP) sample subjected to four-point bending test (FPBT), immersed in seawater for two months (2M), and the first-row sample (1S). The same sample was coded in Turkish as GFRP-7K-DNET-2AY-1N. Here, GFRP represents glass fiber-reinforced plastic (GFRP), 7K represents the number of layers, DNET represents the four-point bending test, 2AY represents the two-month immersion period in seawater, and 1N represents the sample number (Figure 5). This bilingual coding approach facilitated

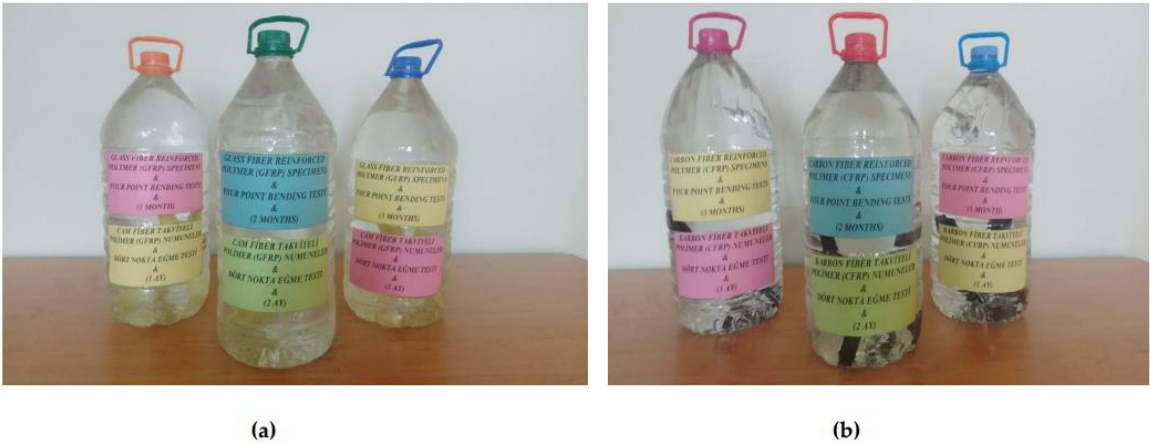
Figure 6. Soaking of GFRP (a) and CFRP (b) samples in seawater with 3.3–3.7% salinity for 1, 2 and 3 months.

The samples were prepared using the single-lap joint method and divided into three experimental groups for exposure to different environmental conditions. The first group was stored in dry conditions, while the other groups were stored in seawater with a salinity of 3.3–3.7% and a constant temperature of 21°C for 1, 2, and 3 months, respectively. The salinity and temperature of the seawater to which the samples were exposed were kept constant throughout the experimental period (Figure 6)

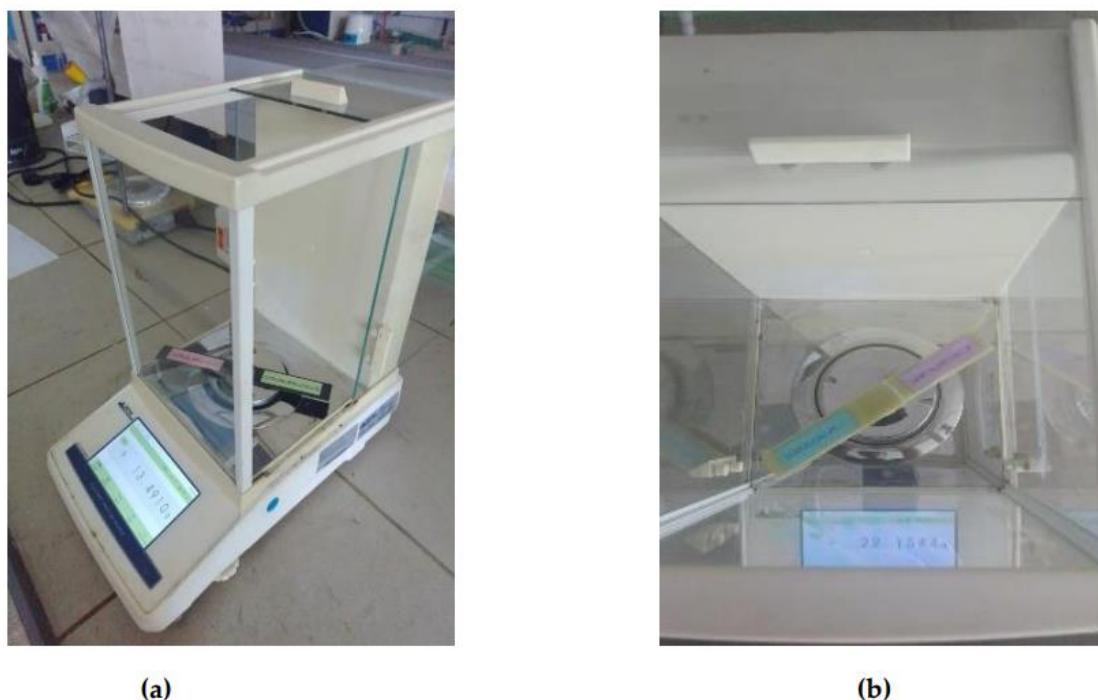
Figure 7. Analytical balance with 0.1 mg precision (DAIHAN Scientific, Korea) used to measure sample weights.

carried out using an analytical balance with a sensitivity of 0.1 mg at the Dokuz Eylül University Faculty of Science, Daihan Biomedical Chemistry Department Laboratory (Daihan Biomedical, DAIHAN Scientific Laboratory & Medical Instruments Manufacturer, Korea). A total of 12 measurements were made using three standard samples and dry reference samples for each aging period and sample type. Graphs were generated for the average mass changes of the samples based on the obtained data (Figure 7).

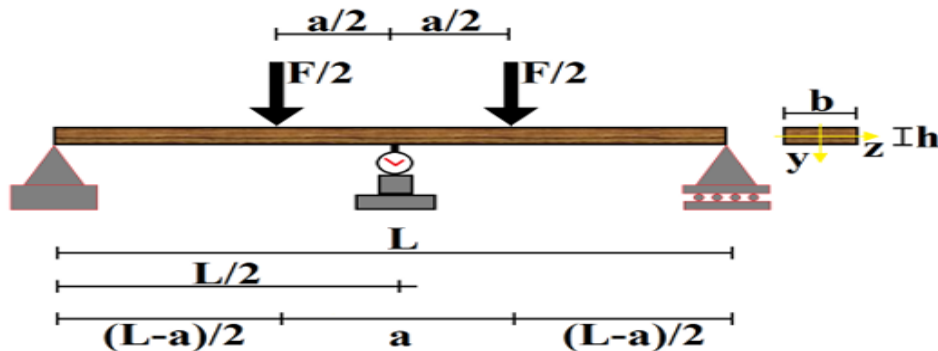
Figure 8. Schematic view of four-point bending test conditions.

Four-point bending testing is a mechanical testing method used to evaluate the elastic and plastic deformation behavior of materials. This test is particularly used to determine properties such as flexural strength, elastic modulus, ductility, and fracture toughness in composite materials. In a four-point bending test, the specimen is supported at both ends, and two equal loads are applied. The region between the loading points is the pure bending region, where shear stresses are close to zero. This allows for a more even analysis of the material's bending behavior. The force applied during the test is evaluated along with the deflection (deflection) at the center of the specimen, and stress and strain values are calculated [20]. The four-point bending test is a test method in which the deformation of a flat test piece, usually of circular or rectangular cross-section, placed freely on two supports is examined by applying two equal forces without changing direction. The region between the load points is defined as the bending zone subjected to a constant bending moment. This reduces the effect of shear stresses, allowing a more accurate assessment of the material's bending behavior (Figure 8) [21].

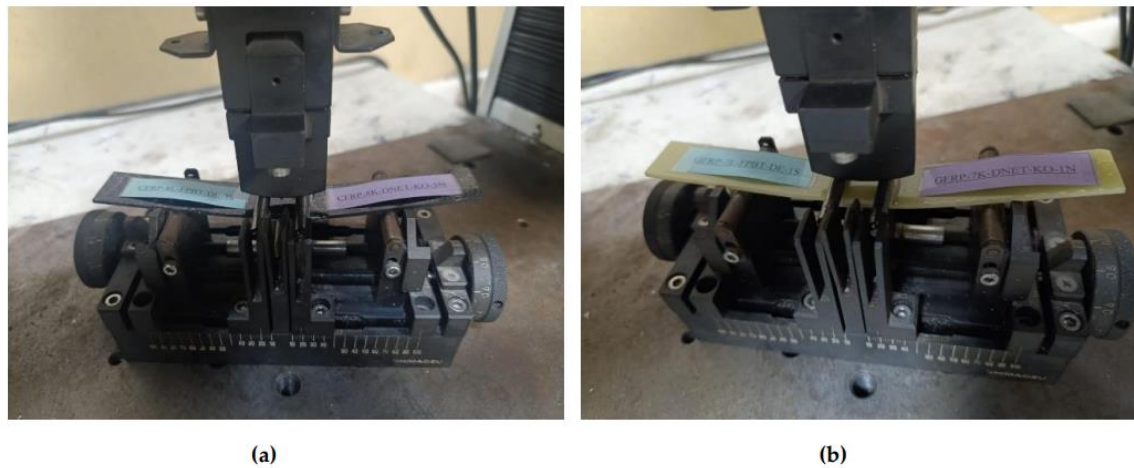
Figure 9. GFRP (a) and CFRP (b) four-point bending tester and specimen positioning.

GFRP and CFRP single-lap joint specimens with 0.2 mm thick adhesive were used in the study. The specimens were tested in both dry and seawater conditions to evaluate the mechanical performance under environmental conditions. Stress-strain curves were obtained using the test software after the experiment, and analyses were conducted using these data. The effect of environmental effects on the bending behavior at the bond interface was analyzed, and changes in mechanical properties were comparatively examined based on the experimental findings (Figure 9).

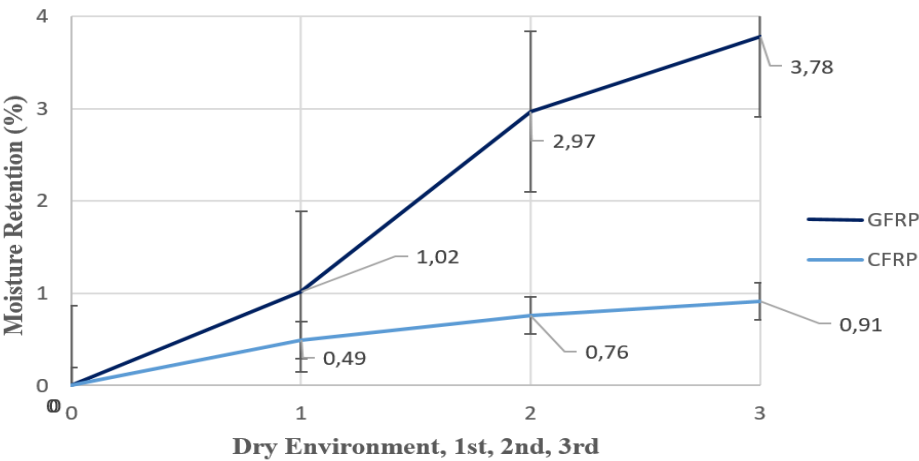
Figure 10. Moisture Absorption Behavior of GFRP and CFRP Connections Over Time in Wind Turbine Blade Connections in Offshore Conditions.

Figure 10 shows the moisture retention rates (%) of GFRP and CFRP single-lap joint specimens measured after 1, 2, and 3 months of immersion in seawater, representing offshore conditions, respectively. The results show that the GFRP specimens exhibited a tendency toward increasing

The comparative moisture absorption behavior of GFRP and CFRP samples is presented in Figure 10.

water absorption over time, and this tendency accelerated, particularly after the second month. This is due to the glass fibers being more permeable to water molecules and their interaction with the epoxy matrix [1]. An increase in moisture retention over time was also observed in CFRP specimens; however, this increase was much less than in GFRP. This difference is due to the lower water absorption tendency and more microstructure of carbon fibers [23].

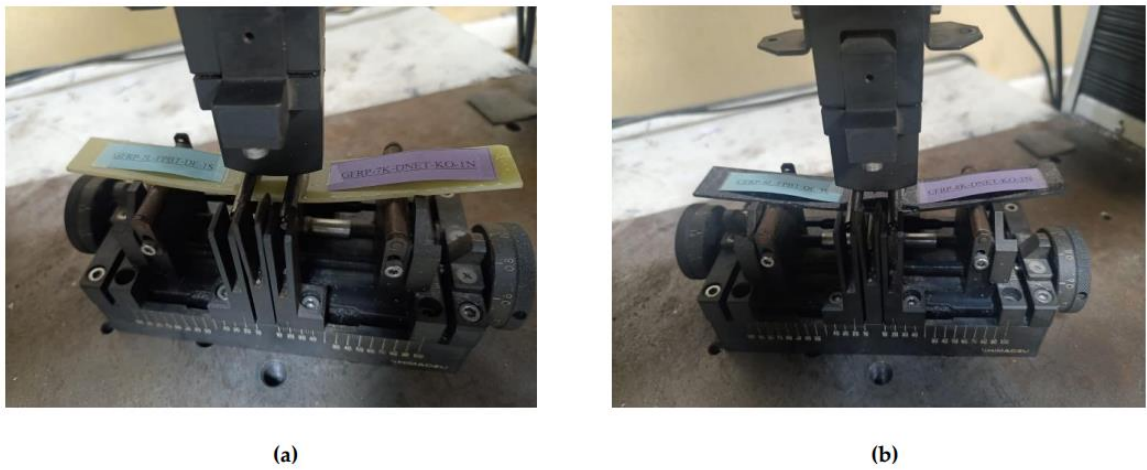
Figure 11. Four-point bending tester and positioning of GFRP (a) and CFRP (b) dry specimens.

The placement of GFRP and CFRP joint specimens, which were kept in a dry environment, in a four-point bending test apparatus and the test setup are presented in Figure 11. This test setup is designed to evaluate the mechanical behavior of composite structures under bending. The specimens are supported at two end points, and forces are applied through two equally spaced loading points. This ensures a homogeneous stress distribution in the central constant moment region [20].

In the test setup, the bonded joint region is positioned to coincide with the central constant moment region. This allows for the observation of damage occurring at the joint interface. Figure 11 shows in detail the support points, loading pins, and the direction of the test, which ensure the correct alignment of the specimen.

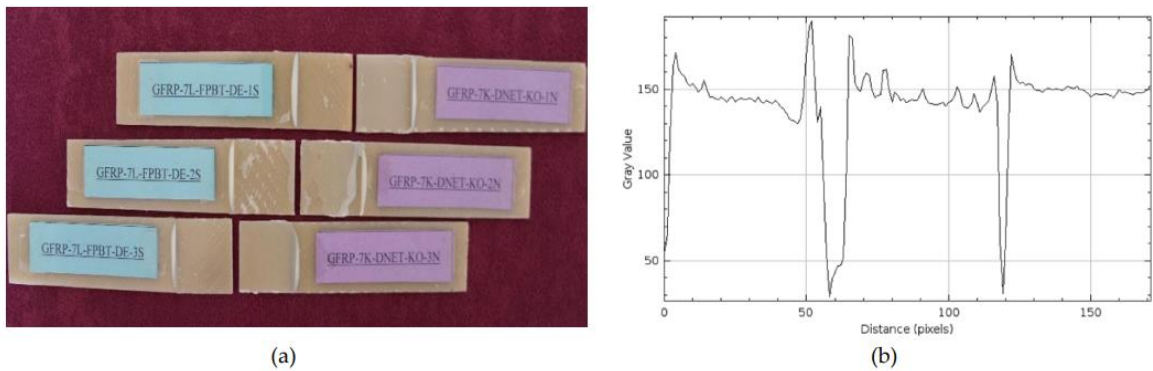
Figure 12. GFRP-7L-FPBT-DE Dry Conditioned (a) and surface roughness profile along the damage zone (b).

In Figure 12a, separations were observed in all GFRP specimens starting from the bond line. These separations were caused by the maximum bending stress occurring in the constant moment region between the two points where the loads were applied in the four-point bending test. Damage was concentrated in the bending region midway between the load application points, and the integrity of the specimen body was largely preserved. This suggests that rupture behavior began in this region, where the highest bending stress was effective.

Damage observations after four-point bending of GFRP and CFRP reference samples stored in a dry environment at 21°C for three different samples are given in Figures 12 and 13, respectively. These samples were used as references for comparative evaluation with samples exposed to seawater for 1, 2, and 3 months.

Comparing the surface roughness profile along the damage area in Figure 12b and Figure 13b:

In Figure 12b, the maximum gray value of the surface profile of the GFRP specimen was measured as approximately 150, and the distance (pixels) value was measured as 150. This indicates a regular but slightly rough surface structure. Despite being conditioned in a dry environment, the damage type, such as limited micro-level distortion, was observed at the fiber-matrix interface after the four-point bending test, resulting in the profile exhibiting wide-ranging but low-intensity fluctuations.

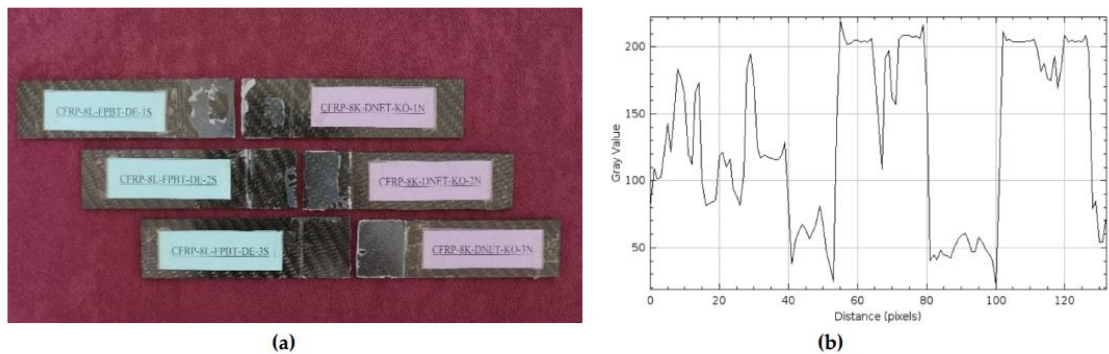
Figure 13. CFRP-8L-FPBT-DE Dry Conditioned(a) and surface roughness profile along the damage zone (b).

Figure 13a shows the CFRP specimens after the four-point bending test. In the CFRP specimens, separation occurred at the bond line, particularly between the load application points, and the integrity of the specimens was maintained. Figure 13 shows that the damage at the bond line began in the constant moment region in the middle, where the maximum bending stress was effective, and progressed along the bond line.

In the CFRP sample in Figure 13b, the maximum gray value exceeds 200, while the distance (pixels) value remains around 120. This profile demonstrates more intense and distinct structural features on the CFRP surface, indicating a more rigid fiber-matrix interface. A higher gray value indicates a surface feature where the fibers form a stronger bond with the matrix, while a shorter distance indicates that this integrity is maintained in a more localized yet robust structure.

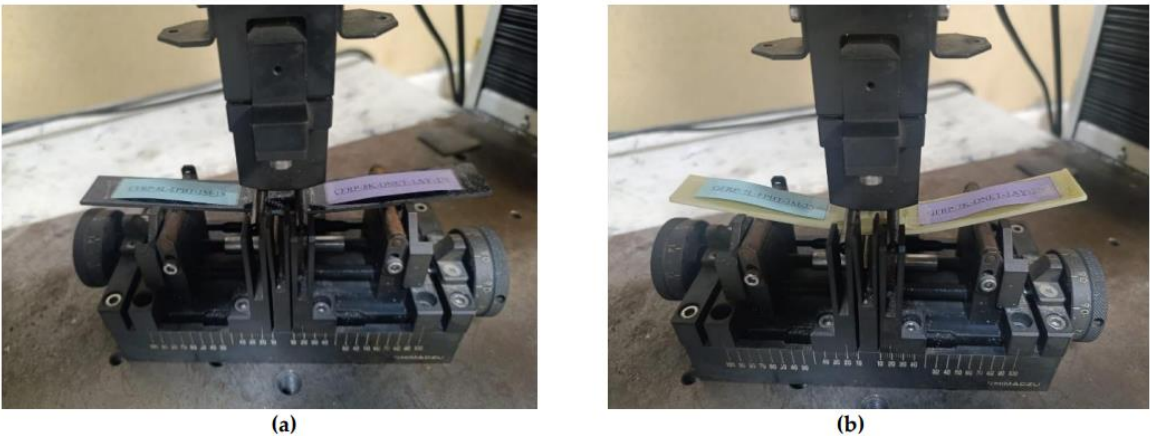
Figure 14. Four-point bending tester, positioning of GFRP (a) and CFRP (b) samples kept in seawater for 1 month.

The placement of the bonded GFRP and CFRP connection samples, which were kept in sea water for one month, in the four-point bending test apparatus and the test setup are presented in Figure 14.

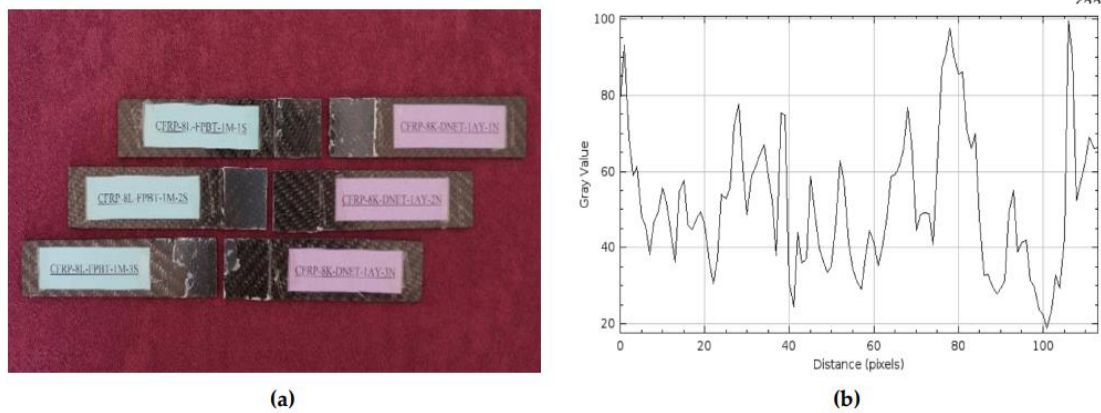
Figure 16. CFRP-8L-FPBT-1M Samples Kept In Seawater For 1 Month (a) and surface roughness profile along the damage zone (b).

The sudden rupture behavior observed in the CFRP samples in Figure 16a is due to the high structural strength of the carbon fibers. Due to their low water absorption, the CFRP samples were able to maintain adhesion at the bond line for longer periods and exhibited sudden, but higher, fracture capacity under four-point bending loading.

The damage types that occurred after the four-point bending tests performed on GFRP (a) and CFRP (b) samples kept in sea water at a constant temperature of 21°C for 1 month are presented in Figure 15 and Figure 16, respectively, in three different samples.

In the CFRP sample in Figure 16b, the maximum gray value was only slightly above 100, while the distance value was measured at approximately 100. A low gray value indicates that surface irregularities are limited and damage is less severe. A low distance value, however, indicates that damage occurs in a narrower, more limited area. This indicates that CFRP specimens maintain their structural integrity better in the seawater environment than GFRP specimens, with less decomposition and deterioration occurring at the fiber-matrix interface.

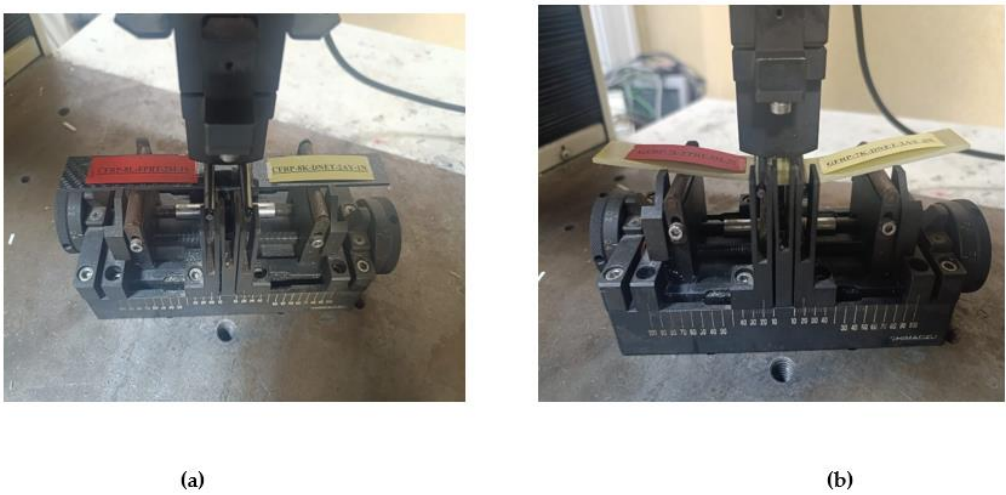
Figure 17. Four-point bending tester and positioning of GFRP (a) and CFRP (b) samples kept in seawater for 2 months.

The placement of the bonded GFRP and CFRP connection samples, which were kept in sea water for two months, in the four-point bending test apparatus and the test setup are presented in Figure 17.

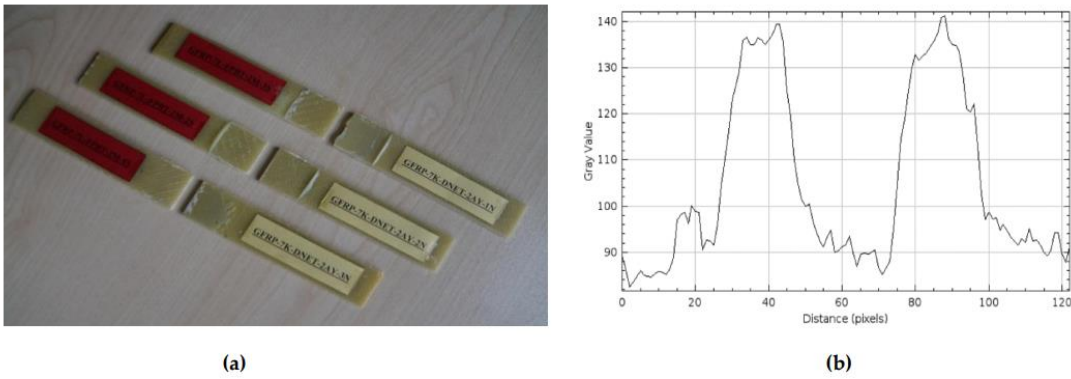
Figure 18. GFRP-7L-FPBT-2M Samples Were Kept In Sea Water For 2 Months (a) and surface roughness profile along the damage zone (b).

In the samples shown in Figure 18a, a mixed (cohesive + adhesive) type of damage was observed, where the damage was not confined to the bond line, but adhesive residue was also present on both surfaces, and both interfacial and intra-adhesive fractures occurred simultaneously. This indicated that during loading, both the internal structure of the adhesive in the bond region weakened and the bond interfaces separated. This distribution of damage indicated that the stress distribution at the bond line was uneven, and seawater weakened the bond.

The damage types that occurred after the four-point bending tests performed on GFRP (a) and CFRP (b) samples kept in sea water at a constant temperature of 21°C for 2 months are presented in Figure 18 and Figure 19, respectively, in three different samples.

In Figure 18b, the maximum gray value and distance (pixels) values for the GFRP samples were measured at approximately 140 and 120, respectively. A decrease in the gray value compared to the one-month post-treatment period indicates that surface differences and microstructural damage have diminished. However, the fact that the distance value remained the same indicates that the spread of surface damage continues at a similar rate.

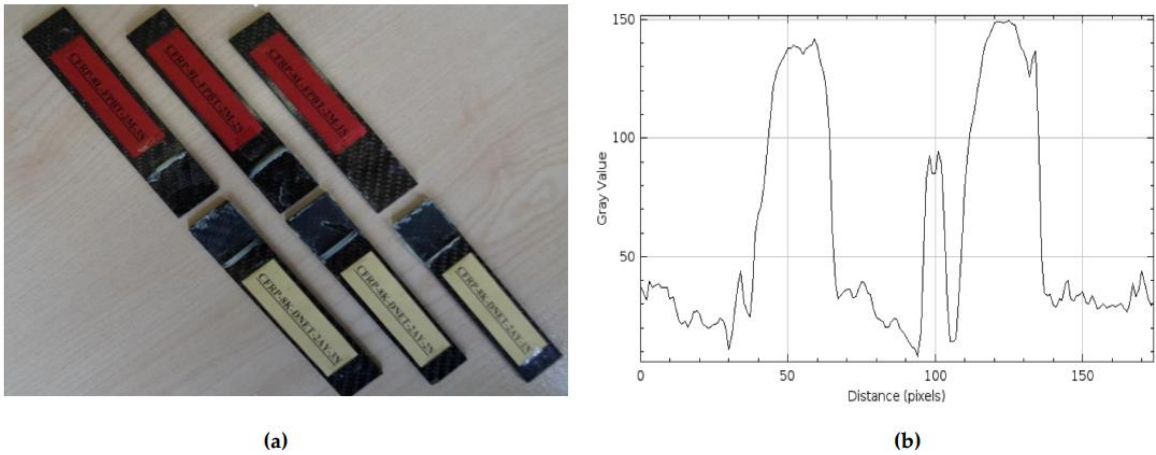
Figure 19. CFRP-8L-FPBT-2M Samples Were Kept In Sea Water For 2 Months (a) and and surface roughness profile along the damage zone (b).

Similarly, in Figure 19a, the presence of adhesive residue on both surfaces along with the rupture at the adhesive bond line in the CFRP samples indicates a mixed (cohesive + adhesive) damage type. Despite 2 months of immersion in seawater, CFRP's superior mechanical properties ensured that the loads transferred from the adhesive to the material were more evenly distributed at the interface, resulting in better adhesion of the adhesive to the sample surface.

In Figure 19b, the maximum gray value and distance values for the CFRP samples were measured at 150 and 150, respectively. Compared to the one-month post-treatment period, an increase in the gray value and distance values was observed. This is because the damage in CFRP samples increases over time.

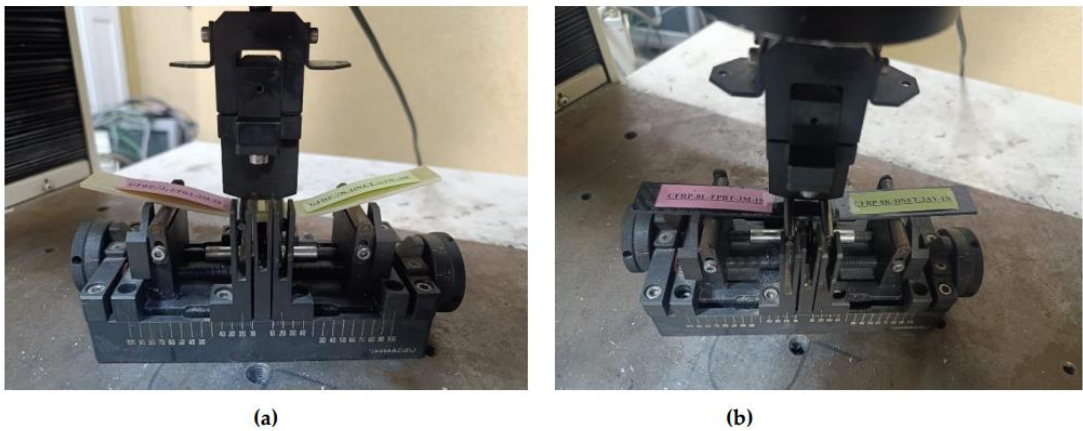
Figure 20. Four-point bending tester and positioning of GFRP (a) and CFRP (b) samples kept in seawater for 3 months.

The placement of the bonded GFRP and CFRP connection samples, which were kept in sea water for two months, in the four-point bending test apparatus and the test setup are presented in Figure 20.

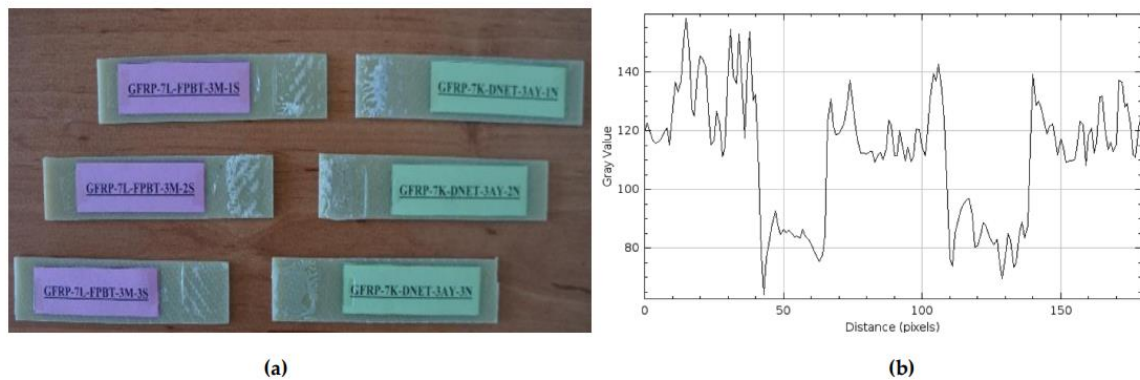
Figure 21. GFRP-7L-FPBT-3M Samples Were Kept in Sea Water for 3 Months (a) and and surface roughness profile along the damage zone (b).

In the GFRP specimens exposed to seawater for 3 months, shown in Figure 21a, damage was observed to occur directly at the bond line. The failure was particularly concentrated in the central region of the joint, and adhesive residue remained on both surfaces of the specimens. This indicates that the damage was predominantly adhesive, weakening the bond strength at the bond surface. Moisture penetrating the adhesive-sample interface during seawater exposure reduced adhesion quality and created microscopic voids and a plasticizing effect at the interface. This weakened the bond line.

In Figure 21b, the maximum gray value for the GFRP samples exceeded 140, and the distance value was measured as 150 pixels. Compared to 2 months, there was no significant increase in the gray value, but the distance increased. This indicates that the roughness on the GFRP surface began to remain constant, but the deterioration spread over a wider area. In other words, the GFRP samples continued to absorb seawater, leading to microstructural deterioration on the surface.

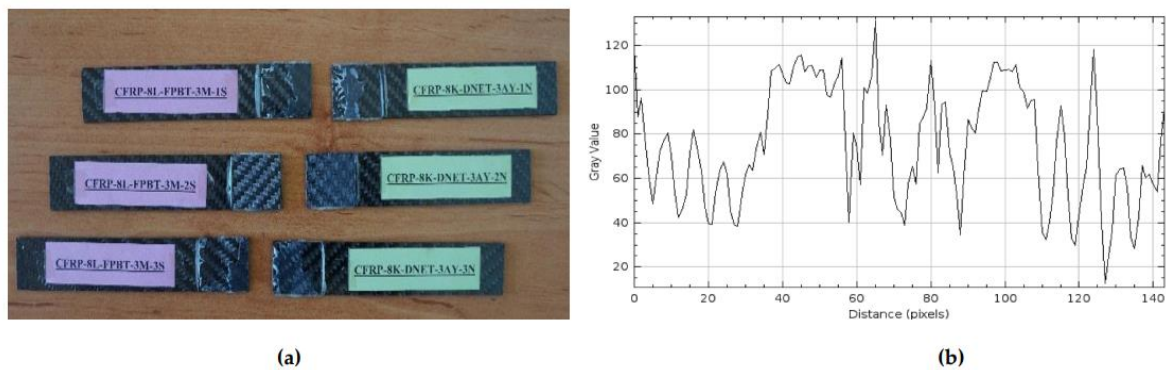
Figure 22. CFRP-8L-FPBT-3M Samples Were Kept in Sea Water for 3 Months (a)) and and surface roughness profile along the damage zone (b).

In Figure 22a, similar damage occurred at the bond line in CFRP samples exposed to seawater for 3 months, with the adhesive remaining on both surfaces, resulting in a cohesive-adhesive transition. However, given the high strength and low moisture absorption capacity of CFRP samples, the damage is less severe compared to GFRP samples.

In Figure 22b, the maximum gray value for the CFRP samples was determined as 120 and the distance value as 140. Compared to the two-month period, the gray value decreased, but the distance value increased. This change indicates that the roughness of the CFRP surface has decreased somewhat, but the deterioration has spread over a larger surface area. This suggests that although

the CFRP samples were initially resistant to seawater conditions, they began to struggle to maintain their surface integrity after prolonged exposure.

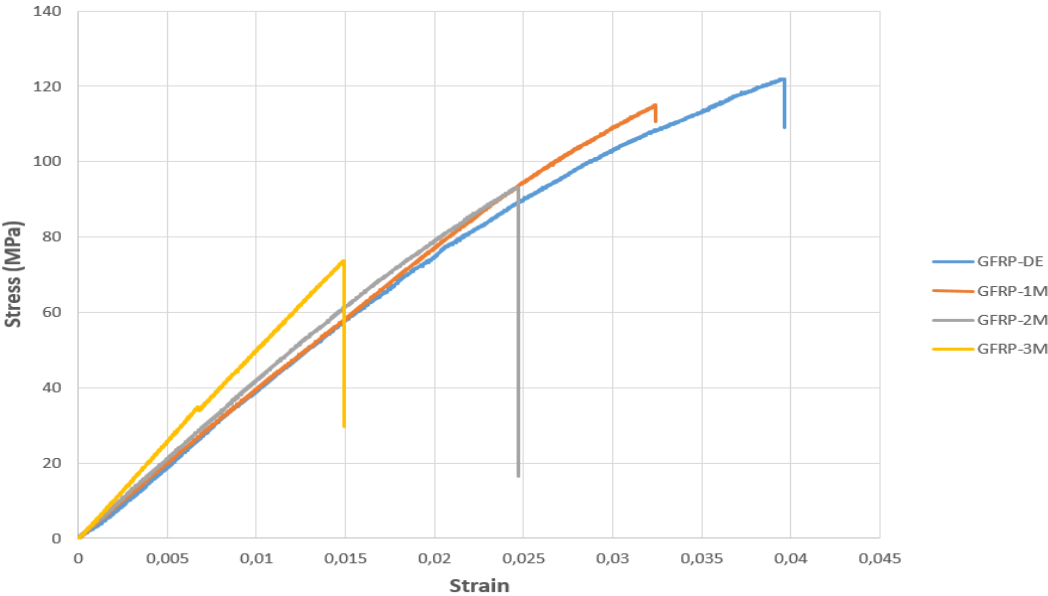
The stress-strain (σ - ϵ) curve presented in Figure 23 shows data obtained from four-point bending tests performed on GFRP composite specimens after exposure to various environmental conditions for specific periods. The specimens were stored in dry environments and in seawater environments for 1, 2, and 3 months, respectively. The effects of these different conditions and exposure times on the mechanical properties of the material were analyzed in detail.

Figure 23. Comparison of Stress–Strain Graphs of GFRP Specimens Stored in Dry and Seawater Environments (1, 2 and 3 months).

Based on the data presented in Figure 23, it was observed that the bending stress and strain values in the GFRP-7L-FPBT series specimens decreased depending on the duration of exposure to seawater. The measurement results for each specimen are presented in Table 5 below:

The flexural stress and strain values of the GFRP-7L-FPBT series specimens presented in Figure 23 indicate a significant deterioration in the mechanical properties of the material depending on the duration of seawater exposure. The reference specimen tested under dry conditions (GFRP-7L-FPBT-DE) exhibited the highest mechanical performance with a flexural stress of 121.6930 MPa and a strain value of 0.0395.

At the end of the second month (GFRP-7L-FPBT-2M), the flexural stress was measured at 92.6155 MPa and the strain at 0.0244. By the third month (GFRP-7L-FPBT-3M), these values further decreased to 72.7945 MPa and 0.0146, respectively, indicating a decline in both mechanical strength and deformation capacity.

Overall, as the seawater exposure duration increased, both flexural stress and strain values consistently decreased in GFRP specimens. With a total reduction of approximately 40% in flexural stress and up to 63% in strain, these results suggest that GFRP may exhibit limited long-term mechanical performance in marine environments.

Young's Modulus is a parameter that numerically expresses the flexibility or stiffness of a material [24]. Here, it was calculated using the slope obtained from the linear regions of the stress-strain curves presented in Figures 23 and 24. Table 6 below presents a comparison of the modulus of elasticity (Young's Modulus, E) values of GFRP and CFRP specimens. These values were calculated after the respective specimens were exposed to environmental conditions for different periods of time. Table 7 also shows the percentage change in modulus of elasticity for each specimen compared to its initial (dry environment) value.

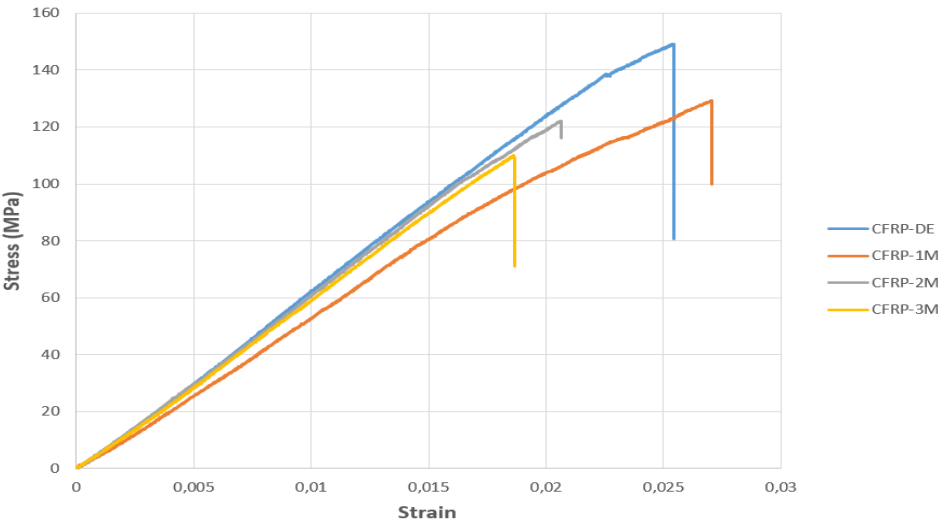
Figure 24. Comparison of Stress–Strain Graphs of CFRP Specimens Stored in Dry and Seawater Environments (1, 2 and 3 Months).

According to the data presented in Figure 24, it was observed that the bending stress and strain values in the CFRP-8L-FPBT series specimens varied depending on the duration of exposure to seawater. Table 6 below shows the measurement results for each specimen:

The bending stress and strain values for the CFRP-8L-FPBT series specimens, presented in Figure 24, reveal a gradual decrease in the material's mechanical properties with the duration of exposure to seawater. The reference specimen (CFRP-8L-FPBT-DE), tested in a dry environment, achieved the highest performance with a bending stress of 148.5722 MPa and a strain of 0.0254.

In the CFRP-8L-FPBT-1M specimen exposed to seawater for one month, the bending stress decreased to 129.2385 MPa, while the strain value increased slightly to 0.0270. This increase was attributed to the short-term softening effect of moisture, which imparted temporary flexibility to the matrix phase.

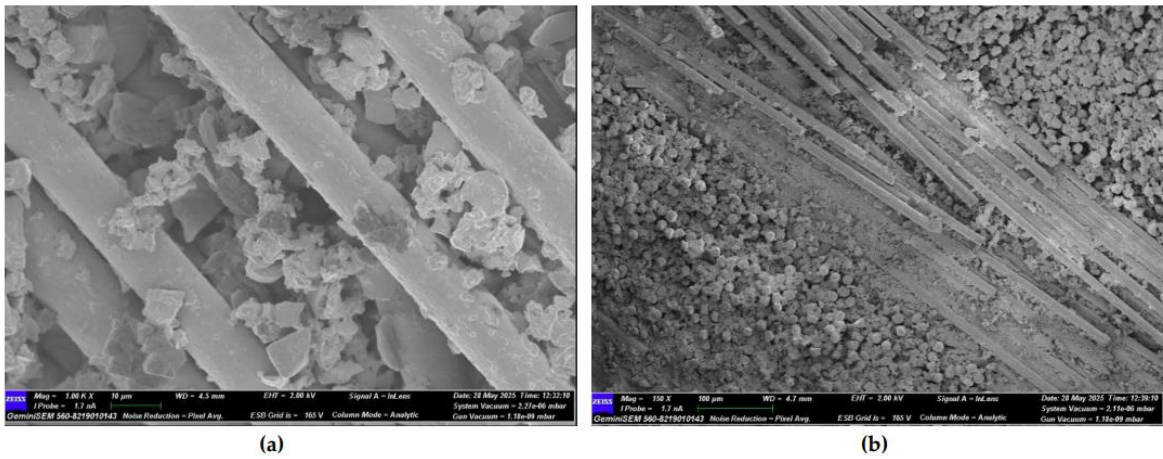
Figure 25. (a) Mag=1.00KX and (b) Mag=150X Images of GFRP Samples not kept in sea water.

In Figure 25, SEM images of the GFRP control sample stored in a dry environment show strong interfacial bonding with the polymer matrix around the glass fibers. There is a regular arrangement between the fibers, minimal voids, and continuity in the fiber-matrix interaction. No extensive fractures or bifurcations are observed on the fibers, indicating that the sample maintains its high flexural strength.

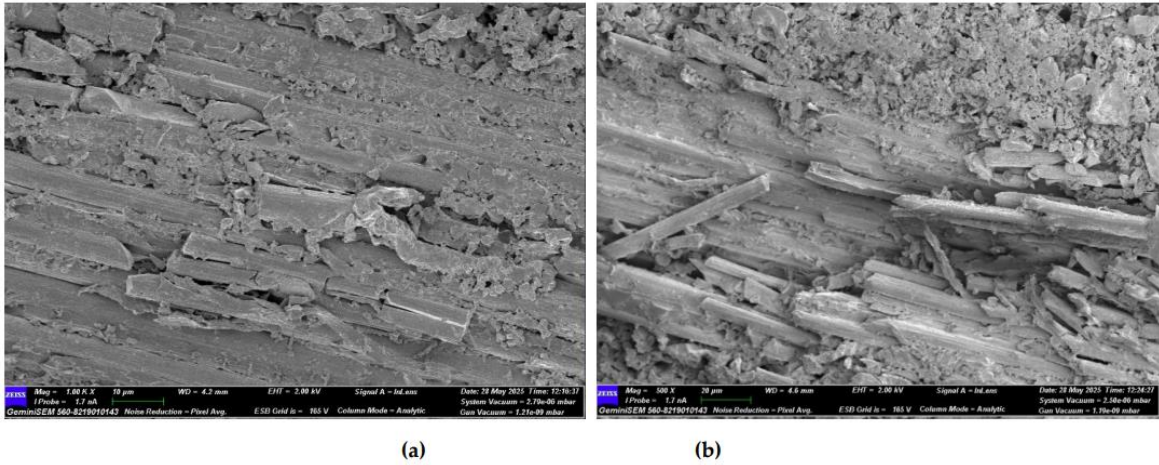
Figure 26. (a) Mag=1.00KX and (b)Mag=500X Images of GFRP Samples 1st Month.

In Figure 26, in GFRP samples exposed to seawater for one month, deterioration began at the fiber-matrix interface, resulting in damage mechanisms such as debonding and fiber pull-out. Microcracks and traces of plastic deformation were observed on the matrix surface. Diffusion of water molecules into the matrix caused the matrix to swell and accumulate stress at the interface, weakening the bond. Mechanical strength decreased compared to the dry environment, but integrity was still partially preserved. Figure 27 shows significant microstructural deterioration in the GFRP samples following two months of seawater storage. While fracture and shrinkage were observed in the majority of the fibers, the matrix exhibited intense microcracks, fragmentation, and void formation. The interface exhibited completely ruptured areas, and the fiber-matrix interaction was largely lost. At this stage, load transfer occurred only to a limited extent through the fibers. A decrease in flexural strength, a tendency towards fracture, and brittleness were observed. Figure 28 shows almost complete loss of microstructural integrity in GFRP specimens conditioned in seawater for three months. A structure in which the fiber-matrix interface was reduced, the fibers became free, and the matrix was chemically degraded is envisaged. The microscopic cracks transformed into macroscopic cracks, and the fracture occurred suddenly and brittle. Furthermore, the mechanical strength of the polymer matrix decreased as a result of exposure to water.

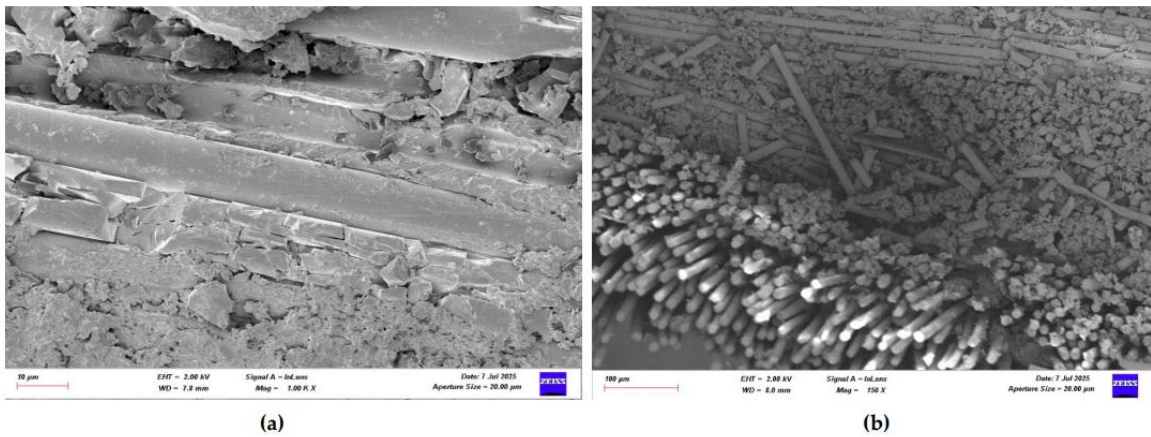
Figure 27. (a) Mag=1.00KX and (b)Mag=150X Images of GFRP Samples 2nd Month.

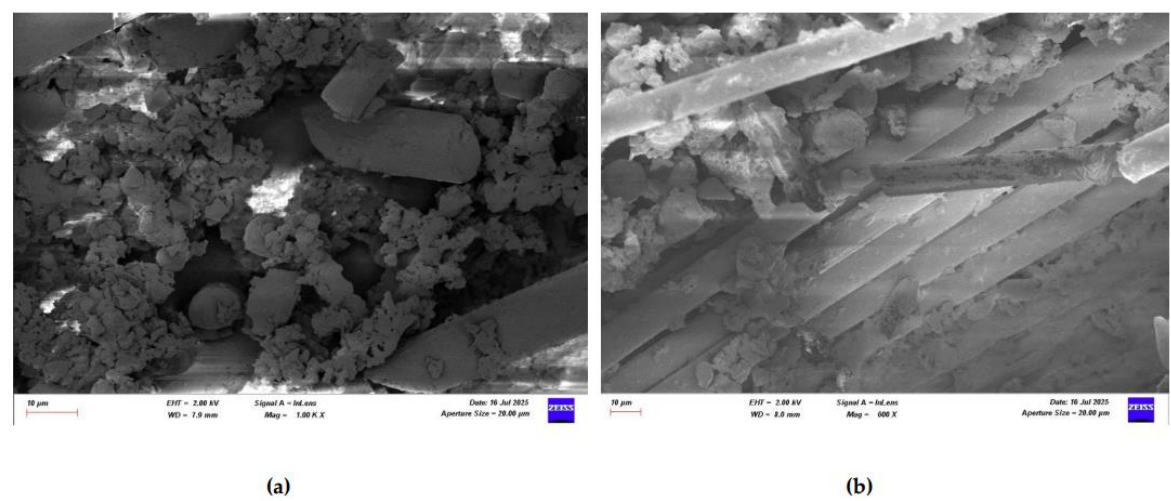
Figure 28. (a) Mag=1.00KX and (b)Mag=600X Images of GFRP Samples 3rd Month.

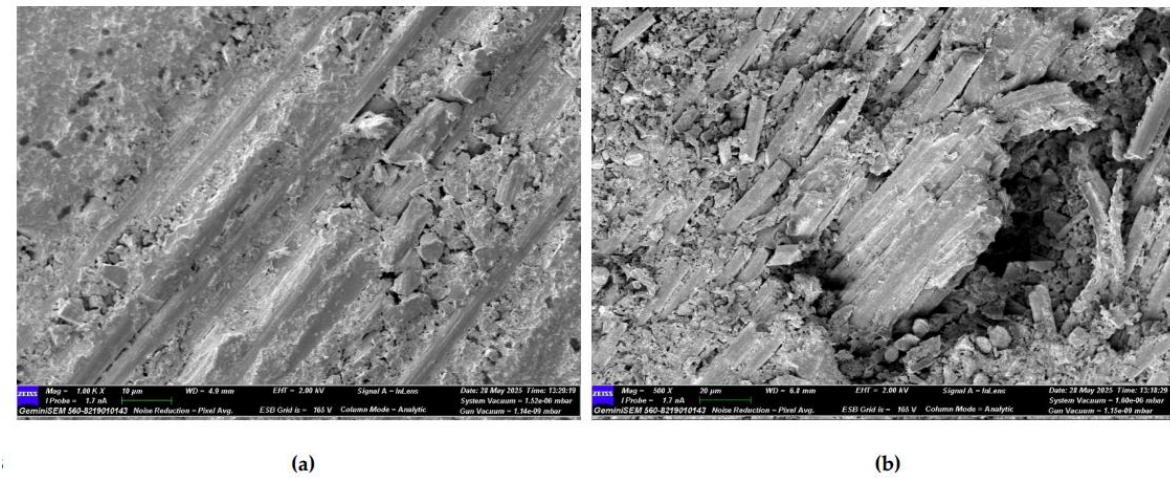
Figure 29. (a) Mag=1.00KX and (b) Mag=500X Images of CFRP Samples not kept in sea water.

Figure 29, the CFRP control sample stored in a dry environment, shows that the fiber-matrix interface has high integrity. The fibers are tightly bonded to the matrix and exhibit a regular structure along the fracture surface. Fiber pullout and fiber fracture appear to be balanced. This indicates that energy was absorbed more ductilely during mechanical testing and that fracture occurred in a controlled manner. Figure 30 shows that signs of microstructural deterioration began to appear in samples stored in seawater for one month. Separation occurred locally at the fiber-matrix interface, with microscopic cracks and matrix deformations observed. This indicates that the interfacial bonds began to weaken and that mechanical performance tended to decline. Figure 31 shows that after two months of aging, microstructural deterioration increased significantly. It was observed that the fibers began to completely separate from the matrix. Swelling, cracking, and void formation are evident in the resin phase. Fiber fractures are more irregular and short-distanced, and the fracture surface exhibits a more brittle state. In Figure 32, microstructural deterioration progressed in samples exposed to seawater for three months, and interfacial bonds became loose. Delamination and voids were observed in the resin structure, leading to a decrease in mechanical performance.

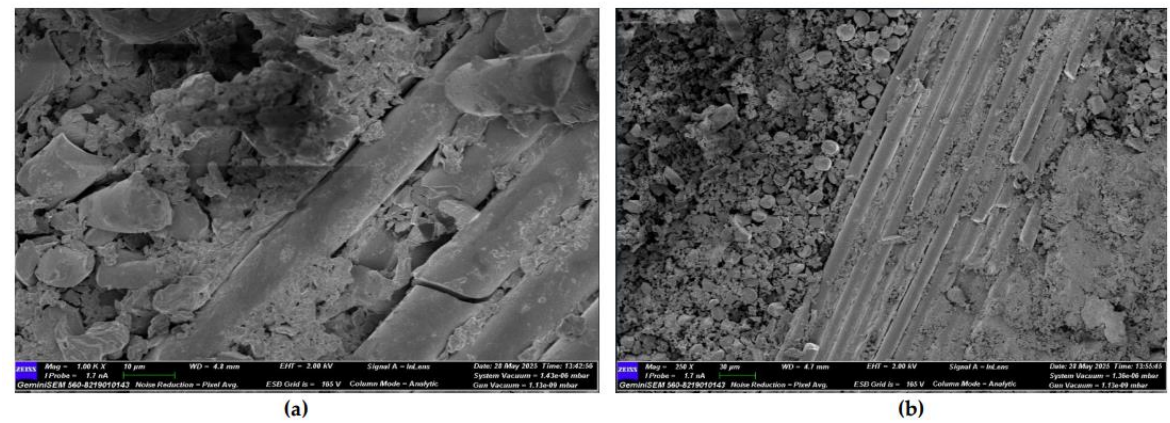
Figure 30. (a) Mag=1.00KX and (b) Mag=250X Images of CFRP Samples 1st Month.

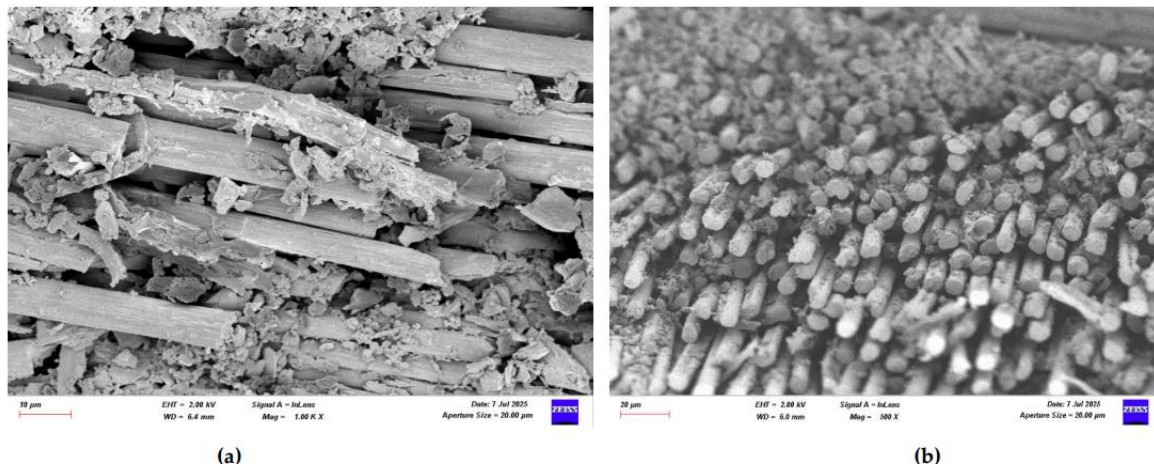
Figure 31. (a) Mag=1.00KX and (b) Mag=500X Images of CFRP Samples 2nd Month.

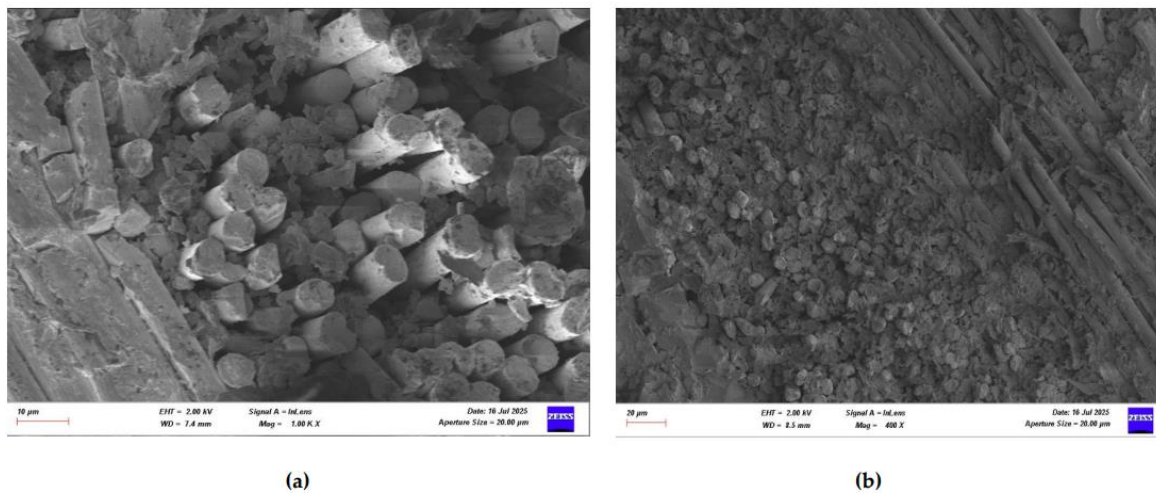
Figure 32. (a) Mag=1.00KX and (b) Mag=400X Images of CFRP Samples 3rd Month.
