Experimental Study on the Mechanism of Overtopping Failure and Breach Development in Homogeneous Earth Dams

Keywords: homogeneous earth embankment; overtopping failure; failure evolution; model test; disaster mechanism

The present study examines the mechanisms of overtopping failure and the evolution laws of homogeneous earth embankments during the flood season. To this end, the Changkai embankment in Fuzhou City, Jiangxi Province, was selected as a case study, with seven groups of indoor model tests conducted to consider the effects of different embankment top widths, embankment heights, river water depths, and river flow rates. The test results are as follows: Overtopping failure of earth embankments can be categorised into three distinct stages. The breach formation process can be categorised into three stages: vertical erosion (stage I), breach expansion (stage II) and breach stabilisation (stage III). River water levels and inflow rates were identified as pivotal factors influencing the final morphology of the breach and the flow velocity within it. Conversely, the height of the dike was found to have little influence on the shape of the breach and the flow velocity. The bre

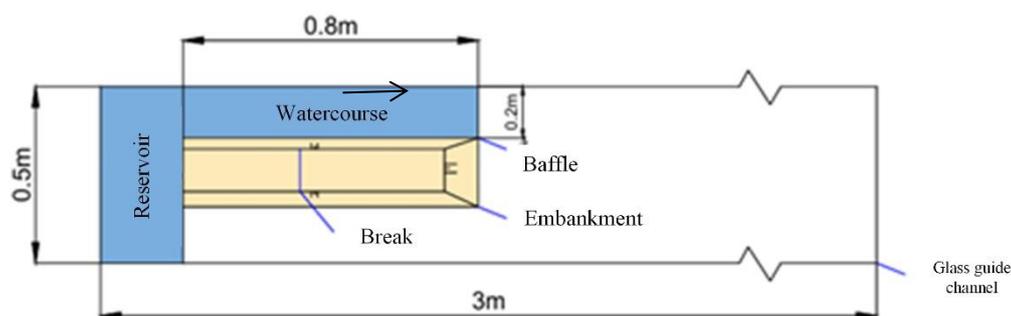
The experiment was conducted within the glass tank of the Water Conservancy Experimental Center of Nanchang University. The glass tank utilised in the experiment had dimensions of 3 m in length, 0.5 m in width, and 0.5 m in height. The component parts of the system under consideration are as follows: firstly, a water storage tank; secondly, a river channel section; thirdly, a breach; fourthly, a water outlet section; and fifthly, a baffle. The river section measures approximately 0.5 meters in length, with its width varying according to different test conditions. As shown in Figure 1, the experimental glass sink is presented.

Figure 1. Schematic diagram of experimental water tank.

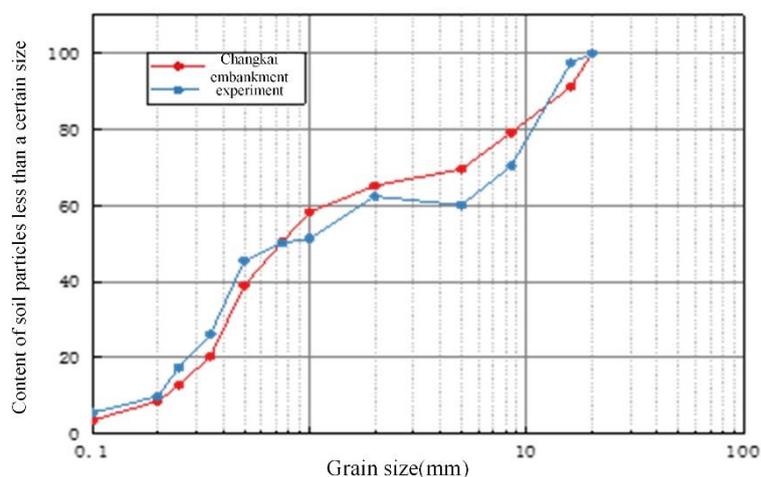
The primary function of this test is to simulate the process of embankment failure. In order to ensure that the internal friction coefficient of the sediment particles utilised in the test is comparable to that of the prototype particles, the test soil materials are configured in accordance with the particle gradation of the soil samples obtained from the Changkai embankment. The soil material with a maximum particle size of 20 mm and a median particle size of $d_{50} = 0.75$ mm is selected for the construction of the main particles of the test embankment. As shown in Figure 2, the gradation curve is analogous to the soil composition observed at the Changkai embankment site.

Figure 2. Experimental and prototype material particle size distribution.

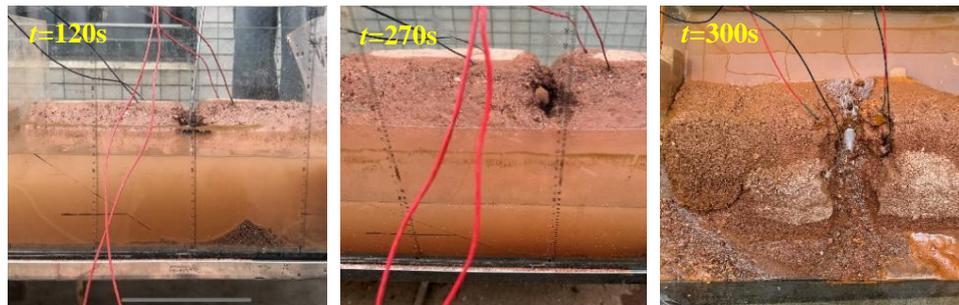
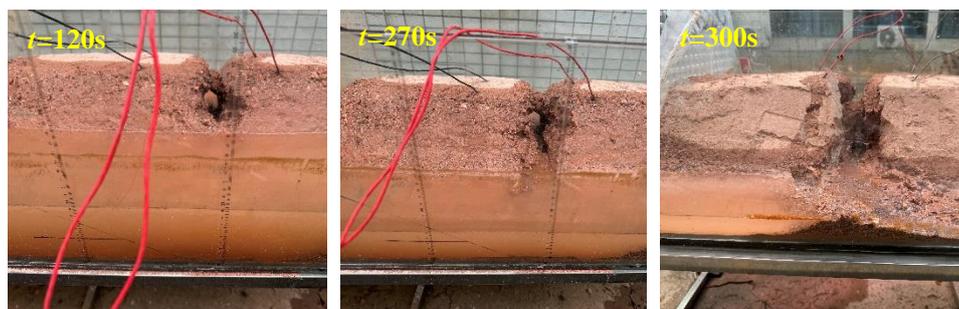
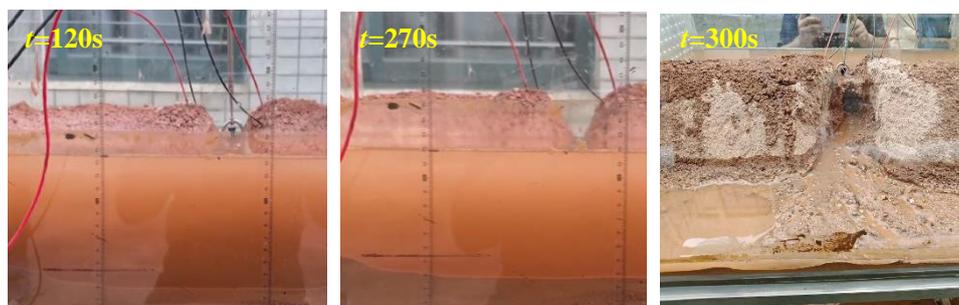
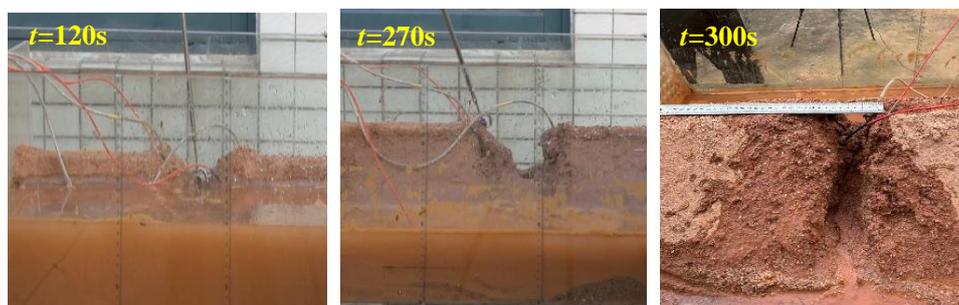
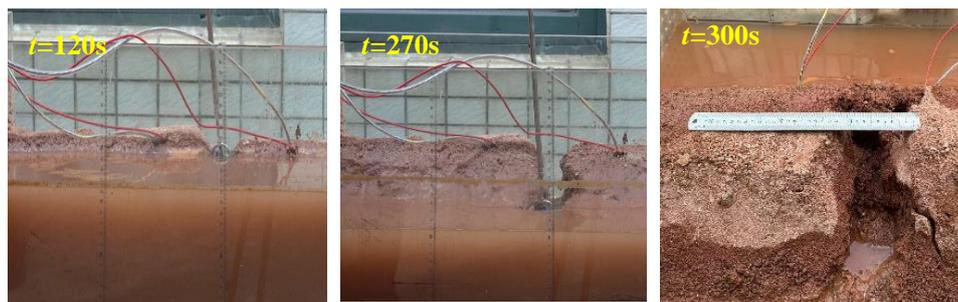
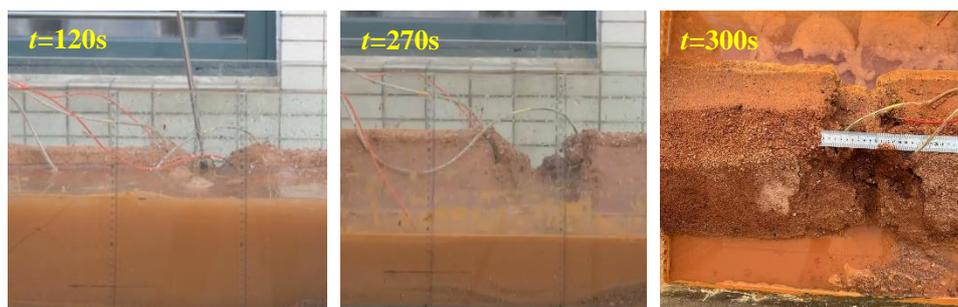
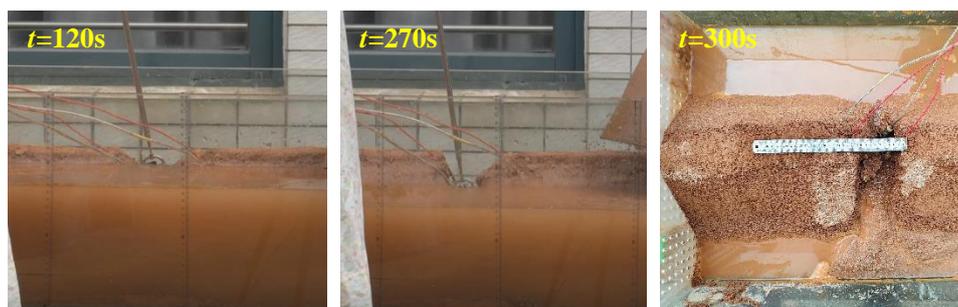
In this experiment, conditions 1, 2 and 3 constitute the water level treatment group, conditions 4 and 5 constitute the embankment height treatment group, and conditions 6 and 7 constitute the inflow treatment group. The analysis of the data from each treatment group has enabled the identification of a discrepancy between the breach process and the breach evolution. As shown in Figure 3, the failure of each group occurred at different times.

(a) test condition 1 outburst process

(b) test condition 2 outburst process

(c) test condition 3 outburst process

(d) test condition 4 outburst process

(e) test condition 5 outburst process

(f) test condition 6 outburst process

(g) test condition 7 outburst process

Figure 3. Stage diagram of collapse morphology.

As demonstrated in Figure 3, at the commencement of the test, the water level did not attain the height of the embankment, and the embankment itself remained stable. The seven test conditions of the test undergo three stages to complete the breach. The phenomenon under investigation can be summarised as follows: approximately 90 seconds after the commencement of the test, the water level is observed to be level with the embankment, and the overtopping is imminent at this time; at approximately 120 seconds after the commencement of the test, the embankment gradually fails due to overtopping. At this time, a minor breach of the embankment was observed, and a narrow erosion trough gradually formed at the summit of the embankment. The flow velocity increased in comparison with the overtopping. The collapse of the soil on both sides of the embankment was due to the effect of water flow. At this time, the breach mainly developed in a downward direction, and the overall vertical erosion phenomenon was presented. At approximately 270 seconds, the vertical erosion of 90 seconds leads to a deeper and narrower breach shape. At this time, due to the erosion of the water flow, it can be observed that the soil on both sides of the breach begins to collapse downward. At this juncture, the flow rate reaches its maximum stage within the test. In light of the escalating phenomenon of water erosion, the morphology of the breach undergoes rapid and unpredictable changes. The breach as a whole demonstrates a rapid expansion phenomenon; however, when the test reaches 300 seconds, the breach gradually ceases to change. At this juncture, the breach has reached its culmination, and the final breach shape is now discernible. The flow velocity and the breach flow undergo a gradual decrease to zero, and the breach tends to be stable as a whole. It is evident from the experimental data that the test groups 2 and 3 demonstrate a higher

velocity of response to elevated water levels in comparison to the treatment group 1. The occurrence of overtopping failure is observed to precede the initiation of the test by 120 seconds, and the rate of breach widening is also enhanced. In the treatment group 4 and 5, it was observed that differing embankment heights did not have a significant effect on the breach, and there was no significant change in the experimental phenomenon when compared with the treatment group 1. The phenomenon of 6 and 7 in the experimental group was similar to that in the treatment group 1, but the break widening was increased, and the widening time was also increased.

During the course of the experiment, the infringement of the seven groups of test conditions is exhibited in three stages. Initially, the infringement is minor, and the flow velocity and water depth undergo negligible changes. At this time, the phenomenon is characterised by vertical erosion and an inclination to spread horizontally. In the second stage of the collapse, the soil layer began to lose stability due to an increase in depth. The collapse mouth underwent a gradual expansion to both sides, and the slope surface away from the river channel exhibited a significantly faster rate of erosion than the river side, due to the action of the water flow. The flow rate and flow rate of the collapse mouth increased and reached maximum values, and the river water level decreased significantly. In the third stage, the discharge of a substantial volume of water into the submerged area results in a decline in the flow and velocity of the breach. This leads to a gradual cessation of breach widening and erosion, thereby stabilising the breach's shape.

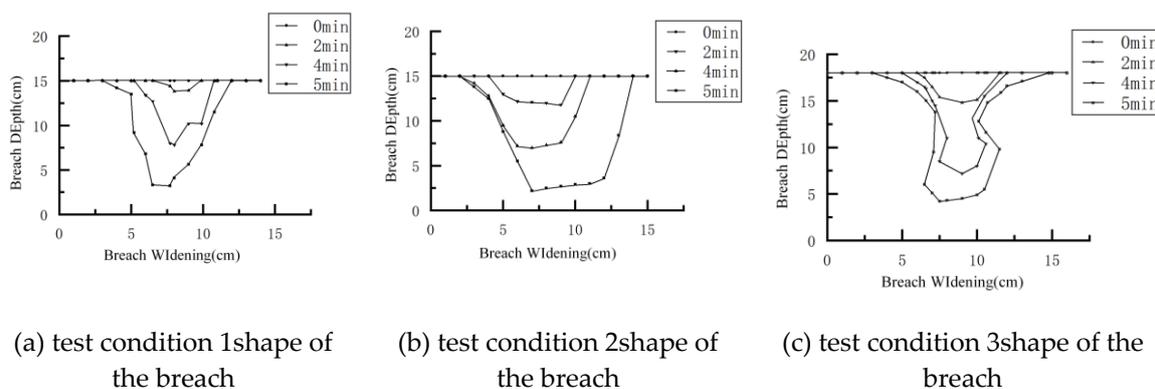
The shape of the breach in the water depth treatment group is shown in Figure 4.

Figure 4. Breach morphology in different water depths.

As demonstrated in Figure 4, the water depth is identified as the primary variable, with the final depth of the breach from large to small being the secondary variable. The tertiary variable is the third condition, the secondary condition, and the primary condition. It has been observed that the rate of development of the breach is increasing gradually. The third test condition is the most rapidly expanding, followed by the second, and the first is the slowest.

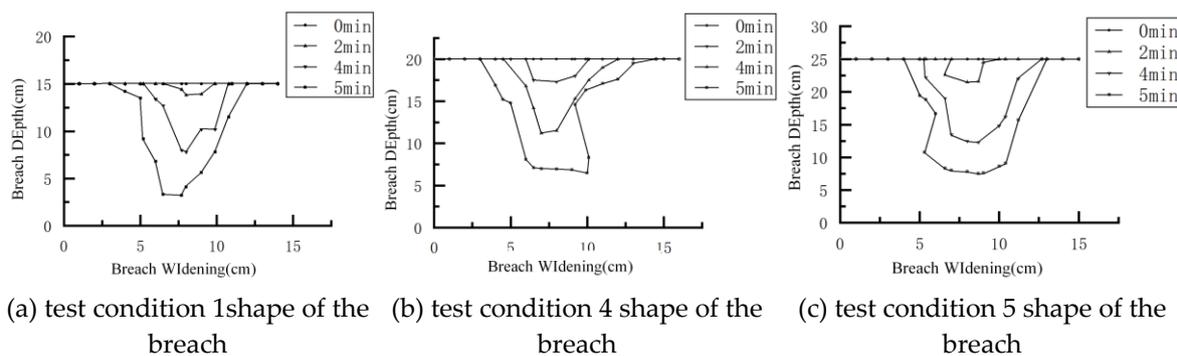
Figure 5. Breach shape at different levee heights.

As demonstrated in Figure 5, there is a lack of statistical significance between the three test conditions of the first, fourth and fifth variables of the test conditions, as well as the height of the embankment and the final depth of the breach. Furthermore, it was observed that the development speed of the breach was essentially unchanging. However, due to the occurrence of force majeure, even if the depth and width remain essentially unchanged, the final breach shape will vary considerably.

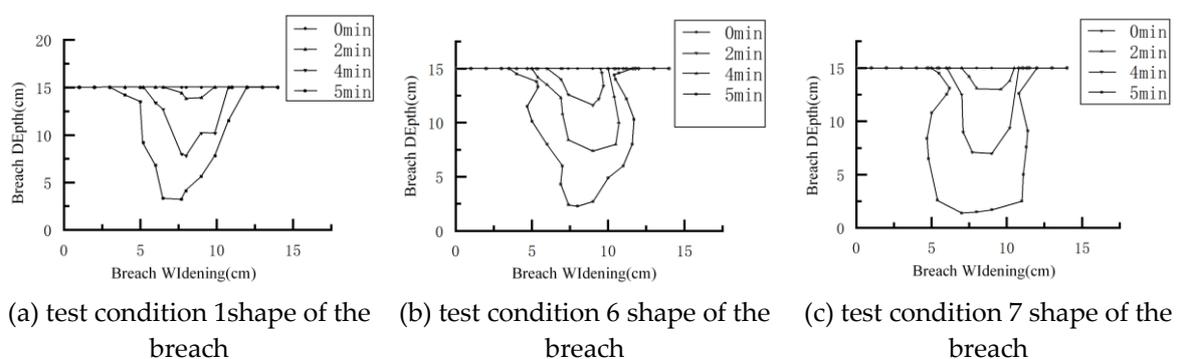
As shown in Figure 6, the variables of test conditions one, six and seven correspond to the inflow, and the final depth of the breach is represented by c , b and a , from large to small. The development speed of the breach is increasing step by step; the width of the breach gradually increases from a , b , c , and develops violently from 2-4 minutes to form the final breach shape.

Figure 6. Breach morphology with different inflow.

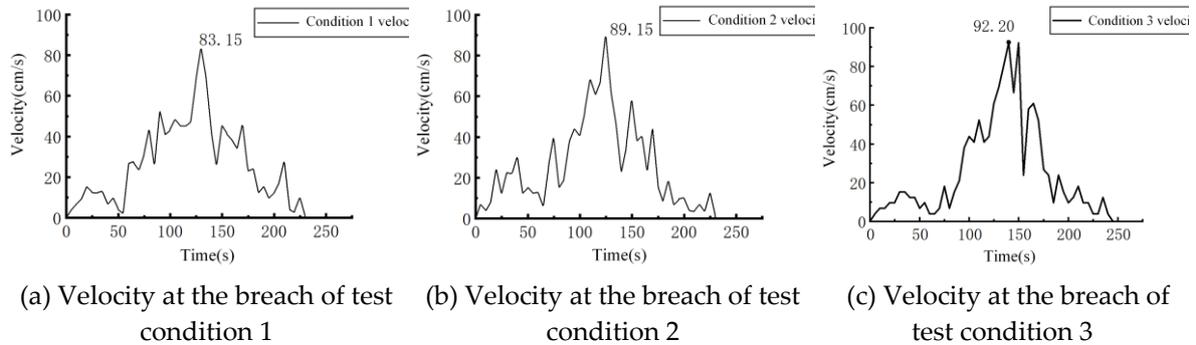
Once the test is complete, the flow rate for each test condition is extracted and processed by computer to eliminate invalid data. A comparison of the flow rate under various test conditions is then made, as shown in Figure 7.

Figure 7. Velocity at the breach of different water depths.

As shown in Figure 7, the flow velocity reached its maximum approximately two minutes after the break was initiated, under the first, second and third test conditions. Thereafter, the flow velocity gradually declined alongside a reduction in the breach's flow rate. The maximum flow velocities recorded for the three test conditions were 83.15 cm/s, 89.15 cm/s and 92.20 cm/s, respectively. There is a clear upward trend.

The analysis indicates that the velocity of the breach is influenced by three factors: the water level, the height of the embankment and the inflow. As Figure 7 shows, there is a direct correlation between the breach's flow velocity and the water level. An increase in the water level has been shown to be accompanied by an increase in flow velocity. The elevated water level during the breach increases the difference in water level across the embankment, thereby increasing the potential energy of the water flow. In the event of a breach, more kinetic energy is converted from potential energy, and the flow velocity at the breach increases. As shown in Figure 8, embankment height has little effect on flow velocity at the breach. As shown in Figure 5, there is no discernible difference in the morphology of the breach, and a substantial decline in flow velocity occurs during its formation. Consequently, the flow velocity remains unaltered. As shown in Figure 9, there is a negative correlation between the inflow rate and the flow velocity at the breach. An increase in the inflow rate has been shown to result in an increase in the erosion time of the breach. Consequently, the embankment is unable to resist erosion from the water flow, resulting in rapid widening of the breach. This, in turn, widens the shape of the breach and gradually decreases the force of the water flow. Concurrently, a decline in flow velocity has been observed. It can therefore be concluded that the water level and inflow rate are significant factors in controlling the breach's flow rate.

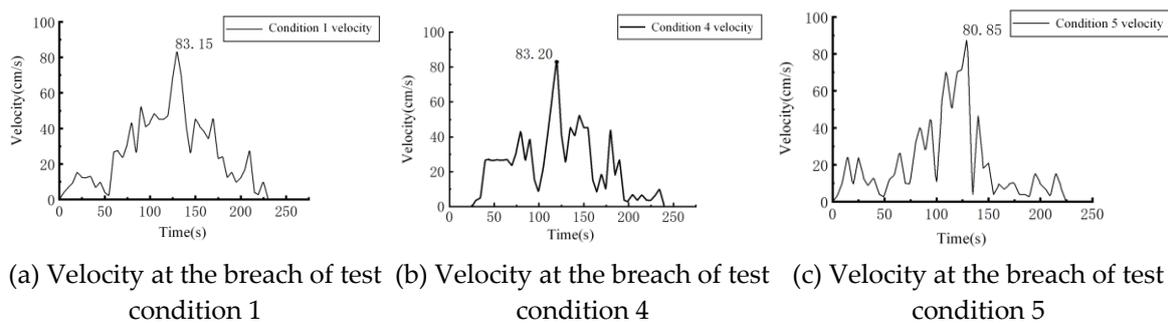
Figure 8. Velocity at breach with different levee heights.

As shown in Figure 8, the variable under consideration is the embankment height in three test conditions (test conditions 1, 4 and 5). The flow rate gradually decreases in proportion to the breach flow rate, ultimately reaching zero. The maximum flow rates observed for the three distinct test conditions are 83.15 cm/s, 83.20 cm/s and 80.85 cm/s respectively. A thorough examination of the data reveals no substantial increase or decrease, and no discernible trend is apparent across the three datasets.

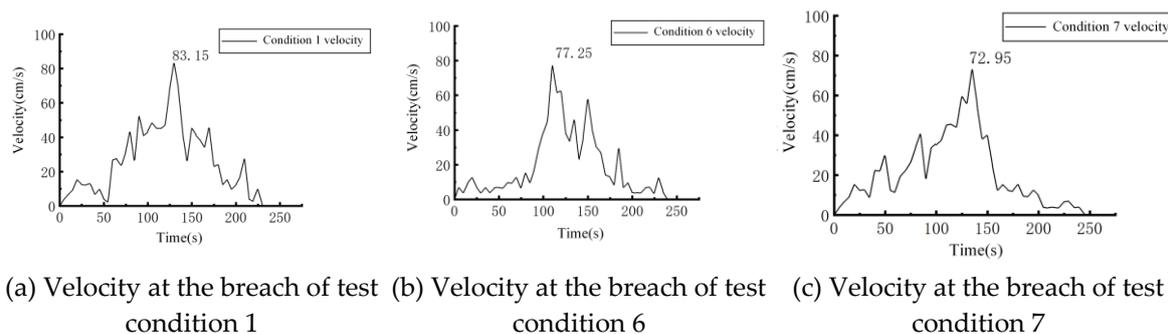
Figure 9. Velocity at breach with different inflow.

As shown in Figure 9, the variable under consideration is the flow in three test conditions (test conditions 1, 6 and 7). The inflow rate decreases from 83.15 cm/s to 72.95 cm/s.

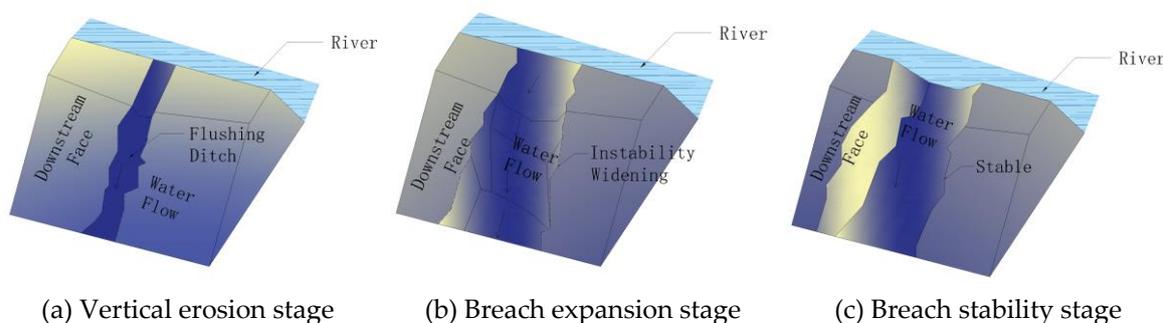
The breach process mechanism is explored through the analysis of multiple breach test sets, with particular reference to breach morphology characteristics and flow velocity data. The seven groups of test conditions have been categorised into three distinct stages: vertical erosion (stage I), breach expansion (stage II) and breach stability (stage III). Stage II is the primary stage of breach development and sees significant changes in velocity and widening velocity. As shown in Figure 10.

Figure 10. Dike break mechanism diagram.

This stage commences at the start of the test. Inflow to the reservoir causes the water level to rise to the same level as the river, resulting in overflow at the top of the embankment. If the inflow increases sustainably, the water will overflow onto the rear of the embankment, causing a breach in the weakest part of the structure. This is because the sediment is damaged by the flow of water, creating a crack. As the inflow to the river increases further, the resulting water flow erodes the rear surface of the embankment, forming a narrow scour ditch. At this stage, the flow velocity is slow and insufficient to cause significant erosion or the rapid expansion of the breach. As the water content of the sediment increases, the friction between the particles rises, facilitating the movement of water away and establishing a prerequisite for stage II. At this stage, the flow velocity and sediment friction mutually restrict each other. Concurrently, the friction of the particles is reduced, the inflow rate increases continuously and the flow velocity gradually increases, thereby enhancing the traction effect on the sediment of the contact surface. Consequently, the breach propagates in a downward

The initial stage (Stage I) is characterised by soil erosion on both sides of the breach and water infiltration. As the depth increases and the influence of soil gravity becomes more dominant, the soil on both sides collapses, resulting in a rapid increase in breach width. As the breach continues to expand, a substantial volume of river water enters it, further widening and deepening the breach and accelerating the breaching process.
