Study of the Clogging Phenomenon of Submerged Nozzles in Continuous Casting

Posted Date: 7 October 2024

Abstract: The continuous casting nozzle which guides and protects the flow of liquid steel undergoes a progressive reduction in its internal diameter following the accumulation on the internal wall of non-metallic inclusions. This narrowing of the channel is due to a mechanical attachment (non-metallic inclusions) and this, because of the turbulent regime of the flow of the liquid steel. This phenomenon is very often associated with the casting of low carbon steels deoxidized exclusively with aluminium. Clogging generally leads to a slowing down of the casting speed and, in severe cases, to the total stoppage of the installation and consequently to the appearance in the slab of the defect called "resumption of casting or belt". The aim of this work is to determine the nature of the deposit and the blocking mechanism of the pouring nozzles. For that, a chemical analysis as well as tests concerning the adhesion of the deposit were carried out on samples taken from damaged pouring nozzles. We found that it was at a load of 187.5 kgf that the rupture of the sample took place, durin

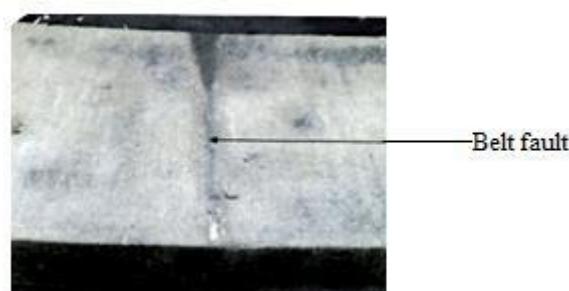
Figure 1. Slab with belt.

The blockages of the nozzles affect the quality of the slabs in the form of "belts" which can be defined as a discontinuity in cross section of the slab; Figure 1 shows a resumption of casting or belt in the slab.

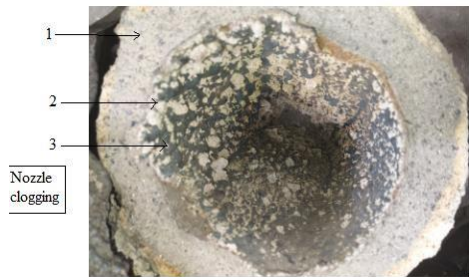
Figure 2. View of a clogged worn nozzle.

The morphological identification of the deposit consists of observing a sample using a binocular magnifying glass. The sample was cut from the lower part and cut by an ordinary chainsaw, and then we detached the metal envelope, as well as the terminal deposit and leaving only the dense deposit which adheres to the refractory body of the nozzle. Figure 2 shows clogged worn nozzle.

(1) clogged nozzle body, (2) white deposit (3) metal casing.

The lower part is almost completely clogged by a deposit, while the deposit in the upper part only measures a few millimeters;

The deposit formed on the inner wall of the lower part can be divided into three layers:

- A gray metallic envelope.
- Layer of slag having a thickness comparable to that of the deposit formed on the upper part.
- An extremely thick deposit, several centimeters long with a crumbly appearance, in the form of a powder stuck to another white deposit, denser and less thick.

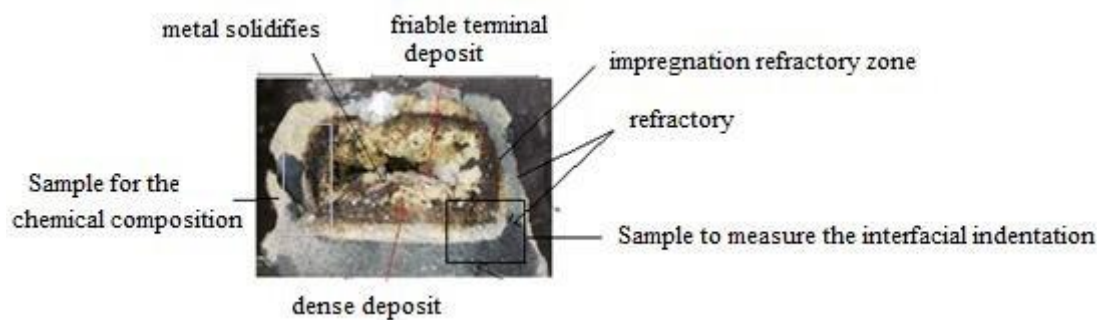
Figure 3. Cross section of a submerged nozzle.

Figure 3 indicates Cross section of a submerged nozzle.

View of a cross section of the lower part of a nozzle

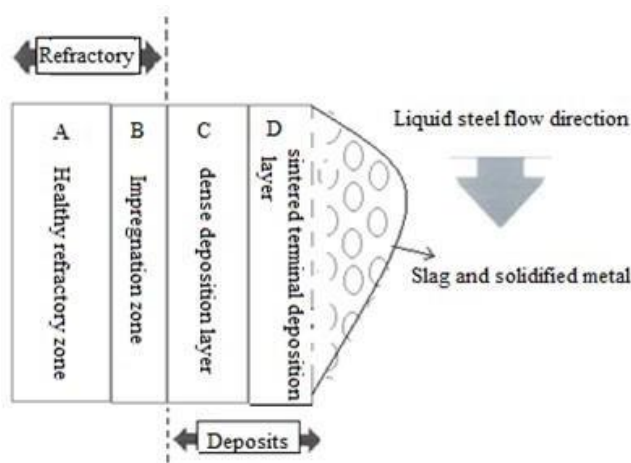
Figure 4. Layout diagram of the different layers.

The metal casing and the deposit of the lower part of the nozzle are made up of a mixture of slag from the converter and metal oxides resulting from deoxidation, Figure 4 indicates Layout diagram of the different layers.

To prepare our samples, we recovered a used nozzle which we cut in the transverse direction of Figure 4.

In the figure, we have divided our nozzle profile into two parts according to the nature of the base materials (refractory or steel), the results obtained after chemical analyzes by X-ray fluorescence are collated in Table 2, namely:

- Refractory: it comprises the zone of sound refractory (A), as well as the zone of the layer of refractory affected by impregnation (B);
- Deposit: it comprises the dense deposit (C) as well as the terminal sintered deposit (D).

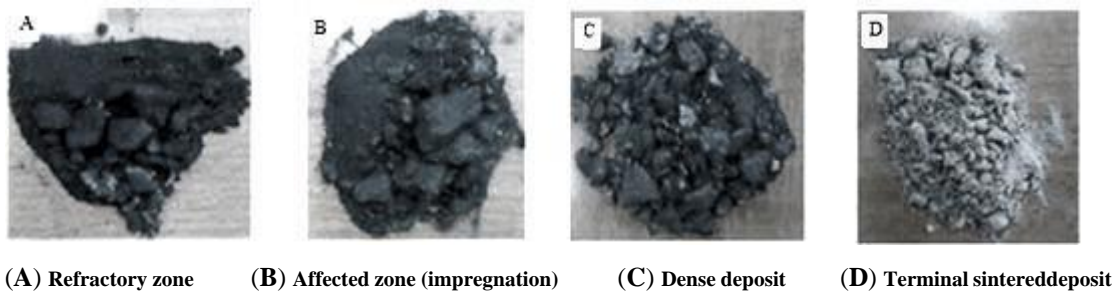
Figure 5. Materials obtained after separation.

The taking of the samples of the deposit to carry out the chemical composition is carried out by a chainsaw, then to take off the dense deposit (C), from the impregnated refractory zone (B), we used a hammer and a chisel, then in the same way we separated the affected refractory zone (B) from the healthy refractory (A). Figure 5 explains materials obtained after separation.

We crushed these materials to obtain fine powders with a particle size of approximately 5 to 15 μm to produce pellets after fusion in order to carry out chemical analysis using X-ray fluorescence.

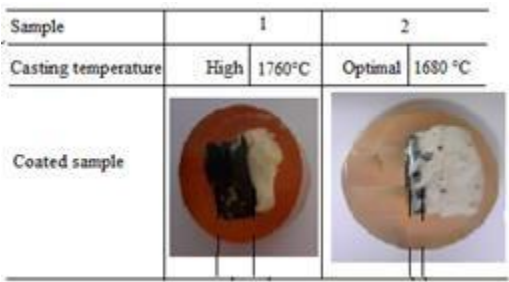
Figure 6. Samples prepared to measure interfacial indentation.

Subsequently, we cut these samples with the Mécatorme TZ 10 type micro-cutting machine, until a flat and uniform sample was obtained and, because of its low thickness (3 to 5 mm), this sample was coated with epoxy as shown in Figure 6 samples prepared to measure interfacial indentation .

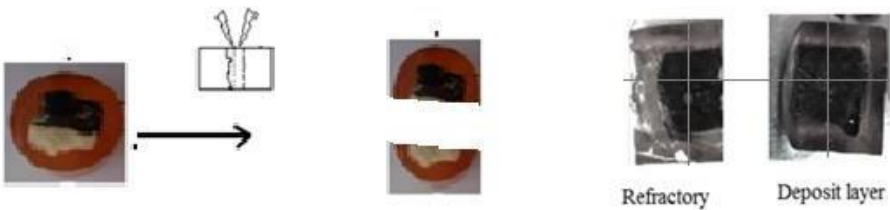
Figure 7. Determination of the nature of the break.

To perform the interfacial indentation, we used a Vickers microhardness tester, a Vickers hardness tester, and finally a Rockwell hardness tester until the part was destroyed. Figure 7 explains determination of the nature of the break

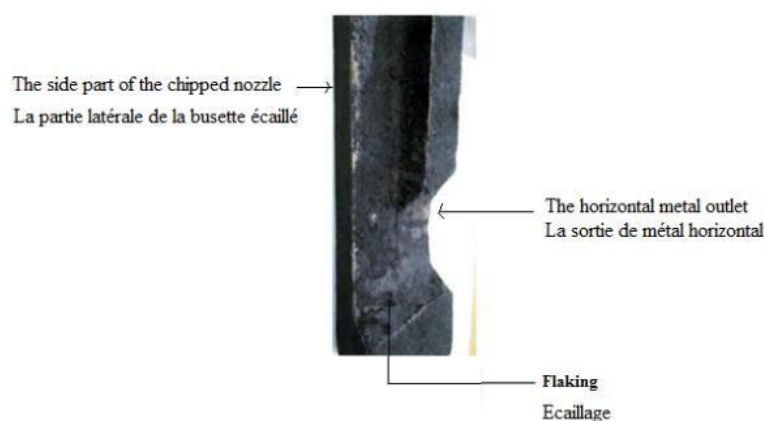
Figure 9. View of a sample of a nozzle after heating at the steelworks.

The heating time from the nozzle to the surface is 8 hours and more in some cases, the burner is oriented towards the bottom of the nozzle which undergoes intense heating over 1000°C while the top remains relatively cold, knowing that refractories are poor conductors of heat, this temperature difference causes the surface to burst, the consequence of which is spalling Figure 9 shows sample nozzle view after heating.

Among the factors that increase the adhesion of non-metallic inclusions (Al_2O_3) on the internal walls of the casting nozzle is the presence of flaking which is due to the overheating of the lower part of the nozzles (more than 1000°C) for a fairly long time (more than 8 hours) in the conditions of steelworks. Indeed, the experiment carried out in our laboratory on three samples heated to 750°C with different holding times has shown that the internal surface condition of the nozzles is smoother, and that there is rather has an improvement in the state of the interior surface as evidenced by the roughness tests Indeed,

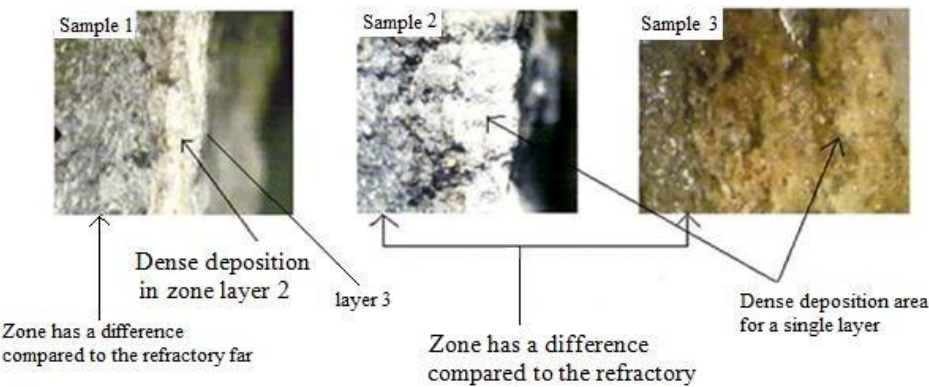
Figure 10. Binocular observation of the deposit.

The observation of the deposit was carried out using an Optika digital binocular loupe, the photos of the different samples with an enlargement of 200 μm ,Figure 10 Binocular observation of the deposit.

In addition to the layer separated before the observation and the dense deposit adhered to our samples, we detected a third layer of refractory origin according to its macroscopic morphology and its color;

After these observations, the new configuration of the deposit layers then becomes included inside the healthy zone according to the following order:

First zone: is the decarburized zone called the impregnation zone, its thickness is between [300; 3000] μm;

Second zone: is the dense deposit zone, white color with dark brown spots and light brown spots. Its thickness is between [200; 6250] μm ;

Third zone friable terminal deposit: a very thick and very friable layer.

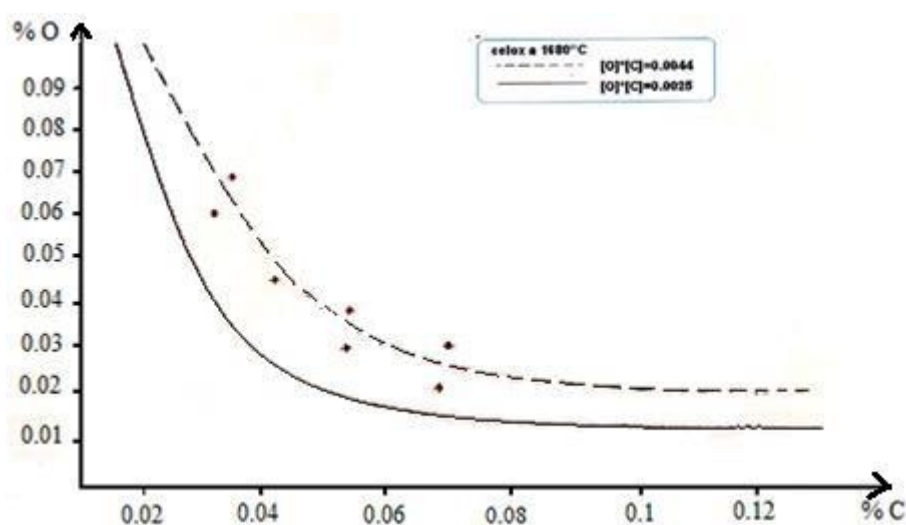
Figure 11. Relationship between carbon and oxygen.

The results of the measurements of the activity of oxygen in our case enabled us to construct Figure 11 where we note that the equilibrium concentration of oxygen at the end of blowing is clearly higher than that of the theoretical equilibrium curve.

All the conditions favorable to the increase of oxygen dissolved in the liquid metal are therefore united. To deoxidize steel, a large amount of aluminum is used.

The activity of the oxygen in the liquid steel must be reduced as much as possible to avoid the formation of blisters, but too much quenching with aluminum causes the clogging of the nozzles by the inclusions of alumina.

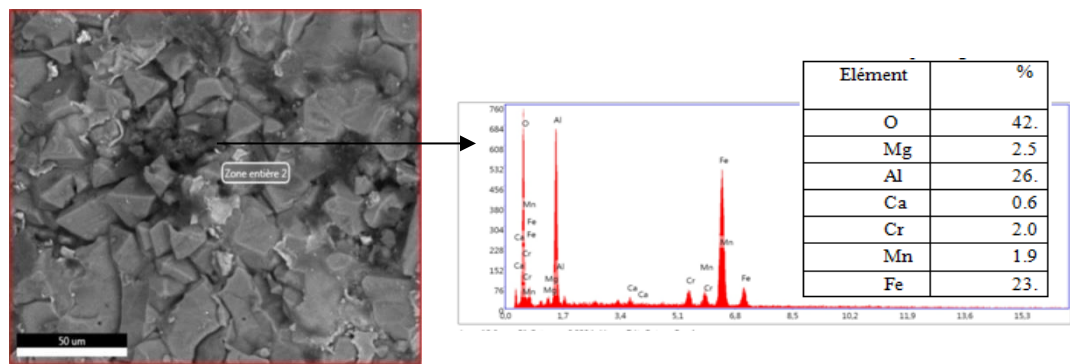
Figure 12. SEM image and chemical composition after EDSLeft side.

We operated in the same way as the previous tests except that this time we started with a load of 60 kg f, but only at 187,5 kg. Force that the damage has taken place as shown in Figure II.6. We consider that this load represents the level of adhesion of the deposit on the internal wall of the refractory, which is quite high. The observation by the SEM of the two faces after the interfacial indentation and the chemical analysis by EDS of the two points selected by the crosses in wire showed that there was a brittle rupture and not a detachment, indeed, one observed in Figures 12 and 13, the same chemical composition,(the iron and aluminum % peaks are superimposable).

The study of the images of the SEM and EDS of the two faces of the damaged sample shows a similarity from the point of view of chemical composition and structure so we can affirm that the sample rather suffered a brittle fracture at the maximum load of 187.5 kg and not a detachment for the separation, of the dense layer and the refractory wall of the body of the nozzle thus showing a fairly high level of adhesion, which is explained by:

The impregnationzone of the internal walls of the nozzle leaves cavities where steel droplets, containing non-metallic inclusions, freeze, and cause the growth of the initial deposit by accretion phenomenon, we know that these are particles of non-metallic inclusions, remained in suspension which while crossing the nozzle cling to the wall of the tube and cause in time, the reduction of the passage of the metal until the complete reduction of the internal diameter of the nozzle. After nozzle internal fattening, indicates the level of growth of refractory nozzle flow channel clogging, the components of the clogging which react easily with the walls of the nozzle during the passage of the molten steel are oxides.

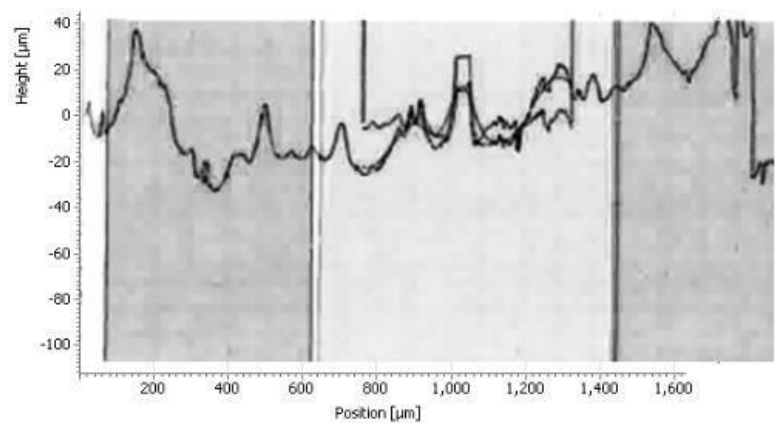
Figure 14. Roughness profile of the sample for 45 minutes of holding 750°C.

The roughness test gives us the graphs of Figures 14–16:

The results of the histograms (Figures 14–16), enabled us to construct the histogram of Figure 17. Indeed, the study of this histogram shows that the roughness decreases with the increase of the time of maintenance of the temperature. The roughness, after 120 minutes of maintenance at a temperature of 750° C., increased from 8.3 μm before heating to 2.81 μm, we can explain this decrease by the crumbling of the spikes during the roughness tests. In the industrial case, the preheating of the nozzles is rather anarchic and unbalanced, which has caused spalling at the level of the internal wall of the nozzle.

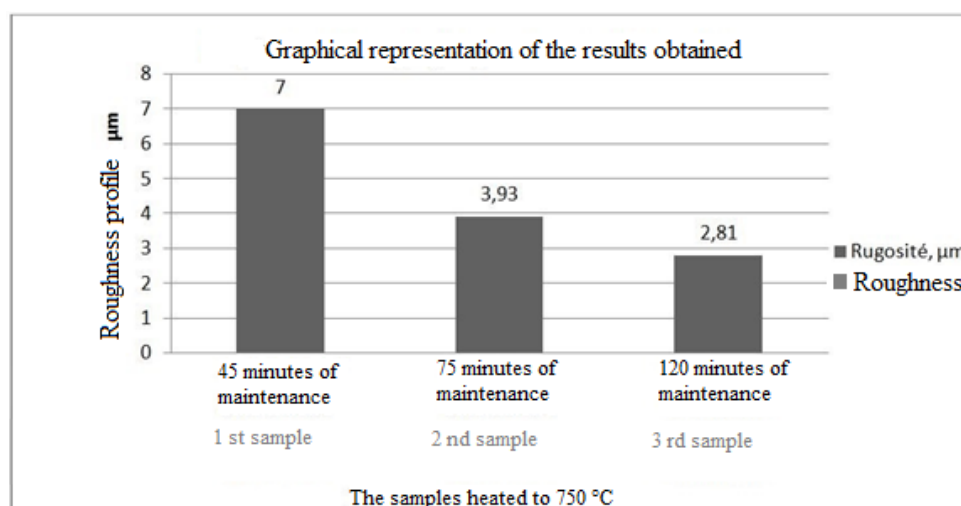
Figure 17. Histogram indicates the roughness.

The histogram in Figure 17 shows the roughness of the sample
