Advancements and Challenges in Coatings for Wind Turbine Blade Raindrop Erosion: A Comprehensive Review of Mechanisms, Materials and Testing

Nur Ain Wahidah A. Yusof ^{1,*}, Talal F. Algaddaime ² and Margaret M. Stack ²

Abstract

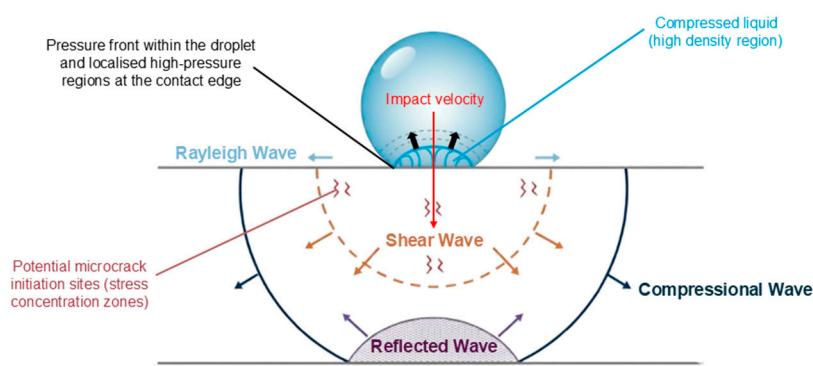
Figure 1. Schematic illustration of shock wave propagation following raindrop impact on a solid surface. Adapted and redrawn from Refs. [19,20].

of dynamic physical forces and the material's mechanical response. When a high-velocity raindrop strikes the blade's surface, it generates a momentary but exceedingly intense pressure pulse, known as water hammer pressure. This sudden pressure can reach magnitudes significantly higher than atmospheric pressure, potentially exceeding the dynamic fracture strength of the protective coating or the underlying composite substrate [17,18]. At the moment of impact, two primary wave fronts are generated: a longitudinal compressional normal stress wave that travels directly through the material, and a transverse shear wave that propagates away from the impact location as illustrated in Figure 1. The shear wave is generated as the contact area between the droplet, and the material increases during impact [12]. Additionally, due to droplet deformation, a Rayleigh wave forms, which remains confined to the target surface.

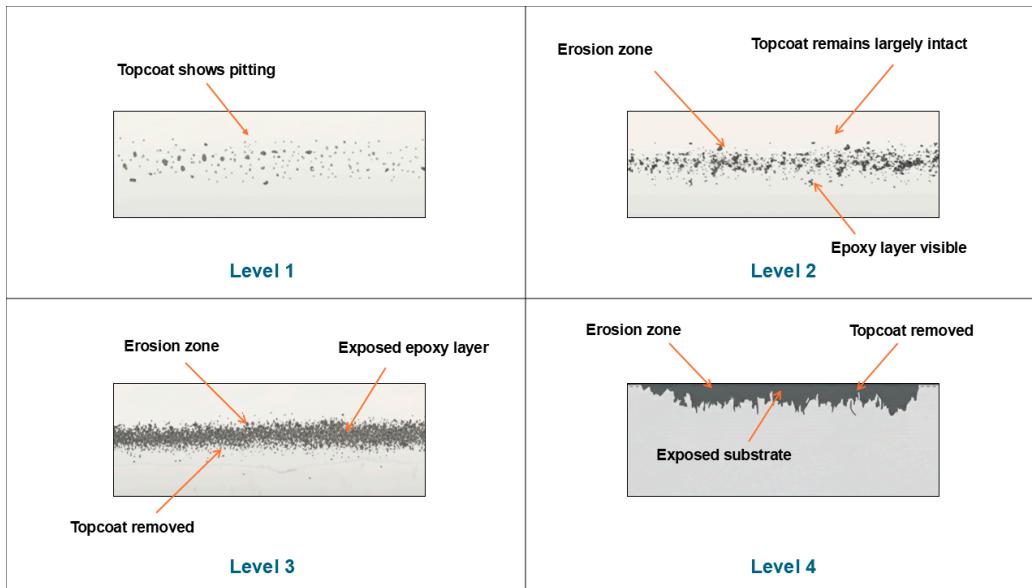
Figure 2. Schematic representation of erosion severity levels across the blade leading edge. Adapted and redrawn from Ref. [32].

This subsurface accumulation of damage gives rise to the commonly observed "incubation period" in erosion testing, during which internal fatigue damage progresses while the surface remains macroscopically intact [31]. Several failure modes are associated with this process. These include uniform erosion, where material is gradually removed across the surface; adhesive failure at the interface between the Leading-Edge Protection (LEP) coating and the substrate; and localised failure stemming from manufacturing defects or microstructural discontinuities [31]. The visual progression of damage is often staged, beginning with minor pitting or roughness on the topcoat (Level 1), progressing to intermittent exposure of the underlying epoxy (Level 2), and eventually leading to full removal of the topcoat and complete substrate exposure (Levels 3 and 4) [32], as illustrated in Figure 2.

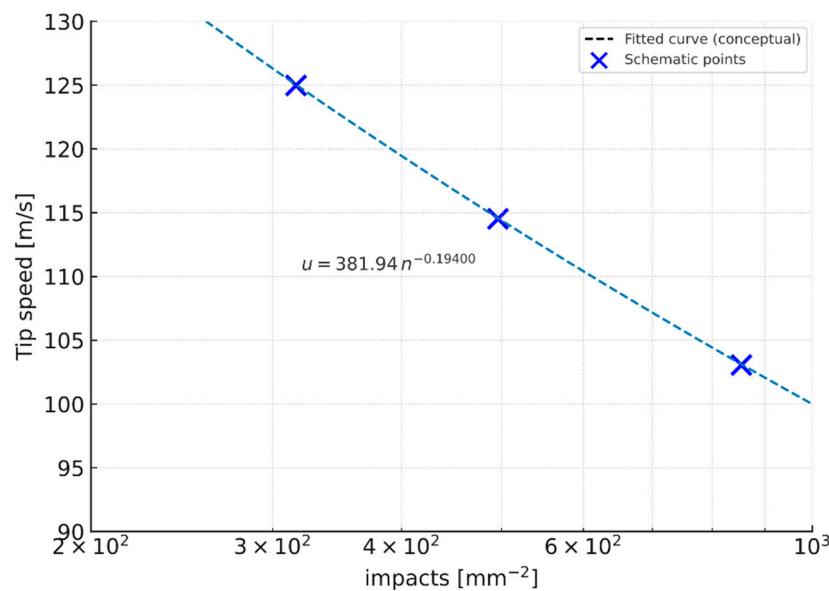
Figure 3. Conceptual velocity–number of impacts (V - n) curve for erosion lifetime prediction. Adapted and redrawn from [37]. Experimental scatter omitted to emphasise the fitted power-law trend.

impacts (n) required to initiate coating failure. Typically derived from rain erosion testing (RET), the V - n relationship is commonly expressed as a power law and serves as a fundamental metric for estimating the characteristic life of erosion-resistant coatings under controlled conditions. A conceptual illustration of the V - n relationship is shown in Figure 3, demonstrating the inverse relationship between impact speed and the number of impacts to failure. The framework, such as the V - n_f formulation proposed by Tempelis and Mishnaevsky [37], normalise the number of impacts per unit area, enabling its integration into probabilistic lifetime models. In this context, the ratio n/n_f is treated as a damage fraction analogous to Miner's rule for fatigue, and its cumulative summation yields a global damage variable that governs predicted failure onset.

To more accurately represent real-world conditions, the V - n_f framework incorporates several critical adjustments. These include scaling factors to capture the transition from incubation to characteristic life, often express through Weibull distributions, as well as corrections for raindrop size using factors of the form $\left(\frac{d_{ref}}{d}\right)^3$. Model calibration and sensitivity analyses have highlighted the strong influence of parameters such as the Weibull shape factor and scaling multipliers on predicted lifetime, underscoring both the utility of the V - n_f approach and its sensitivity to experimental assumptions [37].

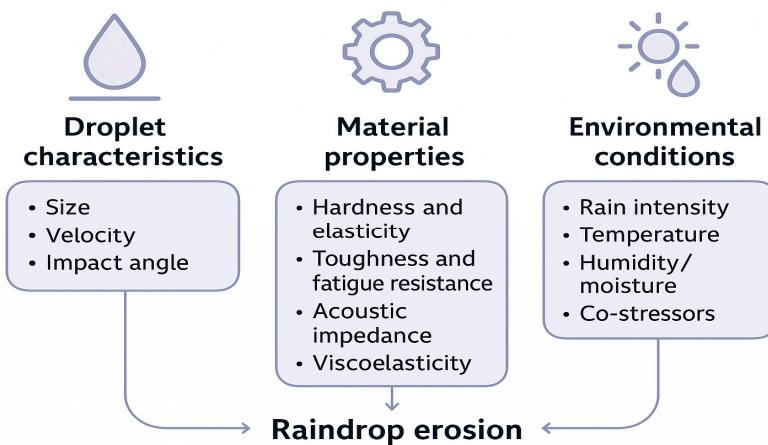
Figure 4. Factors influencing rain erosion progression.

The severity of raindrop erosion on wind turbine blades is influenced by a complex interplay of droplet characteristics, material properties of the blades and their coating, and ambient environmental conditions. A conceptual framework linking droplet characteristics, material properties and environmental conditions to the progression of rain erosion is presented in Figure 4. This synthesis diagram integrates the key factors discussed above, illustrating how they interact to influence the degradation pathways of wind turbine blade coatings.

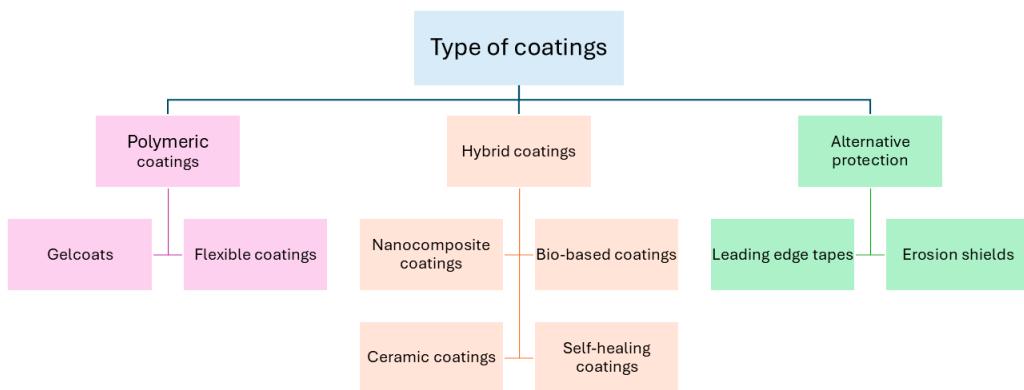
Figure 5. Classification of protective coatings.

Protective solutions for wind turbine blades are classified based on composition and application method into polymeric, hybrid and alternative systems, as illustrated in Figure 5.

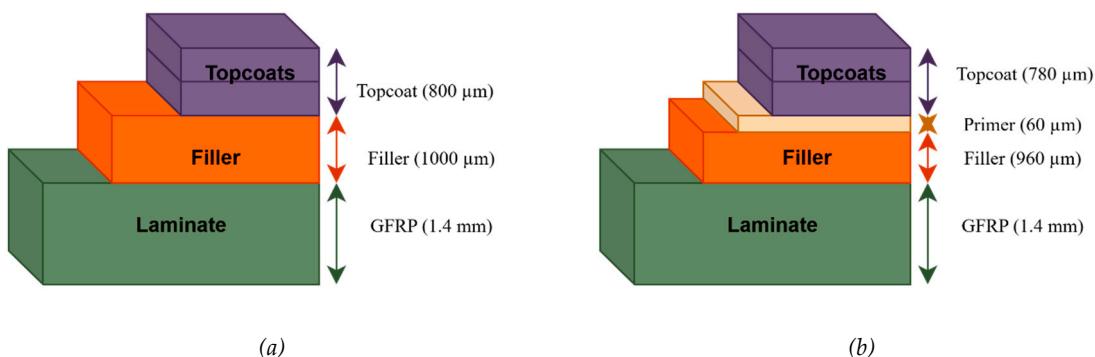
Figure 6. (a) LEP coating system incorporating a filler layer; (b) modified system with an added primer layer to strengthen bonding with the substrate. Redrawn from [21].

Post-mould coatings are applied after blade fabrication, most commonly by spraying or painting flexible polyurethane-based layers. These coatings are widely used for LEP and allow more versatility in material choice compared to in-mould systems. Cortes et al. [21] reported that elastomeric post-mould coatings outperformed rigid in-mould gelcoats in rain erosion testing. The performance of LEP systems can be further improved with multilayer architectures incorporating putty and primer layers; the addition of a primer significantly improved adhesion and reduced delamination risks. A schematic representation of the coating layer is shown in Figure 6. Similarly, Keegan et al. [13] noted that post-mould coatings provide flexibility and repairability, making them well suited for both initial protection and maintenance. Nonetheless, Herring et al. [12] pointed out challenges associated with manual application, such as surface defects, poor adhesion due to contamination, and difficulties in field repairs under uncontrolled conditions.

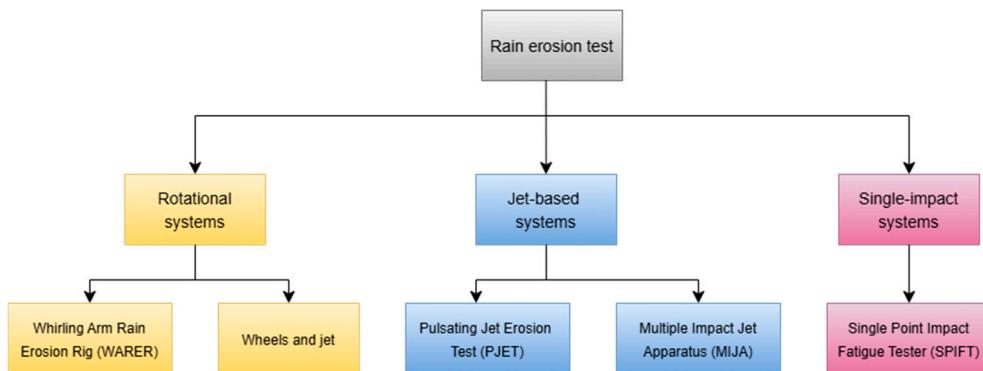
Figure 7. Overview of common erosion test configurations used for rain erosion studies.

A wide range of testing facilities has been employed in the literature [71,78-82]. According to [83], rain erosion test setups can be classified based on two main criteria: whether the target specimen is stationary or in motion, and whether the system produces single or multiple droplet impacts. The configuration of these four possible combinations is left to the researcher's discretion, leading to a variety of innovative experimental designs. Figure 7 illustrates the main types of erosion facilities and their respective classifications.

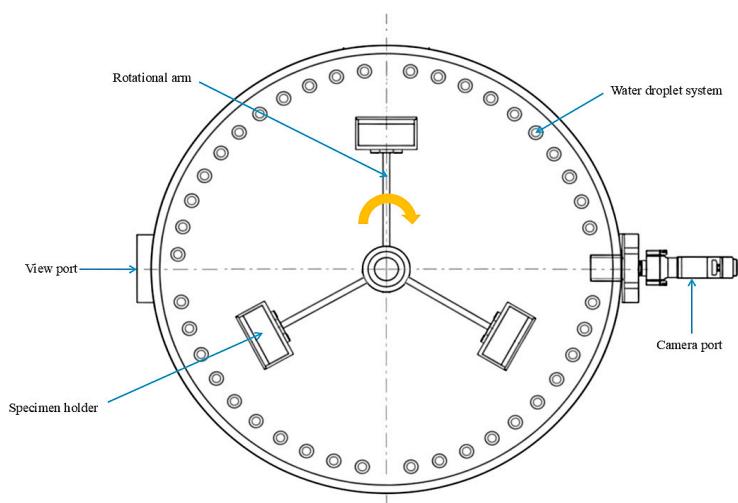
Figure 8. Schematic top-view illustration of the whirling arm rain erosion rig, showing the rotating arm, specimen holder, and artificial rain field used to simulate droplet impacts. Adapted and redrawn from Ref. [20].

The whirling arm rain erosion test (RET) is the most widely used and standardised method for evaluating LEP systems, formalised under DNV-RP-0171. In this setup, coated specimens are mounted on a rotor and accelerated through an artificial rain field generated by arrays of drop-

dispensing needles. Figure 8 shows a simplified schematic of the whirling arm rain erosion rig used for coating erosion evaluation. The method provides accelerated testing by increasing rotational velocities, rainfall intensity, and droplet diameters beyond natural values. Performance is often assessed using V-n curves, which describe the number of impacts to failure as a function of droplet velocity. Kinsley et al. [77] emphasised its value in producing controlled and repeatable data but noted critical shortcomings, including unrealistic constant droplet sizes, the absence of dry recovery periods, and inadequate representation of viscoelastic material responses. Similarly, Bech et al. [84] confirmed its utility of systematic studies on drop size effects but raised concerns regarding extrapolation of accelerated data to operational ranges, high costs of multi-size testing, and limited field validation.

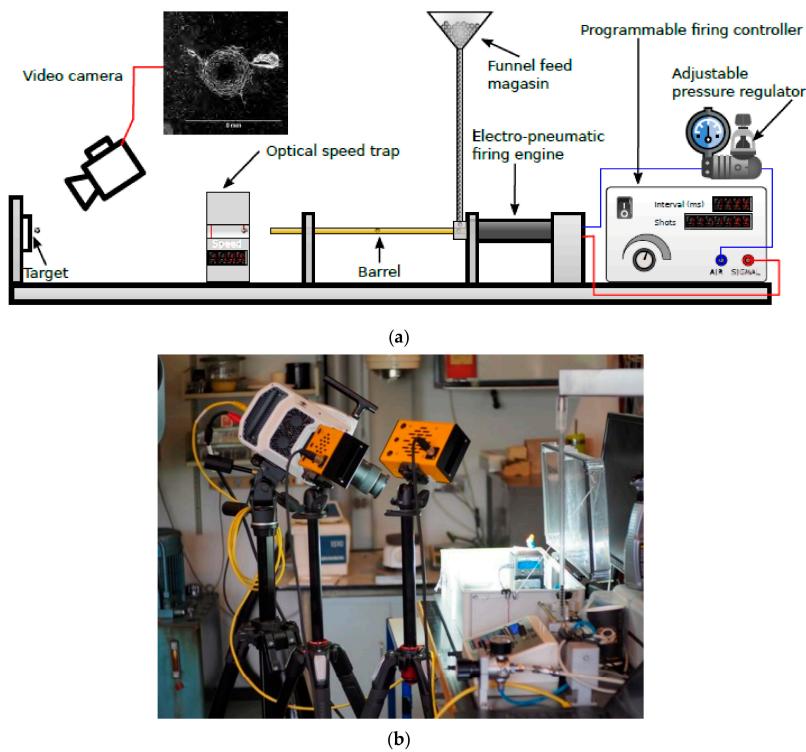
Figure 9. (a) Schematic of the SPFIT configuration; (b) high-speed imaging system used to capture the ball impacts. Reprinted from Ref. [71] with permission.

The Single Point Impact Fatigue Tester (SPIFT) offers an alternative approach by subjecting coatings to repeated high-velocity impacts at a single location using compliant nitrile rubber projectiles as shown in Figure 9. This recently developed technique employs an electropneumatic firing system that propels balls using compressed air. The exit velocity is influenced by factors such as barrel length, air pressure, ball mass, and nozzle diameter. Balls are supplied to the firing chamber from a vibrating magazine hopper through gravity feeding [85]. The method allows precise control of impact velocity, impact frequency, and loading history, and provides accelerated testing conditions up to 173 m/s. The use of rubber projectiles produces a deformation response closer to raindrop impacts than hard-particle methods. Johansen et al. [71] reported that SPIFT enables detailed observation of damage initiation, growth, and viscoelastic heating effects through high-speed imaging and thermography. However, SPIFT departs from natural rain erosion by concentrating impacts on a single point rather than distributing them over a surface, and the complexity and cost of the equipment pose additional limitations.

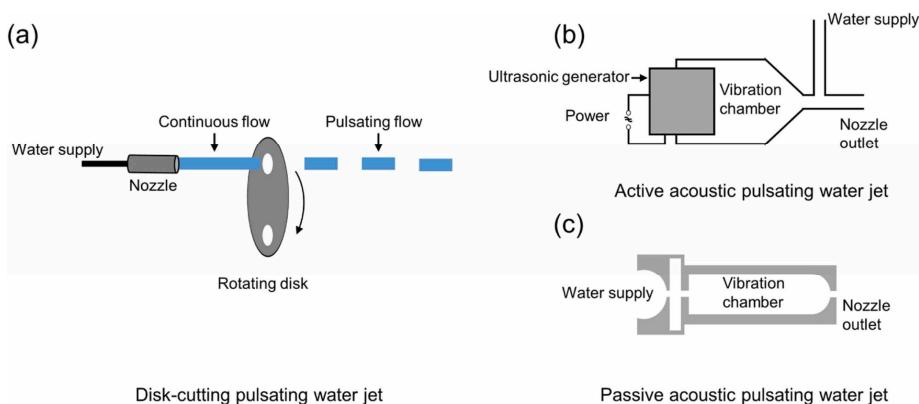
**Figure 10.** Three methods to produce pulsating flows. Reprinted from Ref. [86] with permission.

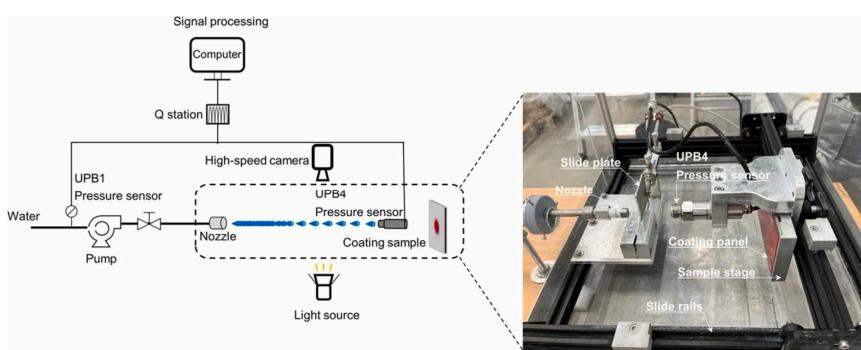
**Figure 11.** Pulsating water jet setup designed for accelerated rain erosion evaluation of wind turbine blade coatings. Reprinted from Ref. [86] with permission.

Wu [82] further demonstrated that the pulsating jet configuration provides a cost-effective and easy-to-operate setup capable of substantially shortening test duration through extremely high impact frequencies. Its ability to reproduce realistic erosion features makes it valuable for mechanistic investigations and early-stage material screening. However, its correlation with industrial whirling arm rain erosion tests remains limited, as droplet size, shape, impact frequency, and overall flow behaviour differ considerably from natural rain conditions. Moreover, rapid material loss can mask the incubation stage, and the combined influence of multiple parameters may lead to failure mechanisms that deviate from those observed in field exposures. Consequently, while the pulsating jet is advantageous for controlled laboratory studies, its applicability for direct performance validation against operational conditions remains constrained.

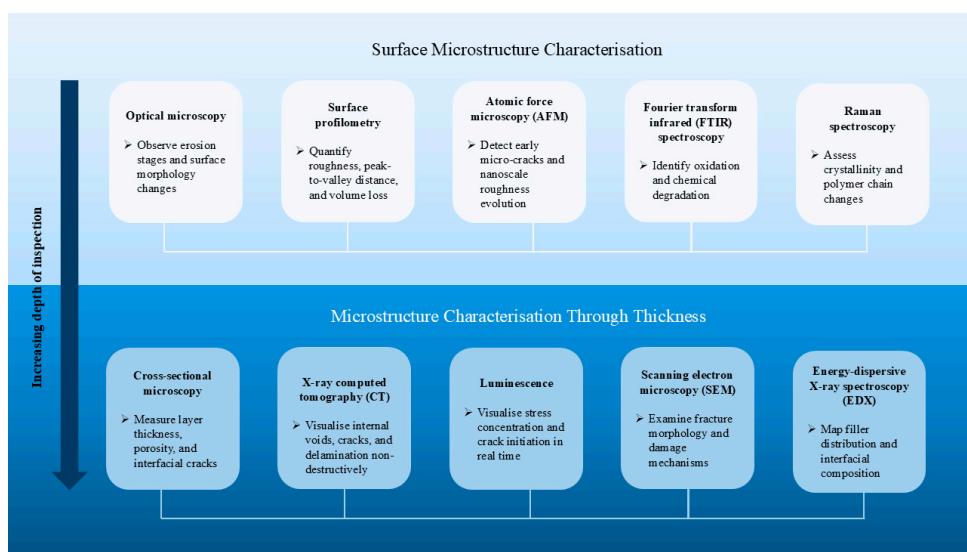
Figure 12. Summary of characterisation techniques used for rain erosion studies.

A wide range of characterisation techniques has been developed to evaluate erosion-induced damage at different spatial scales and depths. These methods can be broadly categorised into surface microstructure analysis and through thickness microstructural examination. Figure 12 summarises the hierarchy of these approaches, highlighting the transition from surface-focused mapping to subsurface tools used for assessing coating degradation.
