Active Confinement of Masonry Walls with Stainless Steel Straps: The Effect of Strap Arrangement on the in-Plane Behavior of Strength, Poisson's Ratio and Pseudo-Ductility

Keywords: masonry walls; CAM® System; shear behavior; reinforcement arrangement; diagonal compression test; pseudo-ductility; anisotropy; elastic moduli; Poisson's ratio.

Article

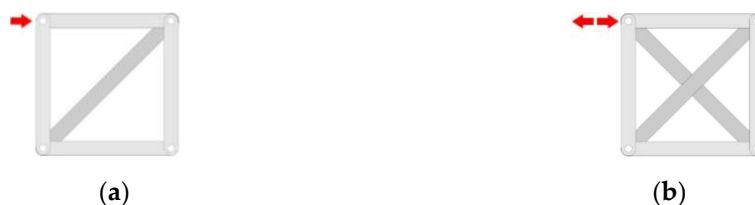
Figure 3. Bracing of a rectangle made of hinged strips: (a) By adding a strip along a diagonal, which will prevent the rectangle from collapsing in one direction but not the other; (b) By adding strips along both diagonals, which will prevent the rectangle from collapsing in either direction.

In rectangular frame structures, it is customary to cancel the horizontal displacement of the hinged nodes by bracing the structures along one (Figure 3a) or both diagonals (Figure 3b).

The straps subjected to tension resist the load due to the tensile strength of the steel (straps with positive slope in Figure 25a). This delays the specimen failure as it counteracts the opening of the failure planes. In other words, the tensioned straps have the same function as the bracing strip in Figure 3a. The straps subjected to compression (straps with negative slope in Figure 25a) are instead ineffective as they undergo instability under axial compressive load. This is not a problem since the forces applied along the direction of the compressed straps are not directly responsible for the specimen failure. These straps are not needed (under the load in Figure 25a) just as the strip along the second diagonal in Figure 3a is not needed.

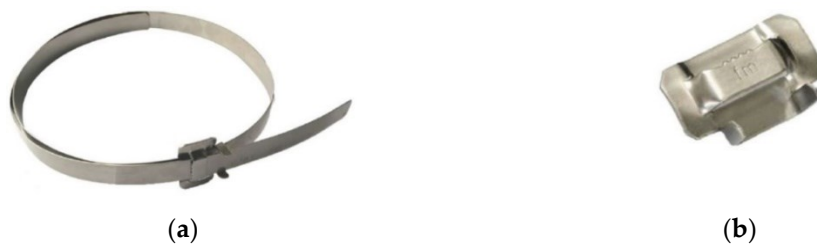
Figure 8. The elements of the active strengthening system: (a) A stainless steel strap closed to form a ring (before tightening the seal); (b) A stainless steel seal used for the strap ring closure.

The active strengthening system consists of the ring closure of stainless steel straps 16 mm wide and 0.9 mm thick, using folding seals (also made of stainless steel) for pre-tensioned closure. The straps (Figure 8a) and seals (Figure 8b) used in this experimental program are not of the same type patented with the CAM® System. Table 3 collects the mechanical properties declared by the manufacturer (Mauser) for the rolls of stainless steel straps.

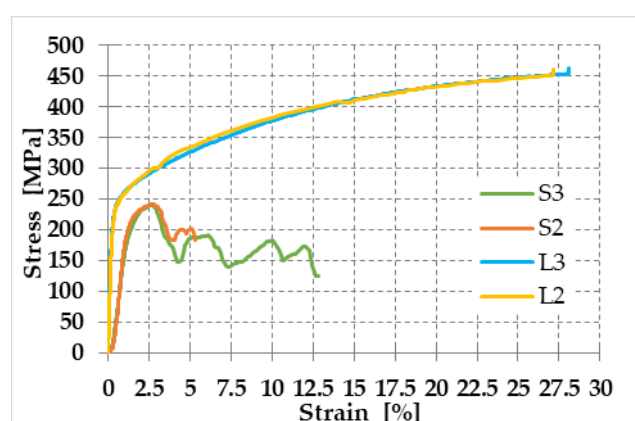
Figure 9. Stress/strain diagrams of the four specimens for the mechanical characterization of the straps.

The reference standard for the mechanical characterization of the stainless steel straps is UNI EN ISO 6892-1:2020 [51]. As with the mortar tests, the testing machine was a Galdabini universal testing machine, with a maximum capacity of 200 kN. Figure 9 shows the results of the tensile tests performed on the four specimens.

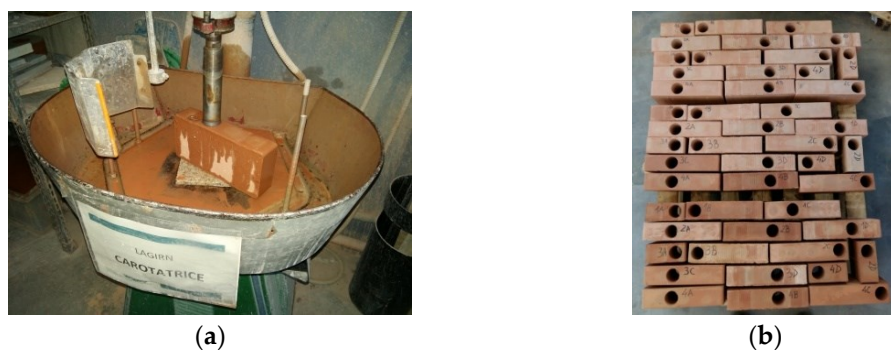
Figure 12. Preparatory stages for laying bricks: (a) Core drilling of a brick; (b) Drying of bricks after core drilling.

To avoid problems of overturning of the masonry specimens during the coring operations for the passage of the straps, core drilling took place on the individual brick units, before assembling them (Figure 12a). Figure 12b shows the hollow bricks left to dry after the coring operations.

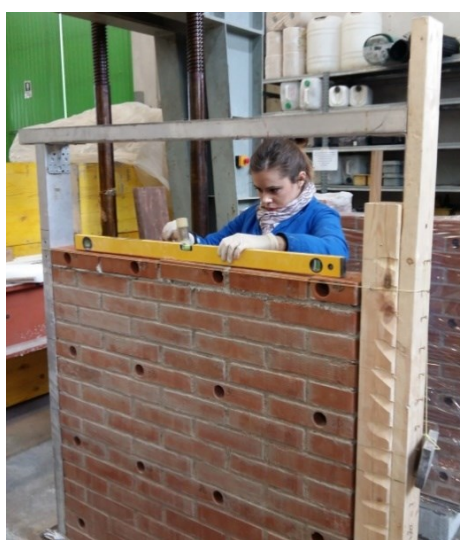
Figure 13. Equipment used for the correct laying of bricks.

The laying of the bricks took place in accordance with the UNI EN 1015-2:2007 standard [53], which recommends mixing the mortar with 15% water. The use of a plumb guide frame, leveling strings and a spirit level helped to check the verticality of the walls and the horizontality of each course of bricks (Figure 13).

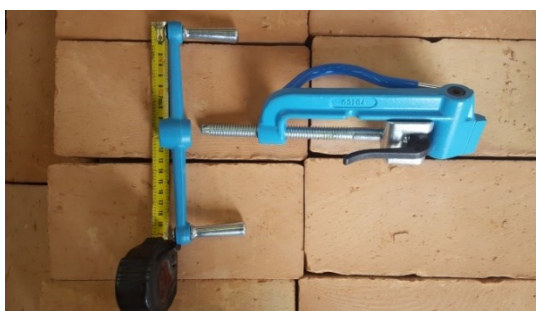
Figure 14. Barbero Mauser strapping system for stainless steel strapping: Model B05.T000S262.

The strapping machine used to close the seals is a product for manual use, by Barbero Mauser brand (Figure 14). When tightening the seals, it allows the application of a pre-tension of up to a maximum of 1.4 kN to the straps. This generates a pre-tension equal to approximately 40% the tensile strength shown in Figure 9 (cross-section dimensions: 16 × 0.9 mm).

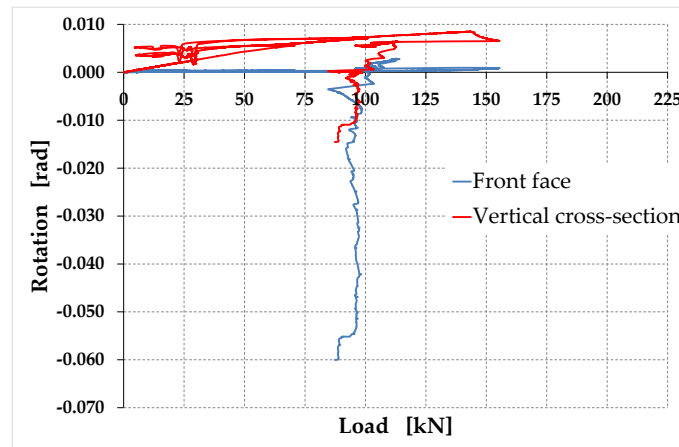
Figure 16. Rotations undergone by Specimen M1-45: positive values indicate anti-clockwise rotations on the front face and on the vertical cross-section, seen from the left side.

Since the values of φ_p and φ_c obtained for Specimen M1-45 (Figure 16) and Specimen M2-45 (Figure 17) are very small for the entire duration of the load test, the active reinforcement was able to keep the two specimens in axis despite the progression of the damage phenomena. The values of the rotations are actually so small that it is possible to consider the angles (measured in radians) equal to their tangents (small-angle approximation):

As a final observation, the comparison between Figure 16 and Figure 17 seems to indicate that the double reinforcement of Specimen M2-45 was more effective in limiting rotations than the single reinforcement of Specimen M1-45, at least up to the maximum load.

The failure was of a ductile type, with a progressive crack propagation hindered by the action of the straps arranged along the tensioned diagonal. This gave rise to a softening branch after the maximum load (Figure 16), which is not present in the test carried out on Specimen M1-90. At the end of the test, the crack extended along the entire compressed diagonal of the wall, but the strengthening system was almost intact and still able to resist the loads. This allowed the specimen to maintain its shape even after removal from the testing machine (Figure 20a). Since the straps are able to keep the two parts of the wall together after the event that caused it to break, we can say that this arrangement of straps is effective.

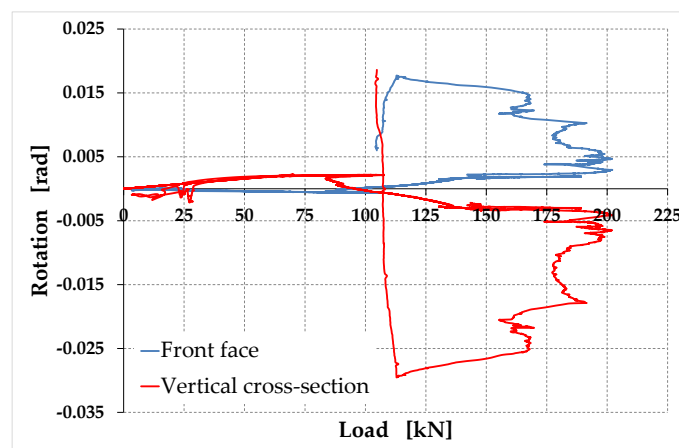
Figure 17. Rotations undergone by Specimen M2-45: positive values indicate anti-clockwise rotations on the front face and on the vertical cross-section, seen from the left side.

As with Specimen M1-45, the crisis was of a ductile type, with a final softening branch (Figure 17). However, the doubling of the reinforcement along the direction of the tensioned diagonal hindered the opening of the cracks along the compressed diagonal to such an extent that the failure mode presented characteristics different from those of Specimen M1-45:

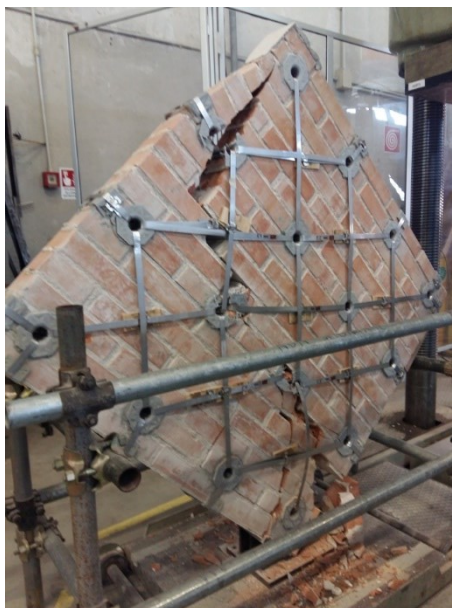
Figure 21. Failure mode of Specimen M2-45.

- No primary cracks opened along the compressed diagonal;
- The maximum load (202 kN) is increased by 30% compared to the maximum load of Specimen M1-45 (155 kN);
- The high load values and the lack of cracks along the compressed diagonal meant that the failure occurred due to a combination of the punching effect of the load heads and boundary effects (Figure 21).

In the final stages of the test, a bed joint also partially failed (Figure 21). Since this only occurred at the end of the test, it is a secondary effect caused by the primary mechanism described above. Despite the high degree of damage at the end of the test, the strapping system turned out to be only partially damaged and still able to withstand loads.

This test also resulted in the breaking of some funnel plates (Figure 21). As already noted in [36], this suggests that the maximum load could increase further by replacing the 3D printed plates with metal rings [35].

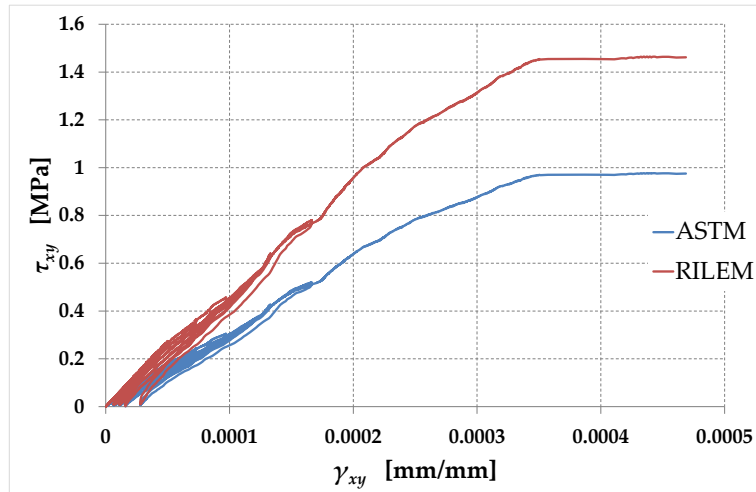
Figure 22. Shear stress/shear strain curves for specimen M1-90, according to ASTM and RILEM interpretations of the diagonal compression test.

Figure 22 shows the difference between the two formulations in terms of shear stress/shear strain curves, for specimen M1-90.

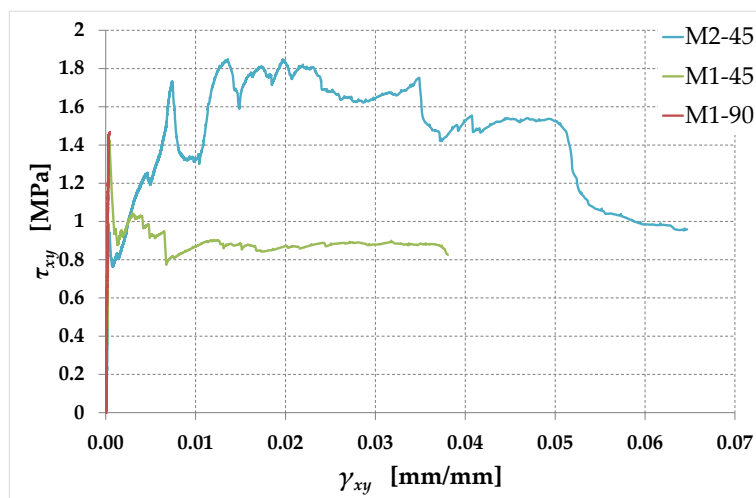
Figure 23. Shear stress/shear strain curves for the tested specimens.

- A $\pm 45^\circ$ rotation of the straps allows the rectangular arrangement to find equilibrium, while remaining a labile configuration. The curves of specimens M1-45 and M2-45 in Figure 23 testify to the effectiveness of the $\pm 45^\circ$ arrangement, since they continue well beyond the first peak, caused by the initiation of the crisis in the masonry. This greatly increases the pseudo-ductility of the strengthened masonry wall (Section 0). The activation of the strengthening system allowed by the $\pm 45^\circ$ rotation of the straps therefore transforms the failure of the specimen from brittle to markedly ductile. The continuation of the curves beyond the peak of first crack (first peak) is possible as the $\pm 45^\circ$ arrangement of the straps is labile but balanced, therefore effective, given the particular load condition. Figure 25 provides an explanation in the Mohr plane of the

In the specimen with two straps per loop along the tensioned direction (specimen M2-45 in Figure 23), the maximum load increases by approximately 26% with respect to specimen M1-90. Also the ultimate shear strain increases in specimen M2-45: it is approximately 138 times the ultimate shear strain of specimen M1-90 (**Error! Reference source not found.**). After the shear stress drop following the first peak, the tensioned straps allow specimen M2-45 to recover shear stress until it reaches and exceeds the shear stress of first peak. A series of successive peaks follows the first peak, with increasing peak shear stress values, which corresponds to the activation of new slip planes in the masonry. This indicates that the damage to the masonry is a progressive phenomenon and does not occur in a single moment, as instead happens in specimens M1-90. After the phase with increasing values of peak shear stress, specimen M2-45 also shows a pseudo-plastic phase, which is even longer than the pseudo-plastic phase of specimen M1-45. This second time, however, the plastic threshold does not denote a residual shear load bearing capacity, as the maximum shear stress reached in the plastic threshold is also the maximum shear stress attained by the specimen. The absence of a drop in shear stress between the point of maximum shear stress and the pseudo-plastic threshold assures us regarding structural ductility, since large shear strains are not necessary for the structure to benefit from the contribution of the straps. The pseudo-plastic phase is then weakly decreasing, with some shear stress drops, due to the progressive but slow damage to the strengthening system. At the end of the load test, the specimen is still capable of withstanding a shear stress equal to 52% of the maximum shear stress and 65% of the URM maximum shear stress.

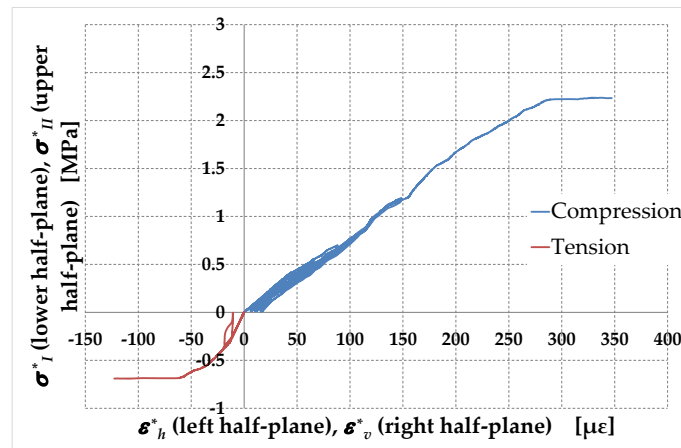
Figure 28. Uniaxial stress/strain relationships obtained for Specimen M1-90.

The ranges of compressive strains in the figures of the apparent Poisson's ratio (Figures 32-34) are the same as the ranges of ε_v^* in Figure 28 and the details in Figures 29b, 30b, respectively.

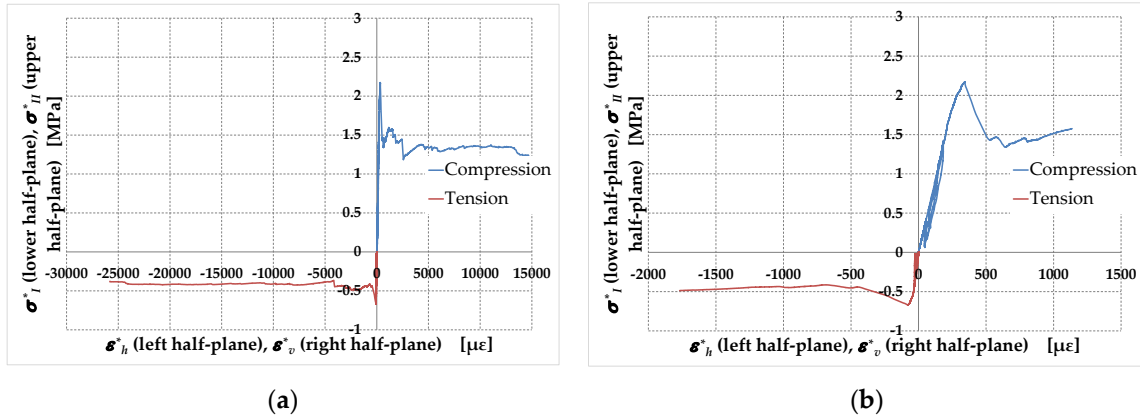
Figure 29. Uniaxial stress/strain relationships of Specimen M1-45: (a) Until the end of the loading test; (b) Truncated, to highlight the difference in slope at the origin in the two quadrants.

Due to the identification procedure adopted for the stress-strain curves under uniaxial loading, all considerations on the effect of the arrangement and the number of straps made for the shear stress/shear strain curves (Section 0) extend to the curves in Figures 28-30. In particular, the diagonal tensile strength given by Equation (5) returns almost the same value of f_{dt} for Specimen M1-90 and Specimen M1-45, while the value of f_{dt} in Specimen M2-45 is 1.30 times the value of f_{dt} in Specimen M1-45.

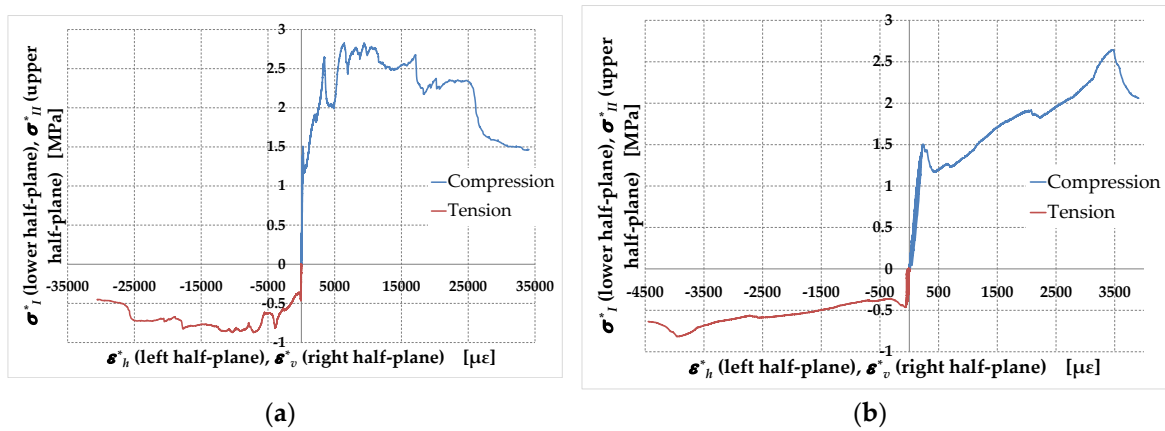
Figure 30. Uniaxial stress/strain relationships of Specimen M2-45: (a) Until the end of the loading test; (b) Truncated, to highlight the difference in slope at the origin in the two quadrants.

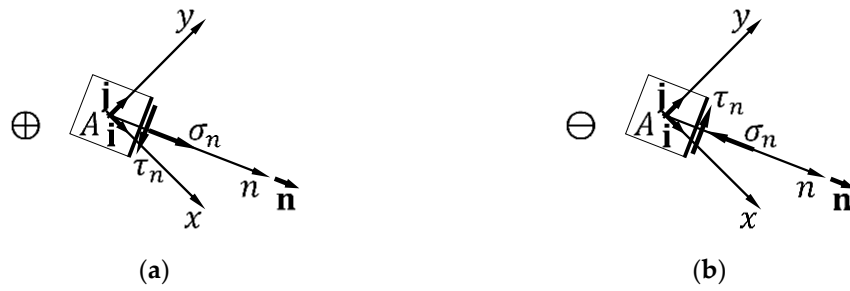
Figure A3. Stress components acting on the plane with unit normal vector \mathbf{n} (the plane perpendicular to the outward-pointing line n) in the reference frame of Figure A1: (a) For normal and shear stresses that are positive in the Mohr plane; (b) For normal and shear stresses that are negative in the Mohr plane.
