## NEW ADVANCES IN THE INSPECTION OF FLARE STACKS

**CODIGO DYNA = 3310.04**

Flare stacks are a key element in the safety of petrochemical and refinery industries; the correct operating conditions thereof must be ensured through a schedule for the periodic reviewing of all parts thereof. Advances in Non-Destructive Testing (NDT) in recent years and the application thereof to this field allow reliable, objective information to be obtained. This article describes and groups together the main applicable NDT techniques, analysing their advantages and disadvantages, updated with the new possibilities offered by unmanned aircraft or drones.

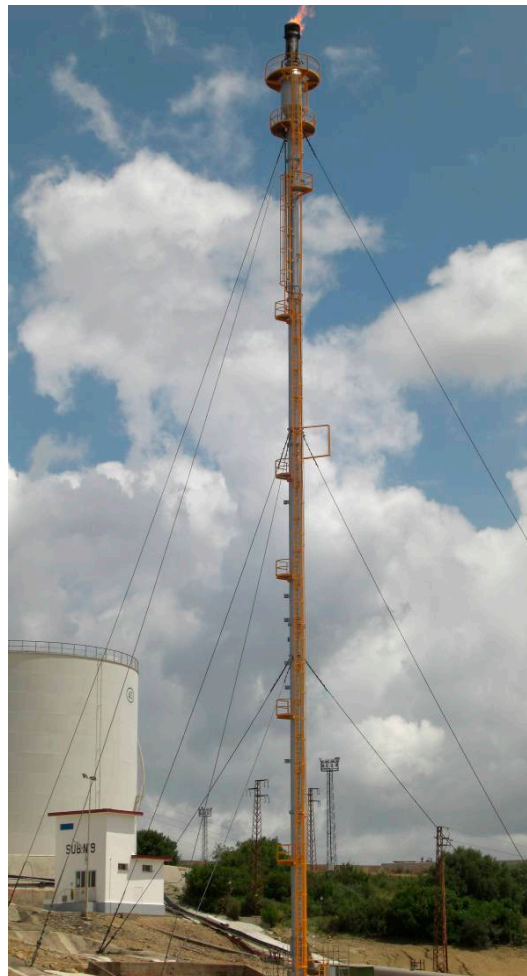
Photo 1: General view of a typical flare stack supported using guy wires

- I. Self-supported flare stacks, with a smaller affected surface area, suitable for heights of up to 76m and with a low manufacturing cost (photo 3).
- II. Supported using guy wires or cables, greater affected surface area of ground, heights of up to 180m and average manufacturing cost (photos 1 and 4).
- III. Supported by a permanent (photo 5) or temporary (photo 6) metal tower (derrick-supported). Small affected surface area, heights of over 200m and high manufacturing cost. Mentioned separately, although this group would also have to include flare stacks for offshore platforms.

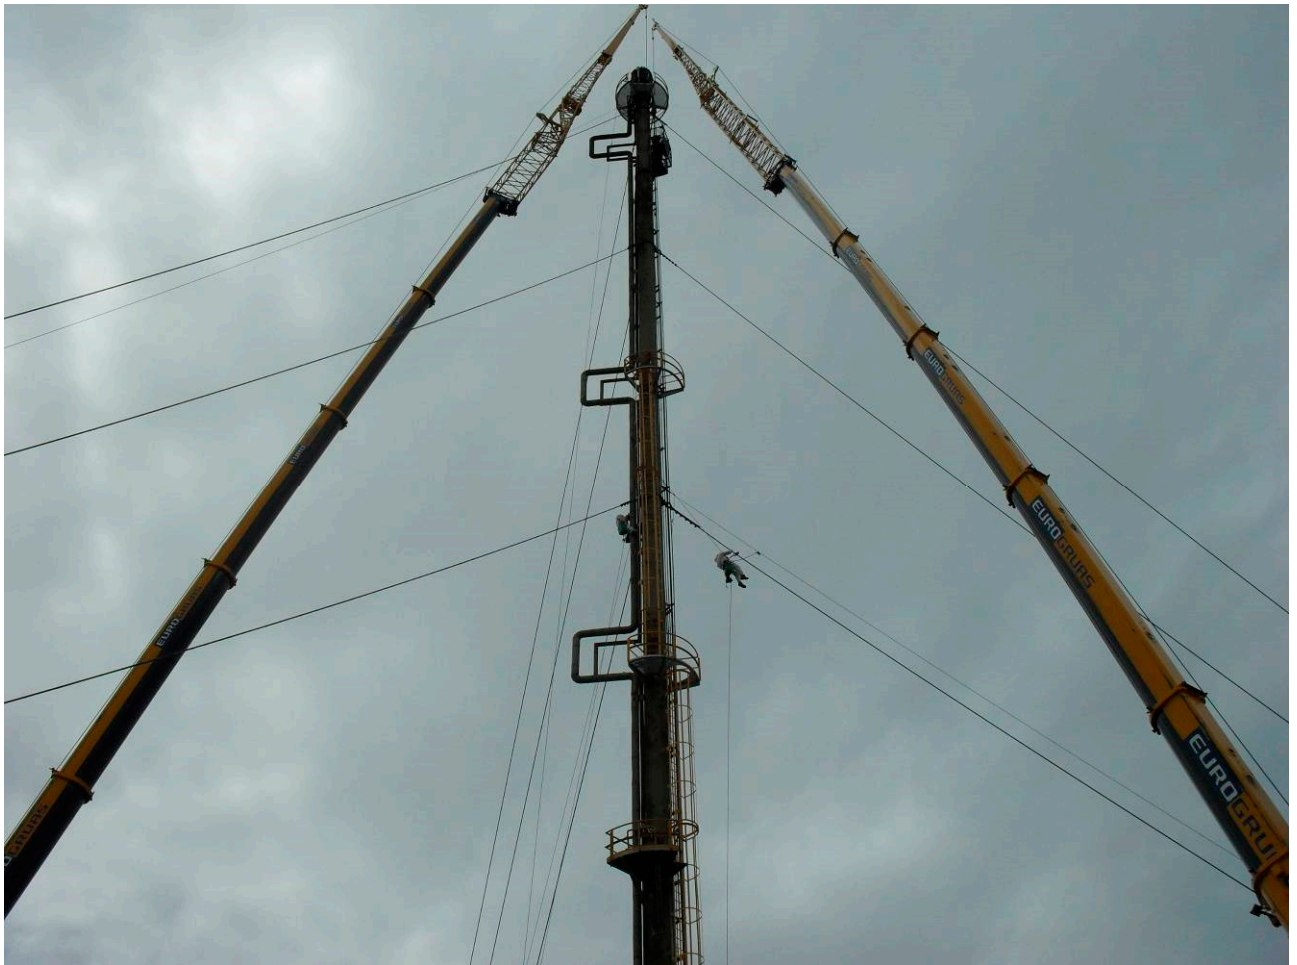
Fig. 02 Works on a flare stack using cranes and baskets, combined with rope access techniques for the inspection and lubrication of guy wires

Access using rope access techniques (photo 2) is currently on the rise; rope access equipment, which is ever more advanced and safe, allows expert personnel to gain access to any part of the flare stack with limited means and great speed. This speed and versatility is the main advantage, the problem being the limitation in the work to be performed (this cannot involve heavy loads), but they are very useful in the case of the application of NDT. The use thereof, as well as the use of scaffolding, is regulated by European directive 2001-45-EC on "Temporary Rope Access Work" [9], in line with the requirements of the current Legislation on the Prevention of Occupational Risk [10] (European Directive 89/391/EEC).

Elevation platforms with a telescopic arm [11] or baskets supported by cranes (photo 2) are particularly useful to perform maintenance operations, for example, the replacement of the burner of the flare stack, replacement of the metal platforms or access ladders, etc. On the other hand, using them for NDT is very expensive, as the cranes have certain limitations in terms of access and reach as a result of the existence of the guy wires of the flare stack and in many cases, different ground levels around the base of the shaft.

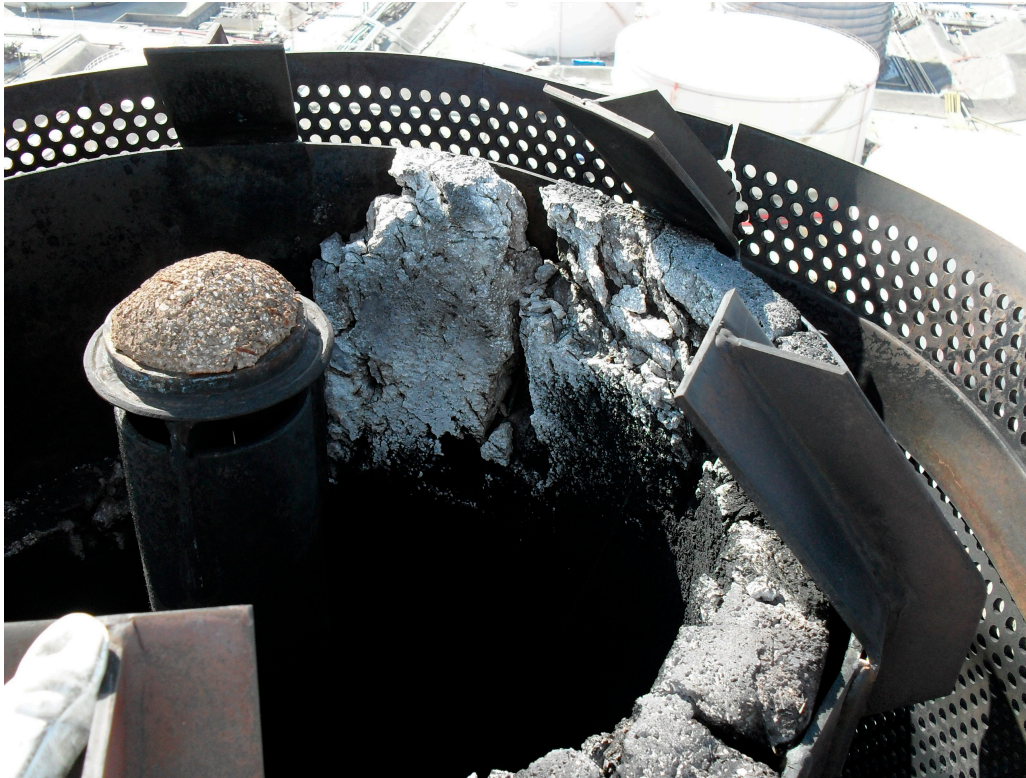
*PHOTO 8.1 View from above of an installed burner, with detachment of fireproof coating*

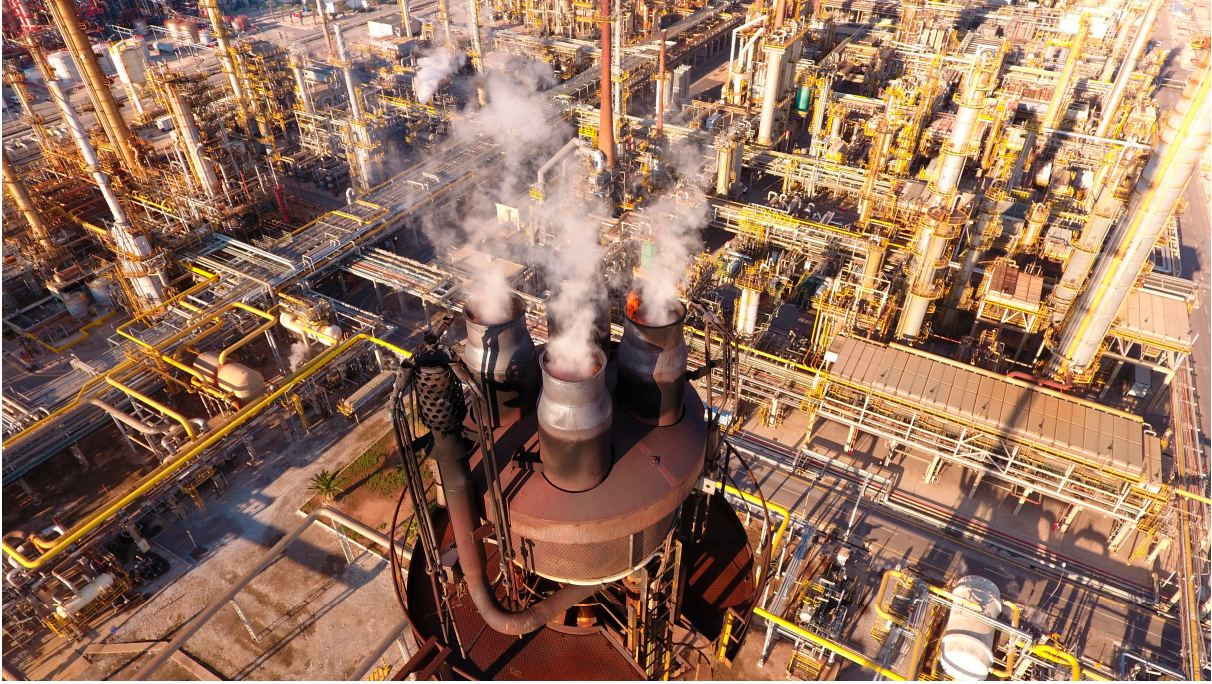
*PHOTO 8.2 View from above of a burner in operation using drone inspection*

*Visual inspection* using unmanned aircraft has the great advantage of being able to perform the inspection whilst the flare stack is operational, without the need to wait for a stoppage, and additionally cover all the areas of interest of the flare stack mentioned in the previous section. The drone can carry a multitude of cameras and devices, the norm being a powerful camera with 4K video recording and optical zoom, which reduces the need to get the drone too close to the flame or other risk areas.

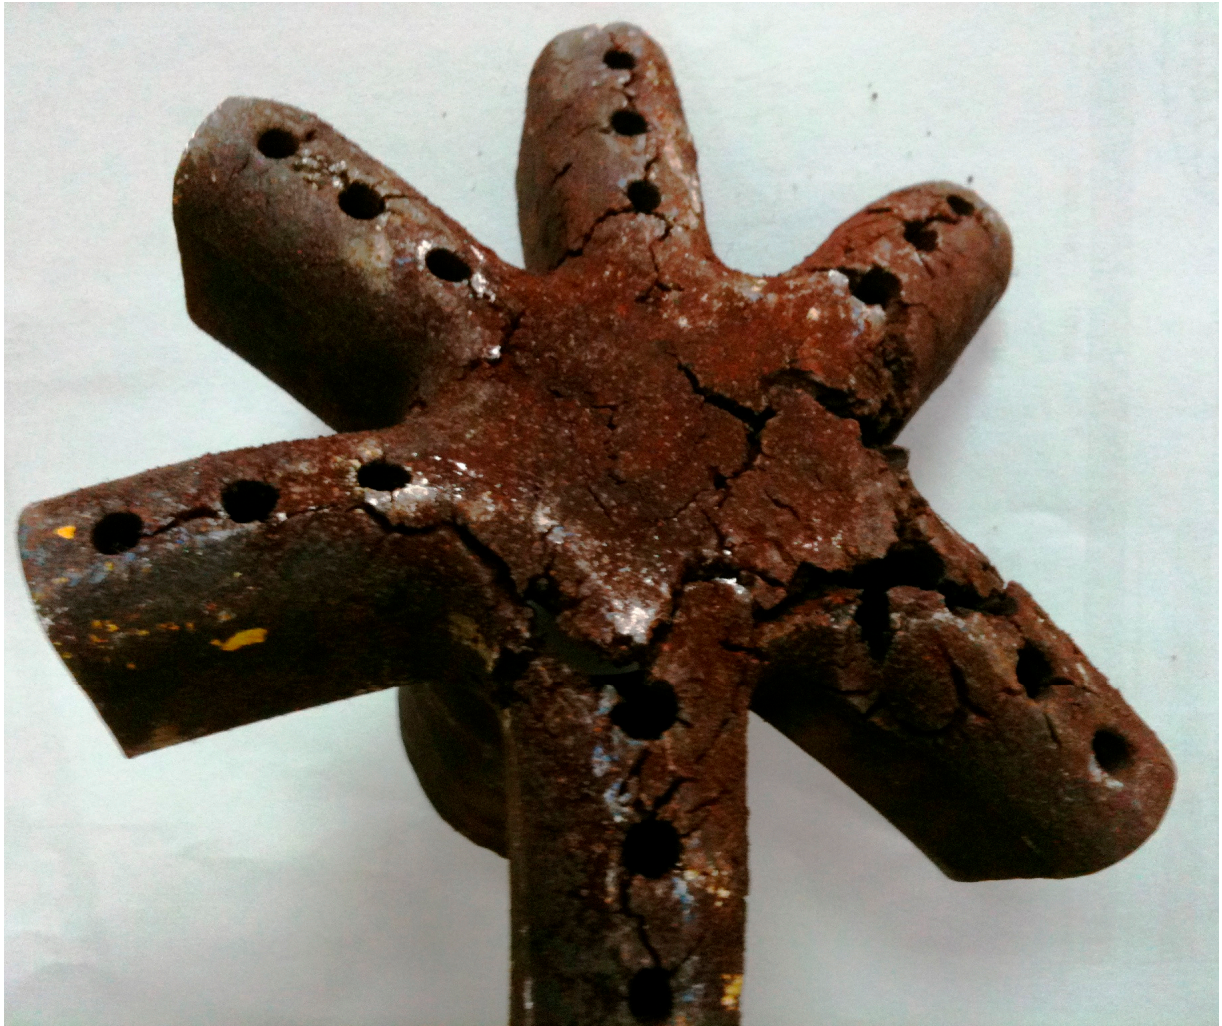
*PHOTO 8.3 Image of a nozzle damaged due to high temperatures*

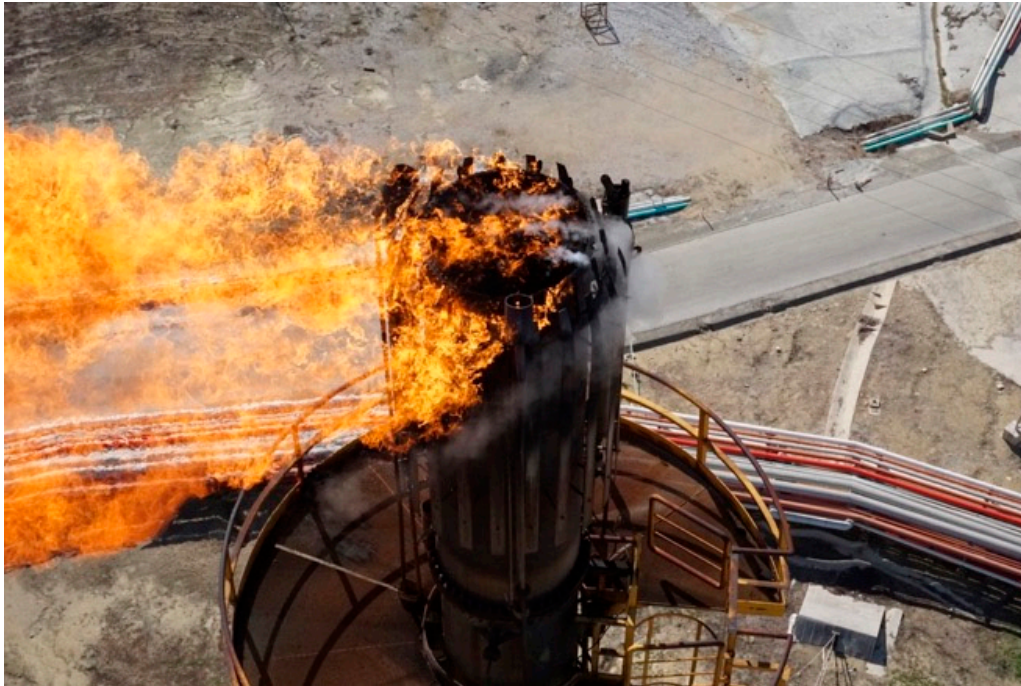
*PHOTO 9. Image from above the burner area (tip) of a flare stack with a defect in the steam seal using a drone*

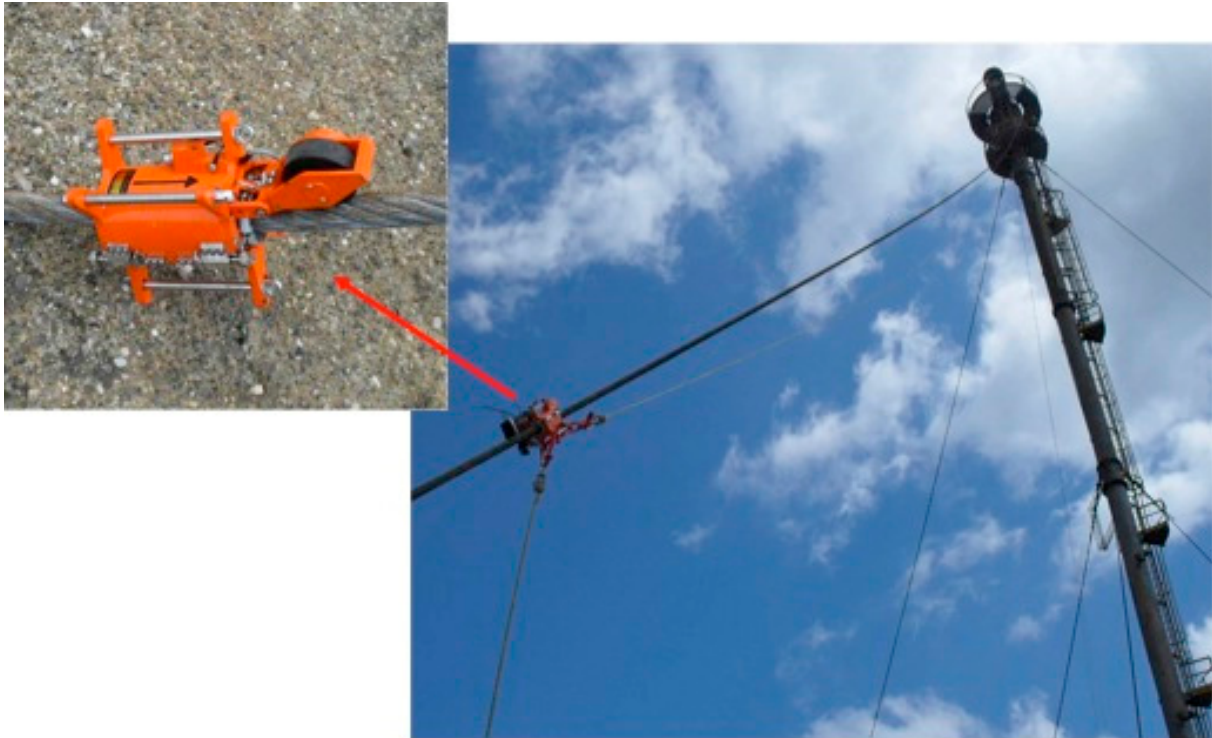
photo 10: Magnetic head for magneto-inductive analysis, moving along the flare stack guy wire

The *magneto-inductive analysis* of the guy wires is based on the method of magnetising the wire with permanent magnets, installing a magnetic head on such and moving it along during the test. Irregularities such as loss of metallic area (LMA) and local faults (LF) lead to a redistribution of the magnetic flow around the wire, which is detected by Hall effect sensors [13, 14, 15, 16, 17, 18, 19].

It is recommendable to perform at least two inspection sweeps with the magnetic head along each wire (photo 10), and thus have at least two results sheets per wire, in order to compare these. The rejection criteria are based on the level of average loss of cross-section and the accumulation of local faults within a specific distance; as these are static wires for the supporting of structures, although there is no specific standard for these, the criteria of EN12927-6 [20] or ISO4309 [21] are generally applied, with the additional existence in Spain of UNE 58111-91 [22].
