Investigation of Gold Electrodes Surface Condition of Plasma Reactor

During the long-term operation of the plasma reactor, decreases in the plasma concentration were noticed despite the constant maintenance of all parameters. One of the factors is the decrease of the nitrogen content on the surface of the electrode, in order to eliminate it, the supply voltage has been increased to 11 kV. The next decisive factor in the decrease of plasma concentration is the oxidation of the electrode surface, therefore two electrodes were used: first one with solid gold and the other one copper covered with galvanized gold with a thickness of 10 μm . During the experiment, a large decrease in plasma concentration was observed when the electrode coated by gold was used. High-energy electrons have knocked out the gold atoms from the electrode, as a result of which the gold evaporated and the raids layers formed. After a month of working of the electrodes, metallographic researches were carried out, the results of which are described in this publication.

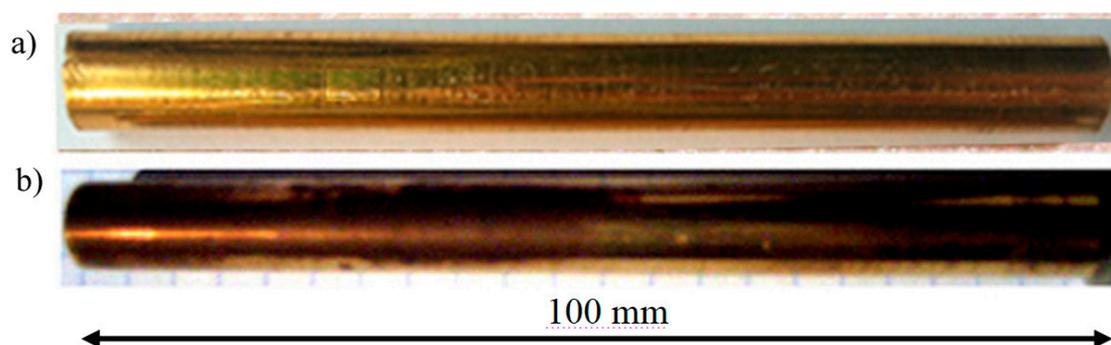
After one month of operation, the electrode made of copper galvanized coated with gold had a matt surface with a dark coating indicating the presence of a layer of oxidation products – Figure 1b. Gold was minted by energetic plasma electrons and evaporated. The gold electrode showed no macroscopic changes in polish and surface coloring – Figure 1a [8, 9].

Figure 1. Photograph of electrodes after monthly use in a plasma reactor a) gold electrode, b) copper electrode galvanized coated with gold

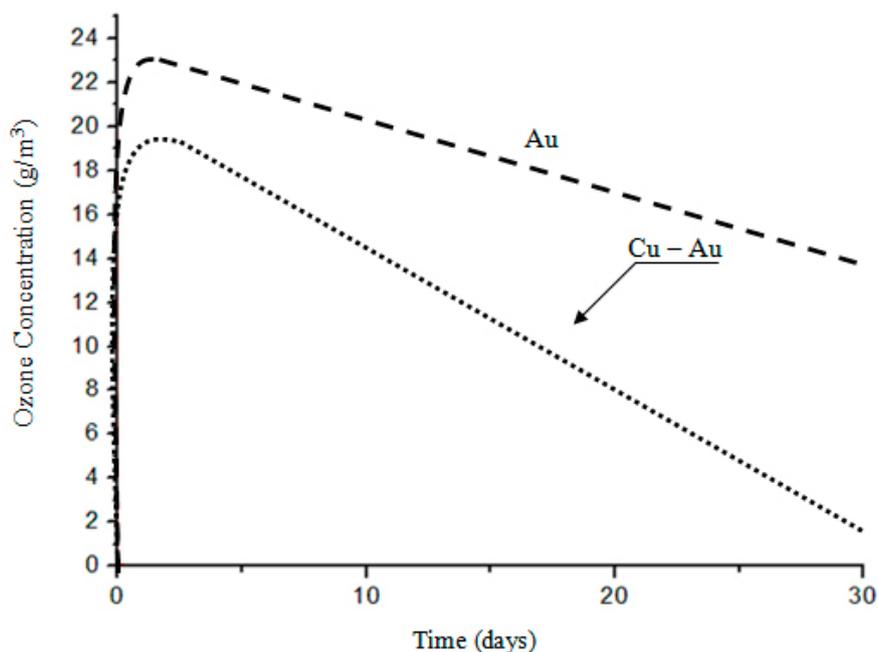
Figure 2. Dependence between ozone concentration and working time of electrodes

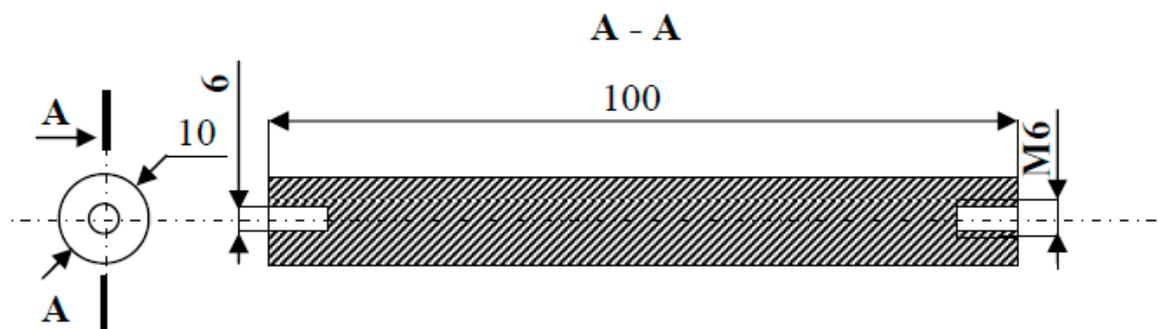
Figure 3. The shape and dimensions of the electrode made of gold

Experimented electrodes in the form of rollers with a length of 100 mm and a diameter of 10 mm had an M6 internal thread on one side and on the other, a hole \varnothing 6 mm with milling for the clamping wedge on the drive shaft – Figure 3.

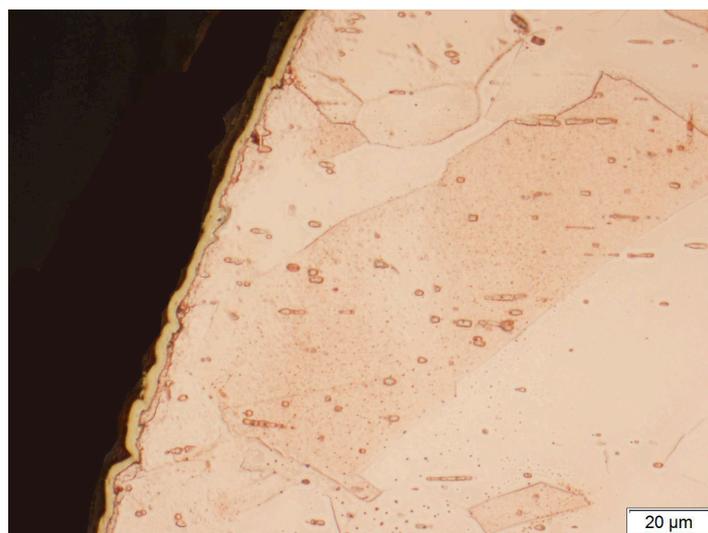
Figure 4. A gold layer applied galvanically to the surface of the copper electrode

A copper electrode with a galvanically applied layer of gold after a month's use is characterized by a structure of large recrystallized copper grains with straight lines and a discontinuous layer of gold – Figure 4. Between the galvanic layer of gold and copper there are areas with no adhesion, mainly at the points where the boundaries between Cu and Au layers meet. – Figure 5. The structure of the electroplated Au layer and the occurring discontinuities may be the reason for ejecting gold atoms from the galvanic layer onto the plasma reactor housing during its operation, formation of discontinuities in the layer, progress of the surface oxidation process and, as a result, a decrease in ozone concentration during the work of the plasma reactor. Observations using the scanning electron microscope revealed the occurrence of oxidation effects in the form of a very thin raid layers on the surface of the electrode. Thickness of the raids layers on the AuEC electrode is in the range of 0.778 μm to 1 μm . X-ray research made it possible to determine the phase state of the raids layers on the investigated electrode. X-ray diffraction lines are from the planes (111, 200, 220, 311) of the following phases Cu, Cu₂O, Au_{0.88}Cu_{0.12} and Cu_{0.88}Au_{0.12}.

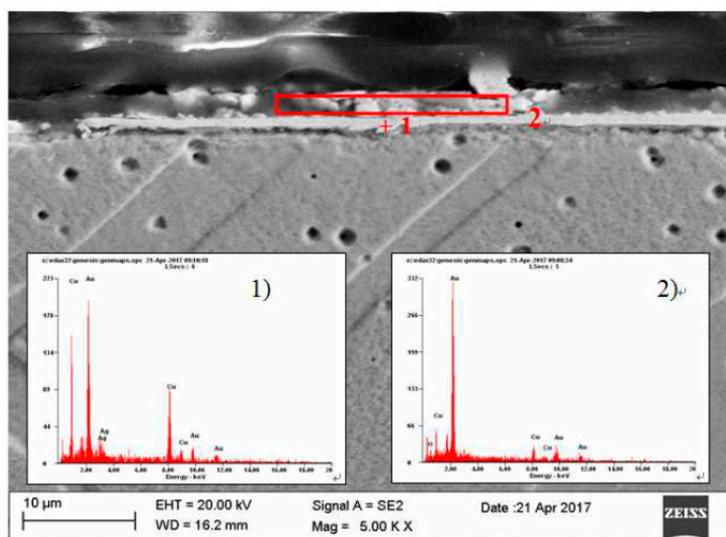
Figure 5. Results of point (1) and surface (2) microanalysis of the chemical composition of the coating layer on electrolytically gold deposited on copper

The analyzed raids layers on a copper electrode with galvanically applied gold consists of two parts differing both in terms of structure and chemical composition – Figure 5. The construction of the part bordering with copper is massive, sometimes discontinuous, while the part bordering with the atmosphere of oxygen and ozone - segmented – Figure 5. The chemical composition of the bordering copper is copper, silver and gold, and in the bordering part of the atmosphere oxygen, copper and gold – Figure 5, Tabela 1.

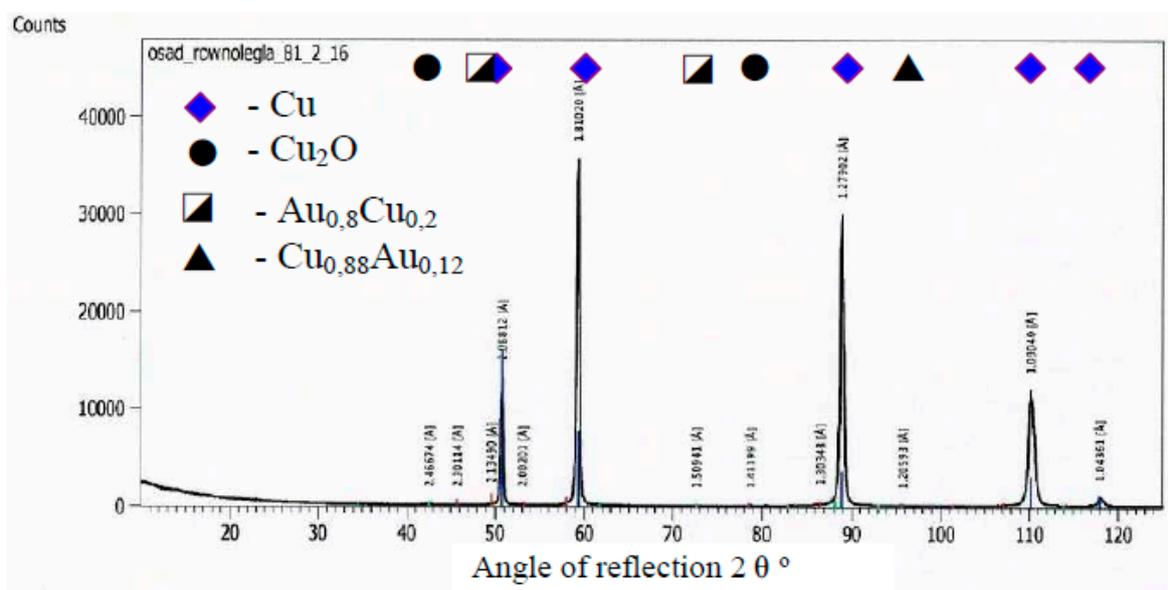
Figure 6. A diffractogram of the surface of a copper electrode galvanized coated by gold

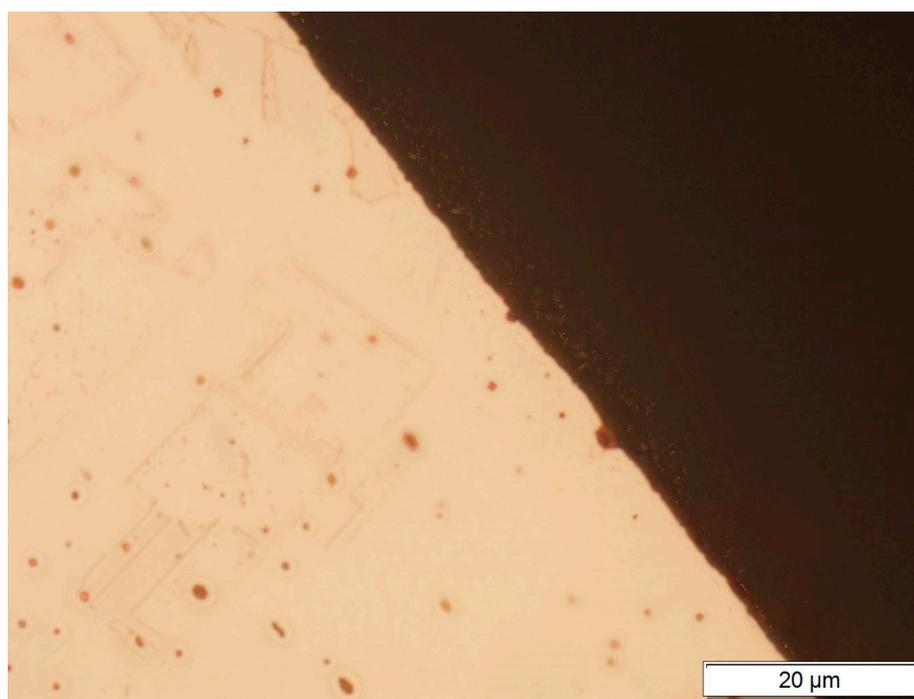
Figure 7. Gold electrode photography

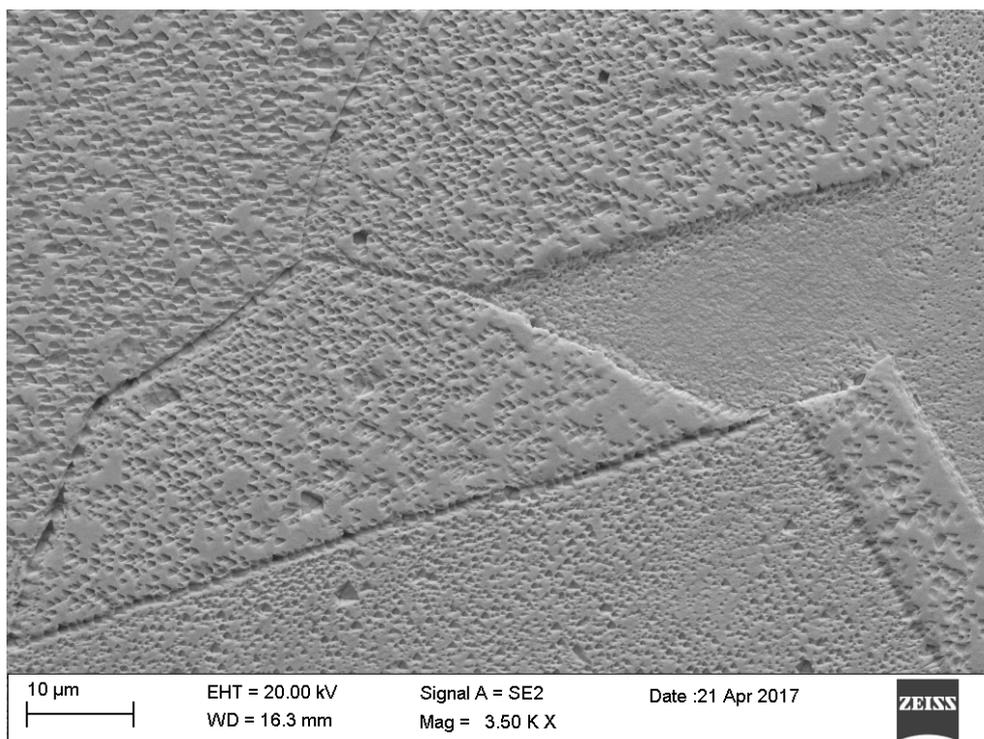
Figure 8. Large Au grains with twins in the structure

In the gold structure, very large grains were observed with annealing twins and geometrical figures inside the grains – Figure 8. The average surface size of the grains disclosed is from about 0.25 mm² to 1.15 mm² – Figure 8. In addition, observations in the scanning microscope allowed to state that the surface of the golden electrode is characterized by a very large development line – Figure 9.

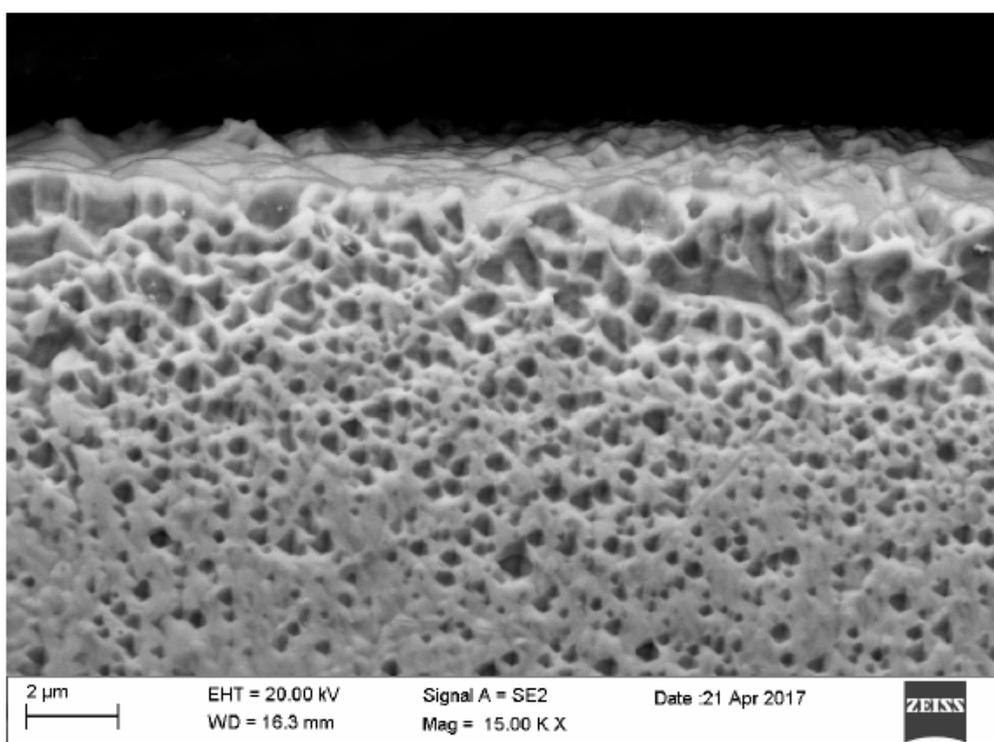
Figure 9. Surface of gold electrode

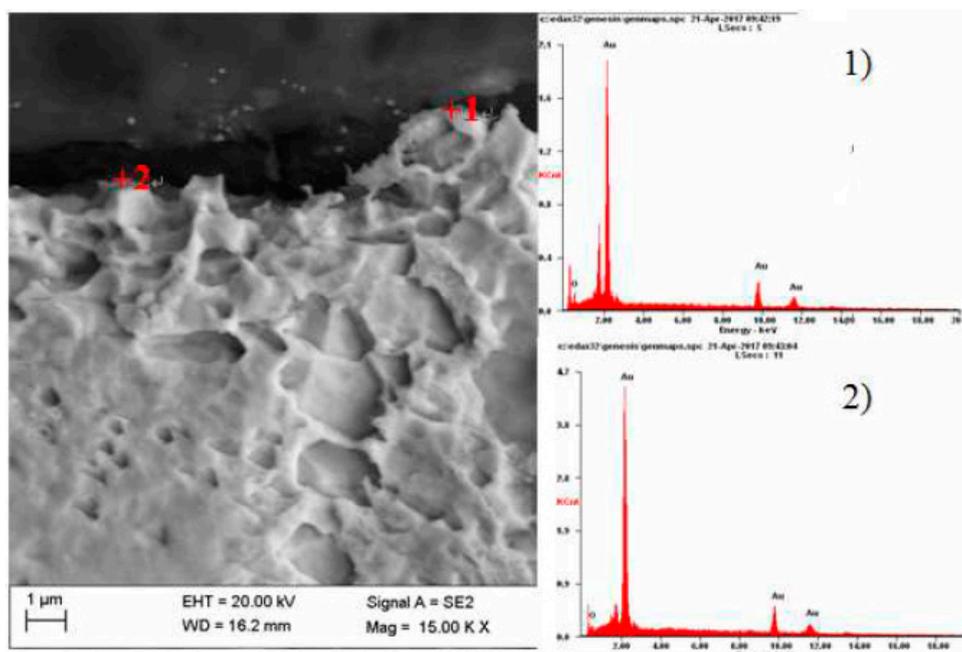
Figure 10. Results of microanalysis of the chemical composition of the Au electrode, from the areas marked in the photomicrographs

Metallographic investigation did not reveal microscopic raids layers on the surface of the electrode made of gold. As a result of the microanalysis of the chemical composition using EDX, however, the presence of oxygen in several micro-areas on the surface of this electrode was revealed. – Figure 10, 11.

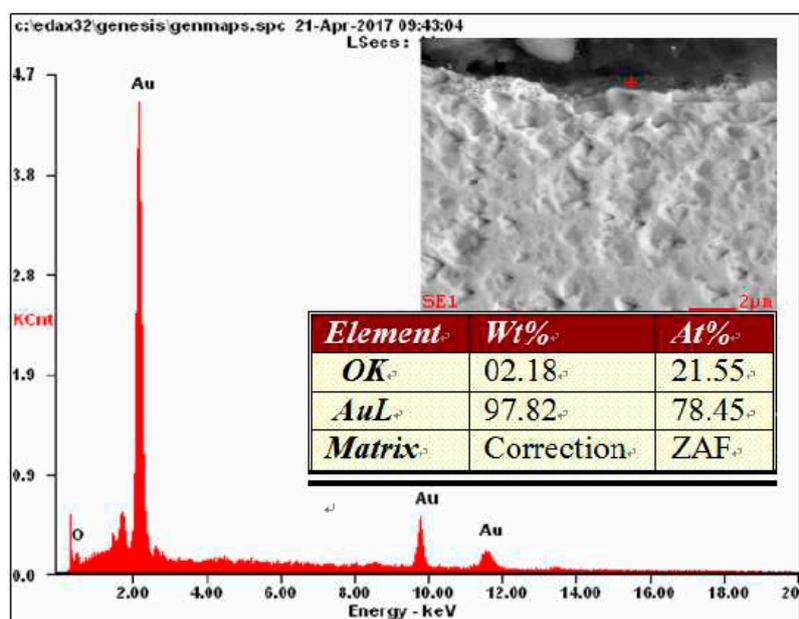
Figure 11. Results of microanalysis of the chemical composition of the Au electrode

On a diffractogram made in X-ray research from Au surface there are only diffraction lines originating from the gold planes with indicators (111), (200), (311) and (222) corresponding to the interplanar distances, respectively: $d = 2,35\text{\AA}$, $2,04\text{\AA}$, $1,44\text{\AA}$, $1,29\text{\AA}$ i $1,17\text{\AA}$ – Figure 12. However, quantitative microanalysis from micro-areas of the electrode surface made using EDX showed the presence of oxygen in the experiments micro-areas – Figure 10, 11, Table XX. The research results do not allow to determine the presence of raids layers on the surface of the electrode made of gold. The occurrence of oxygen in micro-areas on the surface of the electrode was found. This is the reason for the slight decrease in the amount of ozone produced. Due to the great ease of oxygen to form compounds, it can be assumed that in the micro-areas in which the presence of oxygen is revealed there are probably gold oxides ($\text{Au}_{0.6}\text{O}_{0.4}$, $\text{Au}_{0.78}\text{O}_{0.22}$) – Table 2, Figure 11.

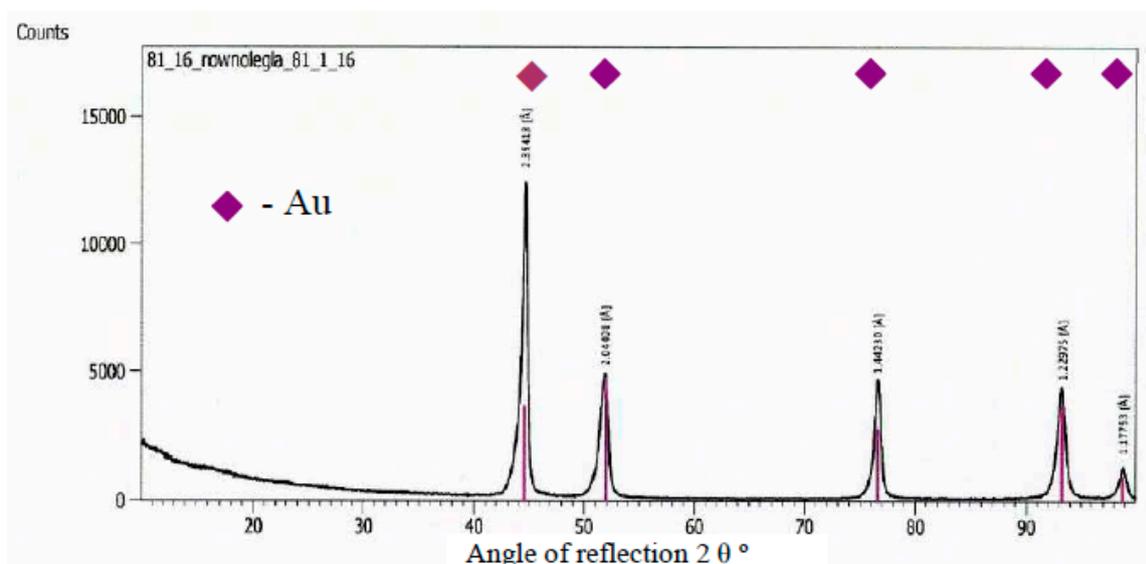
Figure 12. A diffractogram from the Au electrode surface
