Highly Molybdenum-Alloyed Materials Hastelloy BC-1 (2.4708) and B3 (2.4600): Diffusion Bonding Experiments and Evaluation of both Mechanical Behavior and Corrosion Resistance in hot 70 % Sulfuric Acid

Thomas Gietzelt*¹, Mario Walter², Volker Toth¹, Florian Messerschmidt¹, Ralf Dahm²

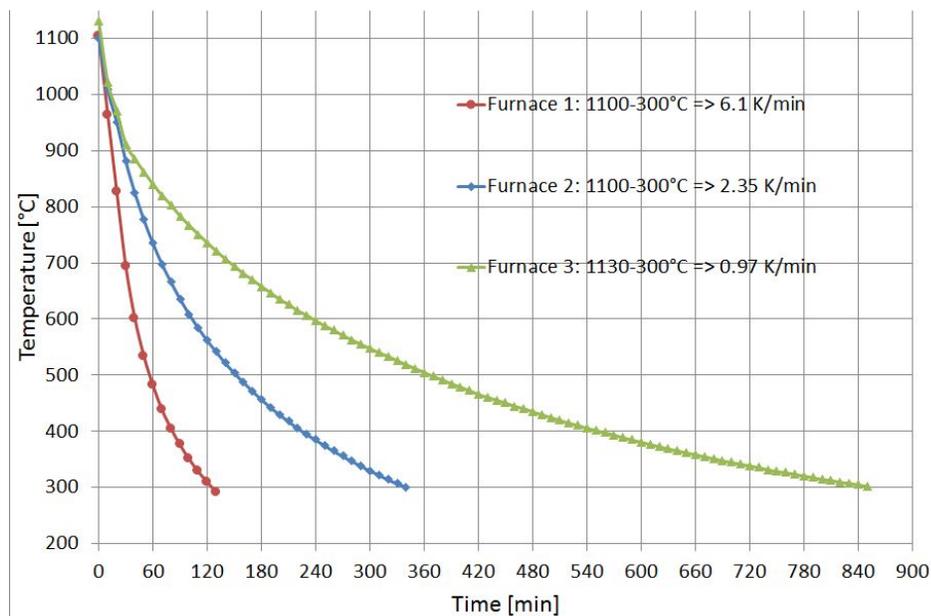
Fig. 1: Temperature profile of the used diffusion bonding furnaces

For the corrosion experiments, coupons of *Hastelloy B3* and *BC-1*, containing a TIG weld and made of 3 mm thick sheet metal, were provided by *HAYNES*. Using a disk cutter from *ATM*, type *Brillant 250*, pieces with a size of approximately 20 x 80 mm² and 40 g in weight were cut. One set of specimens was investigated in condition as delivered. A second set of specimens was placed inside a diffusion bonding furnace during a run to simulate a heat treatment. For this purpose, a temperature of $T = 1100^{\circ}\text{C}$ was applied for $t = 4$ h. Subsequently, the samples were cooled down in diffusion bonding furnace 2. Fig. 1 shows the cooling behavior of three diffusion bonding furnaces of different sizes with 20 kN, 200 kN and 2 MN compressive load, respectively, available at *IMVT*. It can be seen that the cooling rate of furnace 2 at approx. 600°C falls below 5 K/min,

what is half of the heating rate. This facilitates sensitization, especially with nickel-based alloys, which has an impact on corrosion behavior in aggressive media. [11, 12]

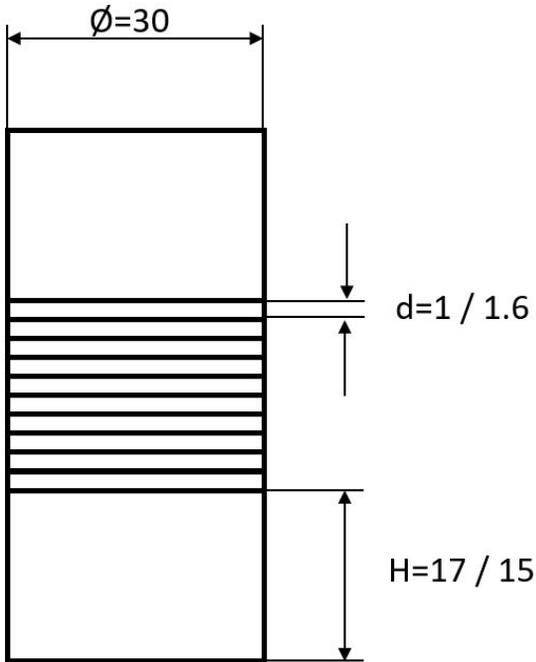
Fig. 2: Diffusion bonding samples used for preparing tensile test specimens.

Round stock of different diameters from both alloys was used to produce the initial material with a diameter of 30 mm by wire erosion. Additional, for both materials, ten disks, 30 mm in diameter, were cut by laser from sheet material. To ensure a reasonable initial height of the diffusion bonding specimens related to the preparation of tensile specimens, two pieces of round stock with a height

of 15 and 17 mm for *Hastelloy B3* and *Hastelloy BC-1*, respectively, were prepared. In between, ten layers of sheet material were stacked, giving an absolute height of 46 and 44 mm, respectively (Fig. 2).

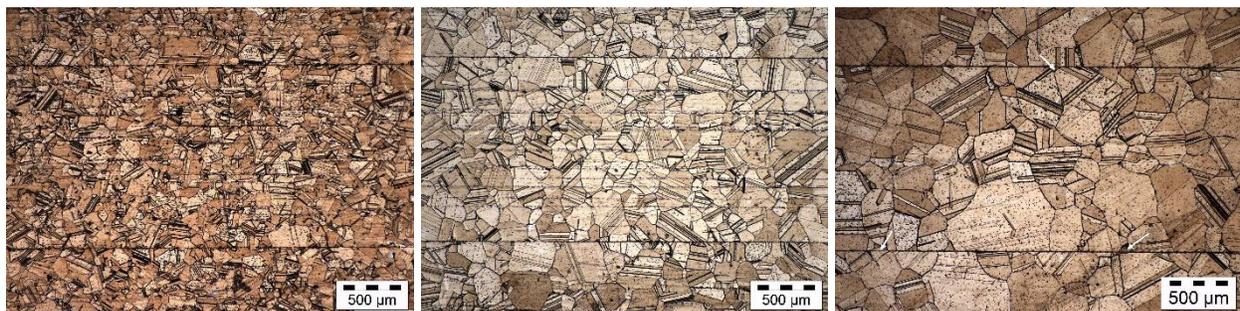
Fig. 3: Resulting microstructure of Hastelloy B3 after diffusion bonding for $t = 4$ h at $T = 1100^{\circ}\text{C}$ (left), 1150°C (middle) and 1200°C (right).

According to Fig. 3, the grain size for *Hastelloy B3* increases with increasing diffusion bonding temperature. At $T = 1100^{\circ}\text{C}$, some pores could be observed. Obviously, the surface pressure of $p = 14$ MPa was not sufficient. Probably due to passivation layers, even at $T = 1200^{\circ}\text{C}$, only the first signs of grain growth over the joining planes were visible.

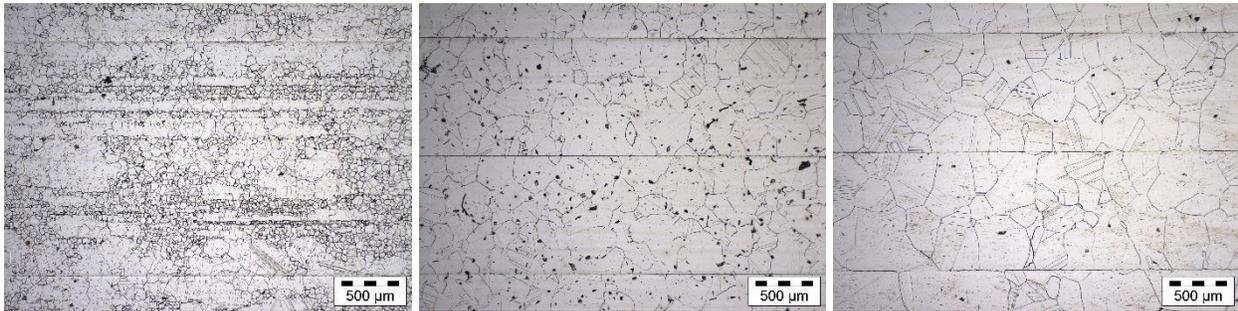
Fig. 4: Resulting microstructure of *Hastelloy BC-1* after diffusion bonding for $t = 4$ h at $T = 1100^{\circ}$ (left), 1150 (middle) and 1200°C (right)

In contrast, for *Hastelloy BC-1*, even for $T = 1100^{\circ}\text{C}$ grain growth across the bonding plane can be seen (Fig. 4, left). However, the microstructure shows strong discontinuous grain growth with a bimodal grain size distribution. For $T = 1200^{\circ}\text{C}$, strong grain growth was observed.

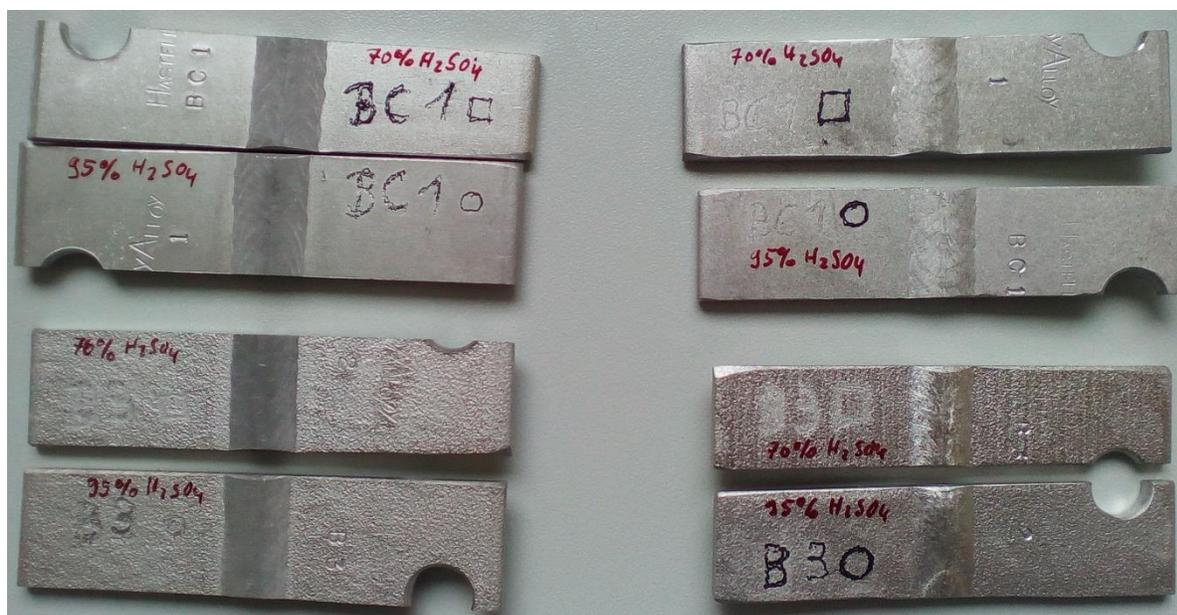
Fig. 5: Test specimens after corrosion tests. Left: Condition as delivered. Right: Heat-treated ($T = 1100^\circ\text{C}$, $t = 4$ h). Top: Hastelloy BC-1. Bottom: Hastelloy B3.

For corrosion tests, the specimens were placed on a bridge made of *PTFE* inside a beaker with a volume of 800 ml, filled with 500 ml of sulfuric acid. 70 % sulfuric acid was diluted from 95-95 % sulfuric acid supplied by *Merck*. The beakers were wrapped with rock wool and a lid made of *PTFE* was used for thermal insulation. A magnetic stirrer was placed under the *PTFE* bridge. A speed of 120 rpm was set for the stirrer. The beakers were controlled every week, however, no green color, due to dissolved nickel ions was observed.

70 % sulphuric acid is considered to be more corrosive than 95-97 % sulphuric acid because of its water content. Compared to the results obtained for the other four materials shown in Tab. 1, especially for the heat-treated condition, for *Hastelloy BC-1*, superior results were obtained. In Fig. 5 it can be seen that the surface of *Hastelloy BC-1* has remained almost unchanged, while the surface of *Hastelloy B3* shows some pitting attack.

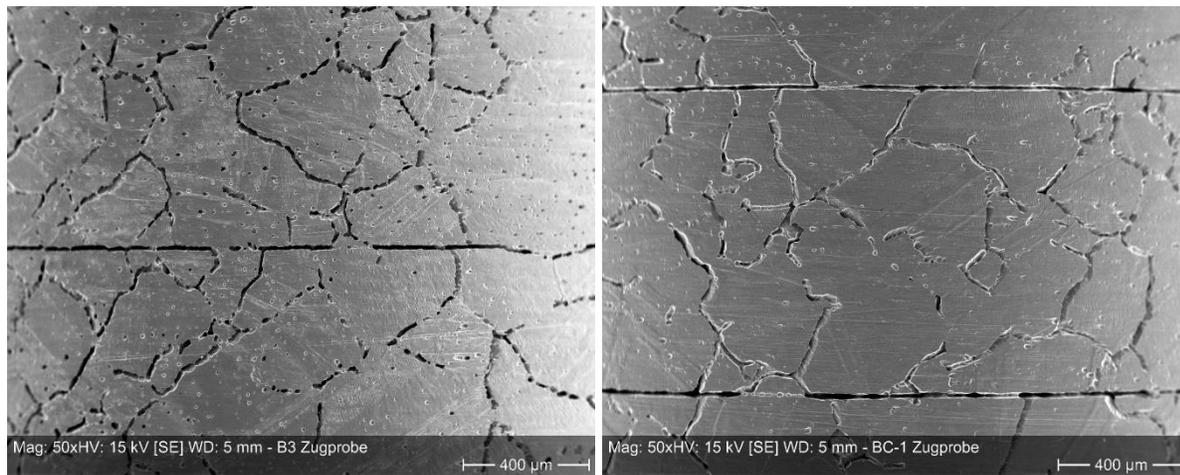
Fig. 6: Surface of tensile specimens from Hastelloy B3 (left) and Hastelloy BC-1 (right) after exposure to 70 % sulfuric acid at 100°C for 1000 h.

In a second series of tests, five diffusion bonded tensile specimens from *Hastelloy B3* and *BC-1*, respectively, were aged in 70 % sulphuric acid at 100°C for 1000 h to investigate the impact of corrosion on the mechanical properties. This is an important aspect in order to assess the integrity of micro process devices as a function of corrosion phenomena over lifetime. The corrosion traces of the SEM-pictures at the circumferential surface of both materials showed no strong differences (Fig. 6). There is some corrosion attack at grain boundaries. Only a few grain growth across the bonding plane could be observed. Instead, pronounced decoration by corrosion of original bonding

planes was observed. Probably, the deformation of approximately 2 % and eleven bonding planes is not sufficiently to level surface roughness and to break passivation layers

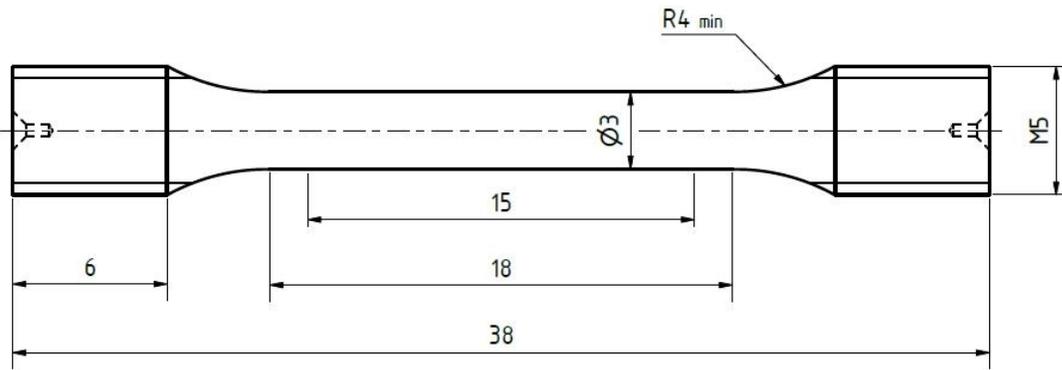
Fig. 7: Geometry of the tensile specimens

The geometry of tensile test specimens is shown in Fig. 7. Tensile tests were performed displacement controlled ($dl/dt = 2$ mm/min) at RT (room temperature) using an universal testing machine from *Instron* (type 4505), equipped with a controller unit from *Doli*. In order to take into account scatter issues, five tests per treatment condition were carried out.

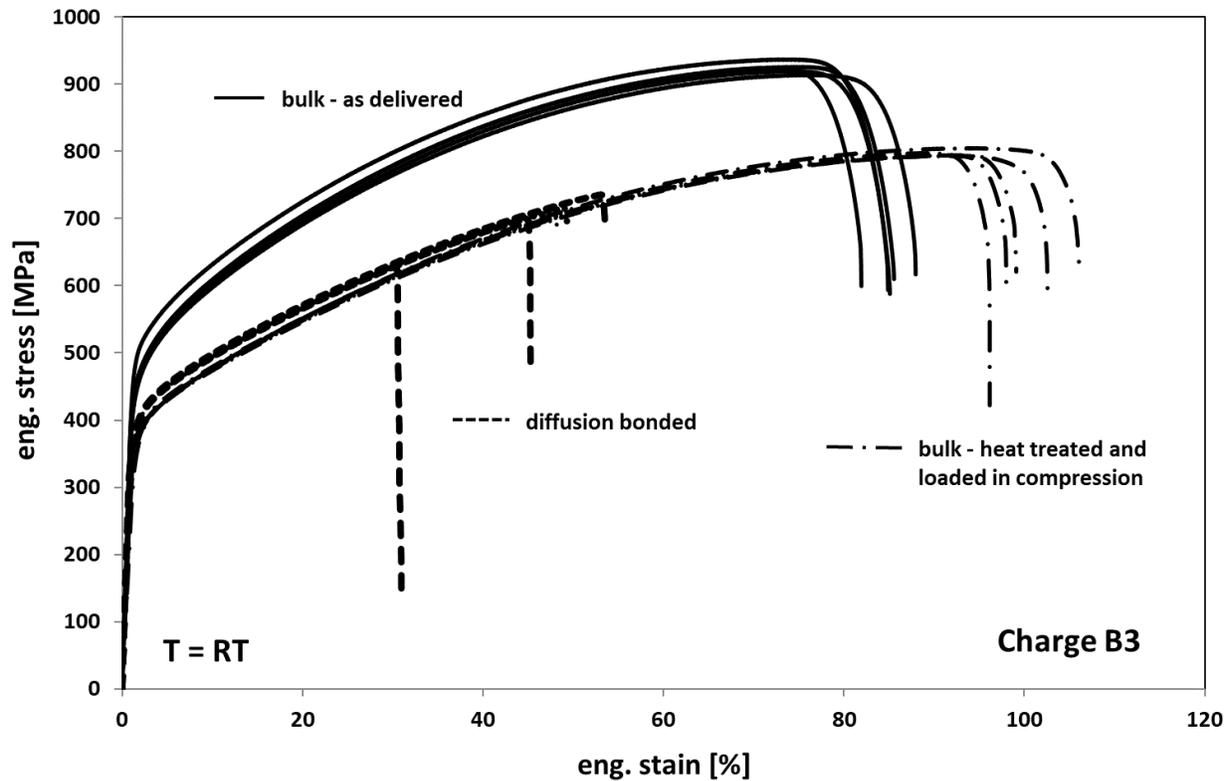
Fig. 8: Tensile response of Hastelloy B3 in different conditions

In Fig. 8, the results of the tests on as delivered-, heat-treated and compressed- and diffusion bonded samples are depicted. When comparing the as delivered condition of bulk material with the heat-treated condition it can be seen, that the annealed samples show a decrease in strength of about 20 to 25 % and an increase in ductility of about 20 %. Accordingly, the annealed material reveals a slightly less pronounced hardening behavior. The change in deformation behavior can be generally traced back on both recovery and recrystallization/grain growth processes (compare Fig. 3 and Fig. 4) occurring during tempering.

Compared to the heat-treated bulk samples, the diffusion bonded samples exhibit a comparable deformation behavior but a significant decrease in elongation at fracture of about 50 % on average. The earlier onset of failure is obviously a result of several weak spots within the bonding planes in the form of non-bonded areas that act as cracks.

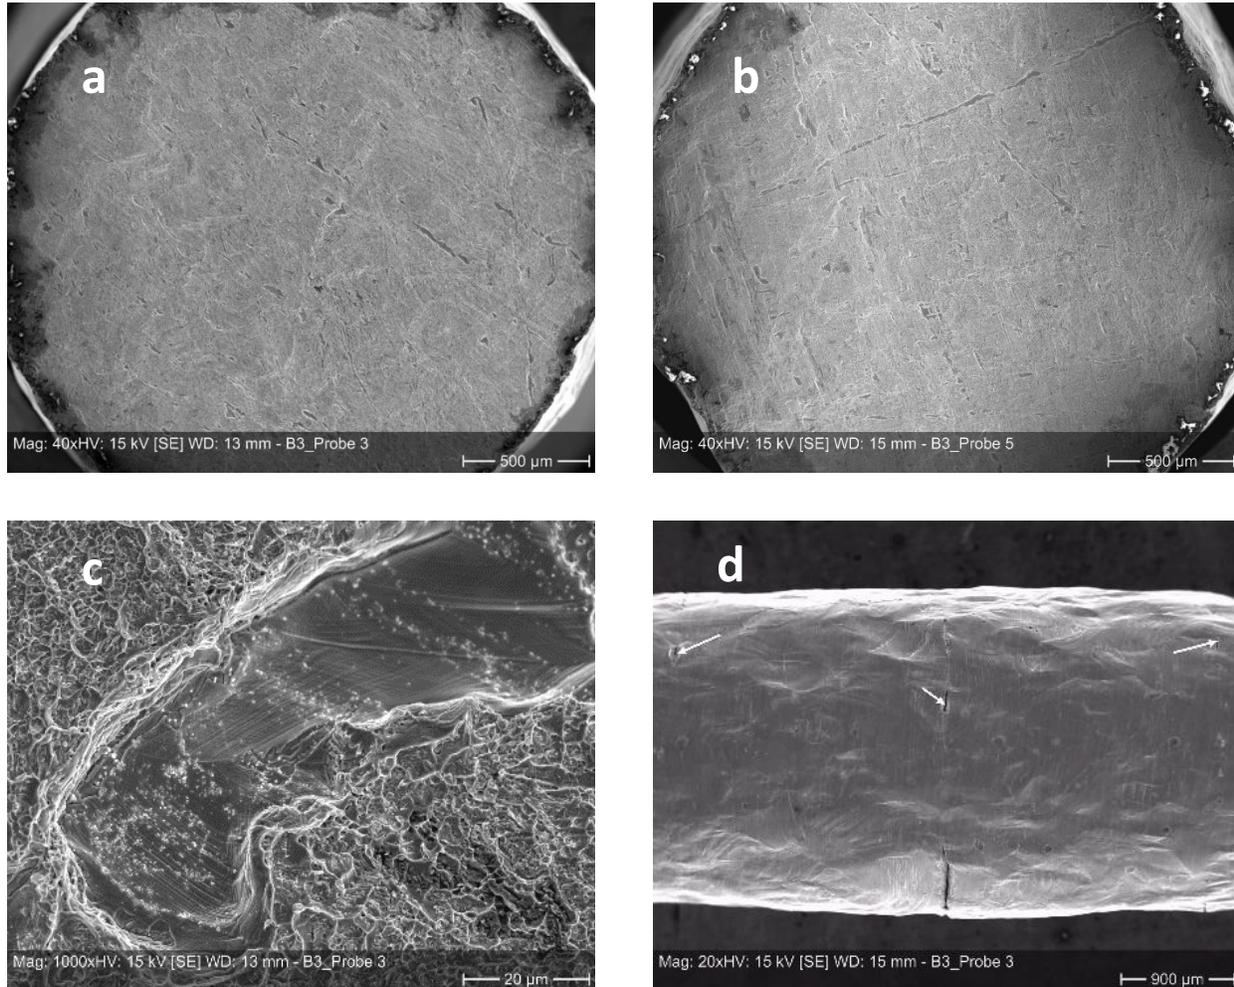
Fig. 9: Micrographs of tensile tested diffusion bonded samples – a and b: overview of fracture surfaces, c: ductile fracture area surrounding a weak spot and d: small surface cracks located at different bonding planes

Examples of such weak spots based on scratches or dents etc. on the individual sheets are shown in Fig. 9. In Fig. 9a and Fig. 9b one can see an overview of fracture surfaces exhibiting a multitude of weak spots. When comparing both micrographs it becomes clear, that the high scatter of the elongation at fracture values is related to the entire size of the non-bonded areas, lowering the real load bearing cross-sections. While sample 5, depicted in Fig. 9b, reveals an elongation at fracture of approximately 30 %, sample 3, depicted in Fig. 9a, reveals an elongation at fracture of almost 50 %. A closer view on a fracture surface (Fig. 9c) is manifesting the general ductile nature of failure within well bonded sections in form of dimples, here, surrounding a weak spot. Non-bonded areas are also located at the surface of a sample. Accordingly, with increasing deformation the occurrence of smaller surface cracks is visible in several bonding planes (Fig. 9d).

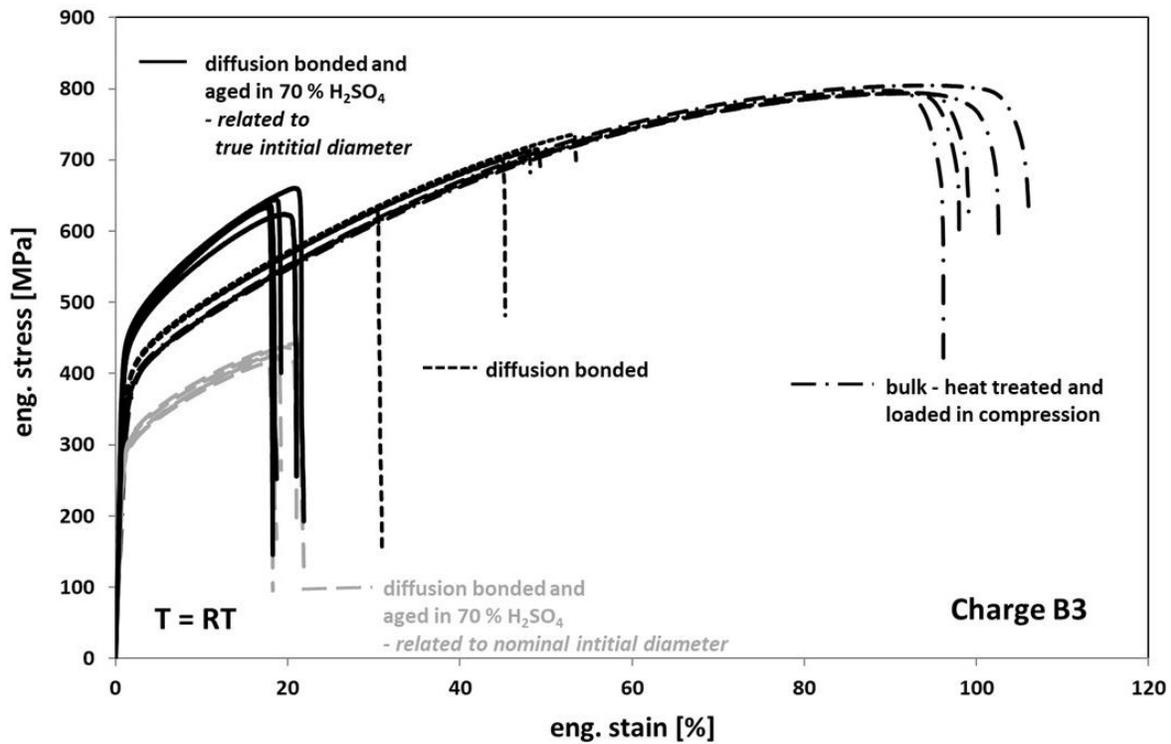
Fig. 10: Tensile response of Hastelloy B3 in different conditions

When comparing the tensile test results obtained from tests on diffusion bonded samples, aged for 1000 h at 100°C in 70 % H₂SO₄ with the results obtained on non-aged bonded samples (Fig. 10), one can see a further strong decrease of the elongation at fracture to an average value of about 20 %. Additionally, the stress level also significantly decreased (Fig. 10, interrupted grey deformation curves). However, this finding is based on the fact, that the stress calculation of the engineering stress is usually related to the nominal initial cross-section. De facto, based on a much stronger corrosive attack into the volume than expected when viewing Fig. 6 left, a real initial cross-section after aging is much smaller as one can see in Fig. 11. Accordingly, by determining the average depth of the corrosion cracks inside the failed bonding planes, the initial cross-sections and

subsequently the stresses were re-calculated. Now, the stress level of aged samples is significantly higher than the one of non-aged samples (Fig. 10, black deformation curves). This might be related to the formation of an inhomogeneous distributed multi-axial stress-strain-field during loading – see Fig. 11c, concave shaped surface between the bonding planes. The pronounced notch effect and the resulting stress concentrations can also explain the decrease of the elongation at fracture values.

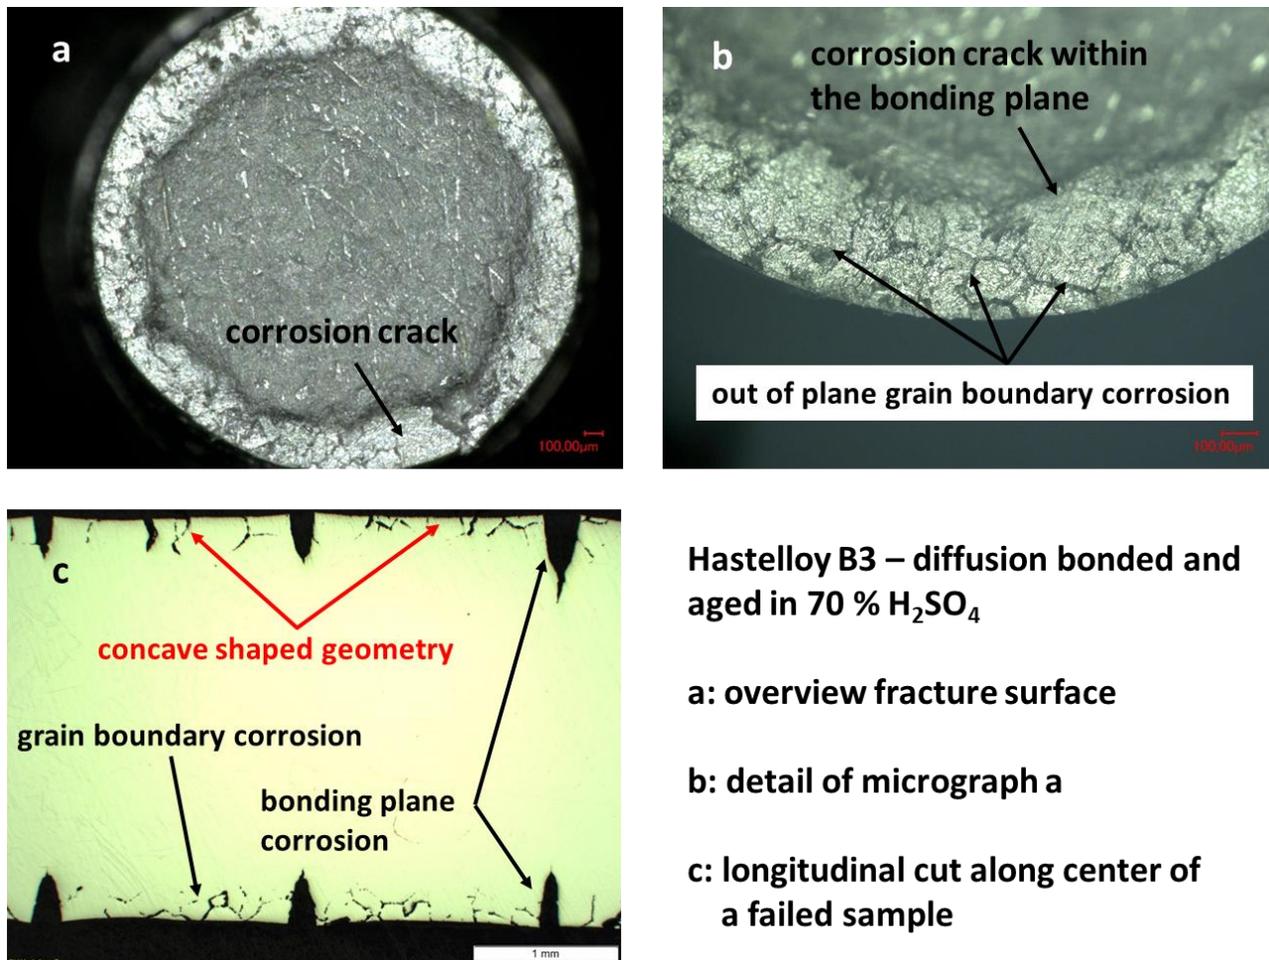
Fig. 11: Micrographs of tensile tested diffusion bonded and aged (1000 h at 100°C in 70 % H₂SO₄) samples

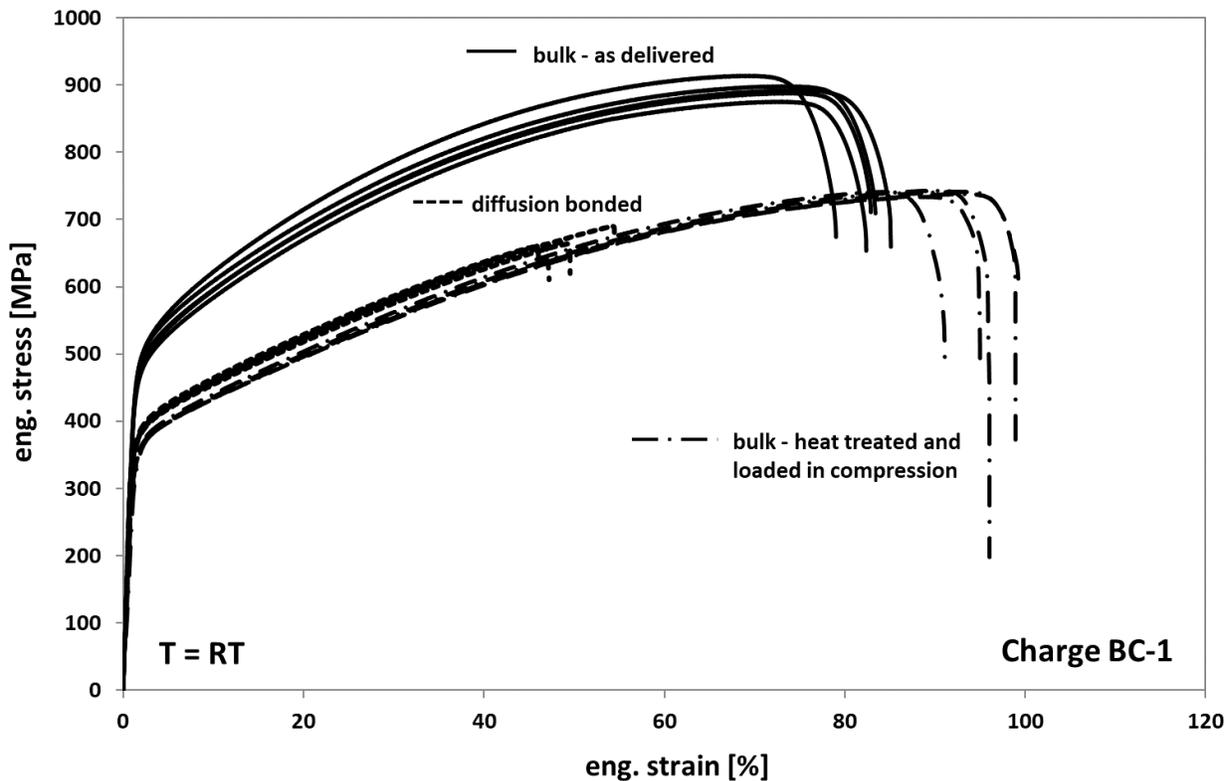
Fig. 12: Tensile response of Hastelloy BC-1 in different conditions

Generally, it is observed that the mechanical behavior of *Hastelloy BC-1* in tension is comparable to that of *Hastelloy B3*. Only the strength of *Hastelloy B3* is found to be slightly higher in all comparable conditions than the one of *BC-1*. In Fig. 12, the results of the tests on as delivered-, heat-treated- and diffusion bonded samples are presented. When comparing the as delivered condition of bulk material from *Hastelloy BC-1* with the heat-treated condition it can be seen, that the annealed and compressed samples also show a decrease in strength of about 25 % and an increase in ductility of about 20 %. The change in deformation behavior can be again traced back on both recovery and recrystallization/grain growth processes occurring during tempering.

Compared to the heat-treated bulk samples, the diffusion bonded samples also exhibit a comparable deformation behavior and a significant decrease in elongation at fracture of about 45 to 50 %. However, the scatter of the elongation at fracture values is clearly lower, indicating a more homogeneous distribution of weak spots and/or a lower variation of the entire size of non-bonded areas within the different bonding planes.

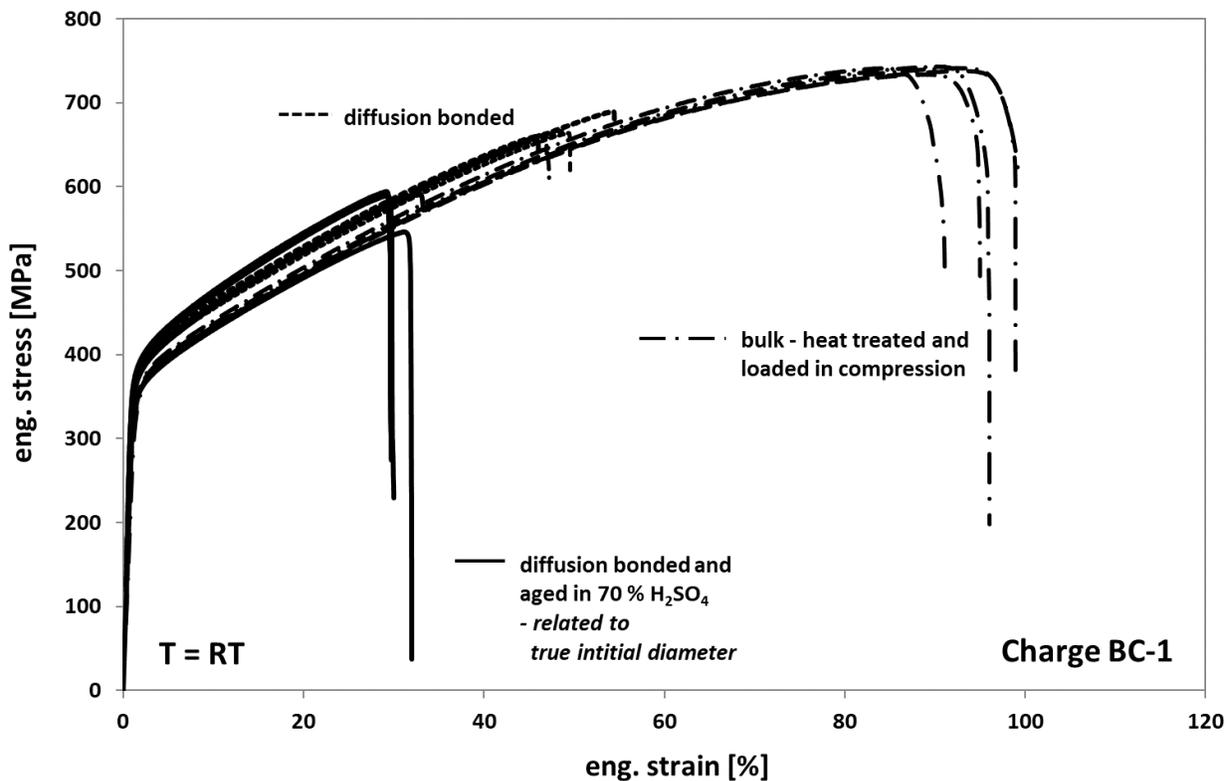
Fig. 13: Tensile response of *Hastelloy BC-1* in different conditions

When comparing the tensile test results of *Hastelloy BC-1* obtained from tests on diffusion bonded samples, aged for 1000 h at 100°C in 70 % H₂SO₄ to non-aged diffusion bonded samples (Fig. 13), one can see a strong decrease of the elongation at fracture to 30 %. However, this is approximately 10 % more than for *Hastelloy B3* (Fig. 10). For *Hastelloy BC-1*, in contrast to *Hastelloy B3*, the

stress level of the aged samples is comparable to the non-aged samples. This behavior is obviously related to a less pronounced formation of an inhomogeneous distributed multiaxial stress-strain-field during loading, since the size of the corrosion cracks within the bonding planes is significant smaller compared to the sizes observed in *Hastelloy B3* – compare Fig. 11a and c with Fig. 14a and c. The much better corrosion resistance of *Hastelloy BC-1* and the resulting low corrosion crack depths might reduce the effect of stress concentrations around the crack tips on the entire in plane stress distribution. As a result, related to *Hastelloy B3*, the onset of failure is shifted towards higher elongation at fracture values.

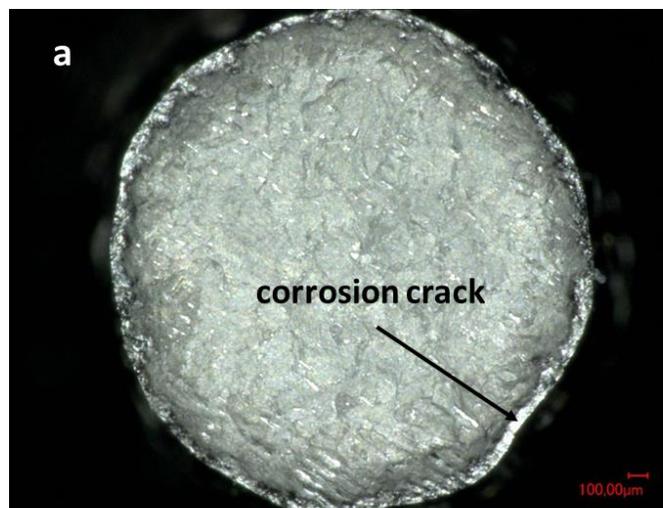
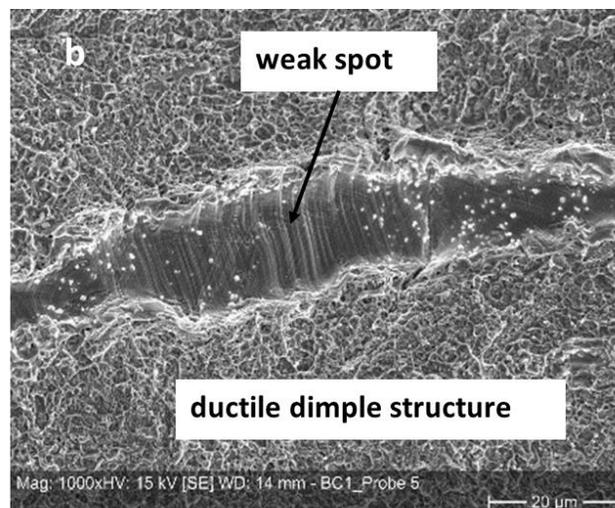
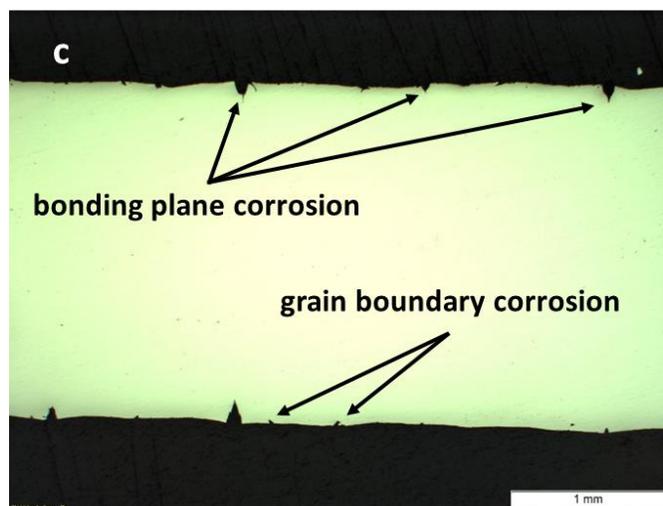
Hastelloy BC-1 – diffusion bonded and aged in 70 % H₂SO₄

a: overview fracture surface

b: fracture surface - ductile fracture area surrounding a weak spot

c: longitudinal cut along center of a failed sample

Fig. 14: Micrographs of tensile tested diffusion bonded and aged (1000 h at 100°C in 70 % H₂SO₄) samples

The fracture mode of all samples is also found to be ductile, at least in well bonded areas, but in contrast to *Hastelloy B3*, the dimples reveal a significant smaller size (compare Fig. 9c and Fig. 14b). In addition, identical to *Hastelloy B3*, small surface cracks in several other bonding planes are observed as already shown in Fig. 9d.
