# Active Confinement of Masonry Walls with Stainless Steel Straps: The Effect of Strap Arrangement on the in-Plane Behavior of Strength, Poisson's Ratio and Pseudo-Ductility

Keywords: masonry walls; CAM&reg; System; shear behavior; reinforcement arrangement; diagonal compression test; pseudo-ductility; anisotropy; elastic moduli; Poisson's ratio.

**Abstract:** Among all the active confinement techniques, the use of pre-tensioned stainless steel straps has recently gained much attention. The flexibility of the stainless steel straps allows us to bend and pass them through the thickness of the masonry, thus creating a three-dimensional strengthening system between the two opposite facings. The use of the same perforation for the passage of several straps closed in a loop generates a continuous strengthening system that prevents parts of the structure from falling and injuring the occupants during seismic events. However, the perforations can nullify the in-plane strengthening, as they act as cylindrical hinges and make the reinforcement system labile for certain strap arrangements. Diagonal compression tests on square masonry panels performed in the present study show that the stra

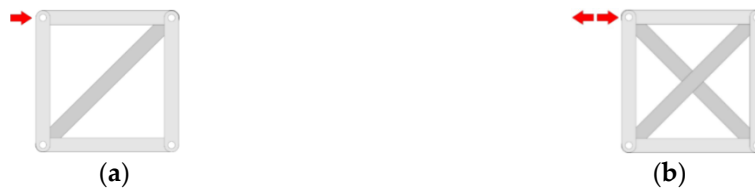
**Figure 4.** Bracing of a rectangle made of hinged strips: (a) By adding a strip along a diagonal, which will prevent the rectangle from collapsing in the direction of the red arrow but not in the opposite direction; (b) By adding strips along both diagonals, which will prevent the rectangle from collapsing in either direction.

In rectangular frame structures, it is customary to cancel the horizontal displacement of the hinged nodes by bracing the structures along one or both diagonals, as shown in the simplified mechanical models of Figure 4(a) and (Figure 4(b), respectively.

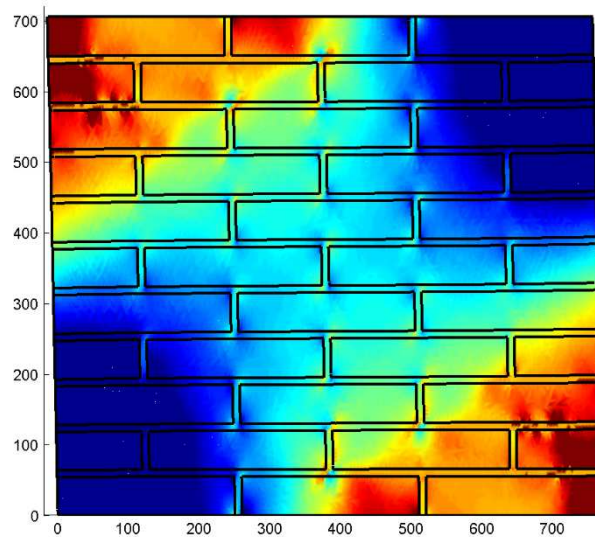
**Figure 6.** Vertical stresses and deformed configuration in a masonry wallette subjected to shear-compression testing [39] (shear load directed towards the left).

In the case of a test carried out in the laboratory, the apparatus for transmitting the shear load consists of a steel beam, made integral with the upper side of the specimen. Since the shear load causes the top face of the specimen to rotate about the center of the specimen, the vertical displacement constraint at the top nodes gives rise to positive and negative normal stresses along the specimen-steel beam interface (top side in Figure 6).

This causes detachments in the tensioned portion of the interface, as the interface bond is unable to withstand the tensile stresses. Since the detachments modify the transmission of forces from the steel beam to the specimen, this experimental method does not allow replicating the desired static scheme. Figures 32-34 of Reference [39] show the difference between the desired static scheme and the static scheme corresponding to the shear-compression test performed in the laboratory.

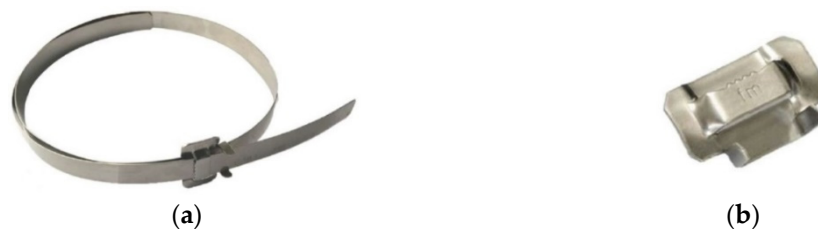
**Figure 11.** The elements of the active strengthening system: (a) A stainless steel strap closed to form a ring (before tightening the seal); (b) A stainless steel seal used for the strap ring closure.

The active strengthening system consists of the ring closure of stainless steel straps 16 mm wide and 0.9 mm thick, using folding seals (also made of stainless steel) for pre-tensioned closure. The straps (Figure 11(a)) and seals (Figure 11(b)) used in this experimental program are not of the same type patented with the CAM® System. Table 4 collects the mechanical properties declared by the manufacturer (Mauser) for the rolls of stainless steel straps.

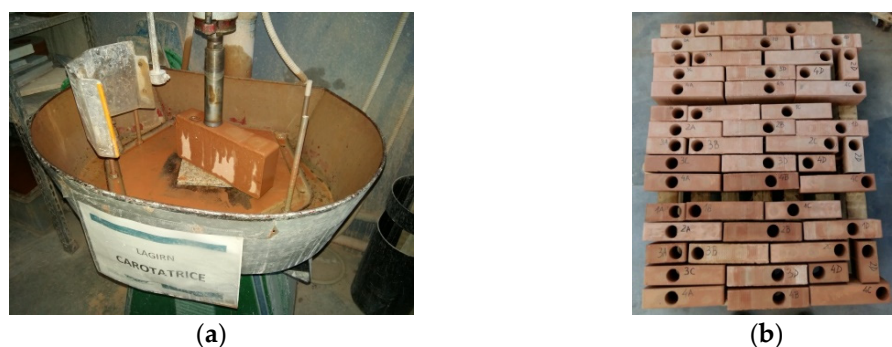
**Figure 17.** Preparatory stages for laying bricks: (a) Core drilling of a brick; (b) Drying of bricks after core drilling.

To avoid problems of overturning of the masonry specimens during the coring operations for the passage of the straps, core drilling took place on the individual brick units, before assembling them (Figure 17(a)). Figure 17(b) shows the hollow bricks left to dry after the coring operations.

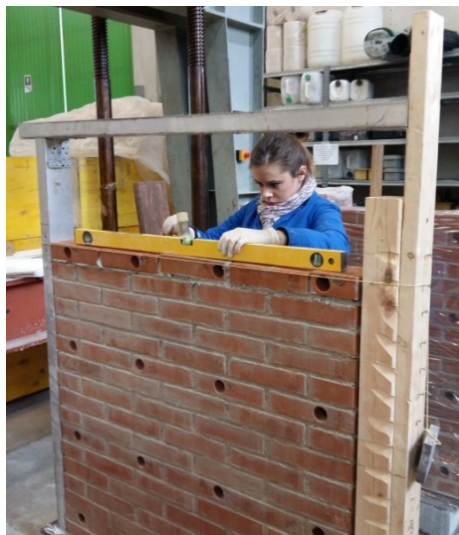
**Figure 18.** Equipment used for the correct laying of bricks.

The laying of the bricks took place in accordance with the UNI EN 1015-2:2007 standard [55], which recommends mixing the mortar with 15% water. The use of a plumb guide frame, leveling strings and a spirit level helped to check the verticality of the walls and the horizontality of each course of bricks (Figure 18).

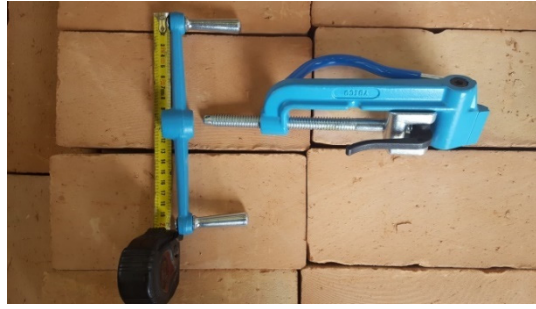
**Figure 19.** Barbero Mauser strapping system for stainless steel strapping: Model B05.T000S262.

The strapping machine used to close the seals is a product for manual use, by Barbero Mauser brand (Figure 19). When tightening the seals, it allows the application of a pre-tension of up to a maximum of 1.4 kN to the straps. This generates a pre-tension equal to approximately 40% the tensile strength shown in Figure 12 (cross-section dimensions: 16 × 0.9 mm).

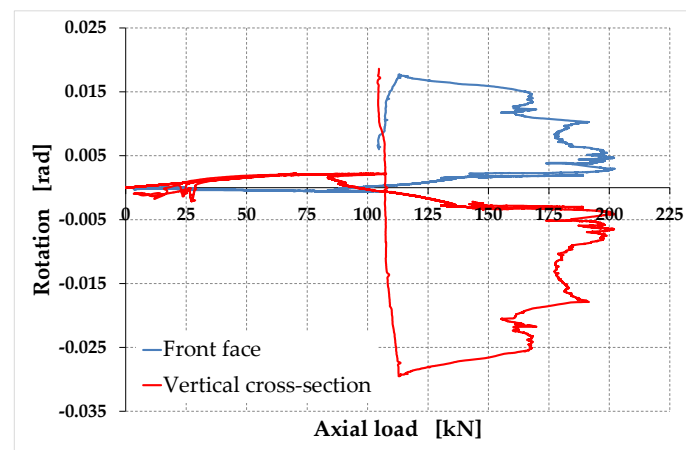
**Figure 23.** Rotations undergone by Specimen M2-45: positive values indicate anti-clockwise rotations on the front face and on the vertical cross-section, seen from the left side.

Figures 22 and 23 relate  $\varphi_p$  and  $\varphi_c$  to the axial load. This allows us to appreciate the variation in the rotations at each load drop and during the long phase following the maximum load (softening branches of Figure 21).

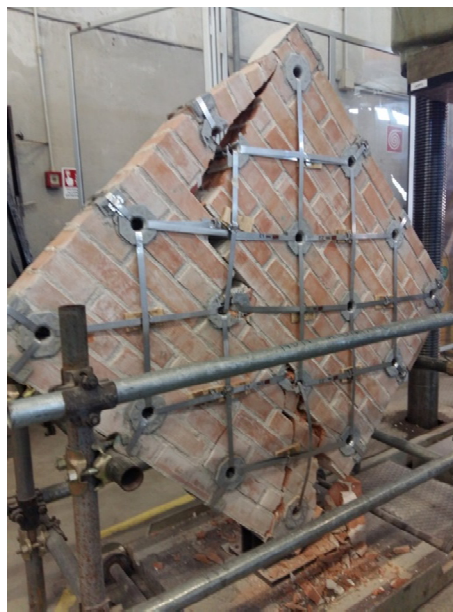
**Figure 27.** Failure mode of Specimen M2-45.

- No primary cracks opened along the compressed diagonal;
- The maximum load (202 kN) is increased by 30% compared to the maximum load of Specimen M1-45 (155 kN);
- The high load values and the lack of cracks along the compressed diagonal meant that the failure occurred due to a combination of the punching effect of the load heads and boundary effects (Figure 27).

In the final stages of the test, a bed joint also partially failed (Figure 27). Since this only occurred at the end of the test, it is a secondary effect caused by the primary mechanism described above. Despite the high degree of damage at the end of the test, the strapping system turned out to be only partially damaged and still able to withstand loads.

This test also resulted in the breaking of some funnel plates (Figure 27). As already noted in [36], this suggests that the maximum load could increase further by replacing the 3D printed plates with metal rings [35].

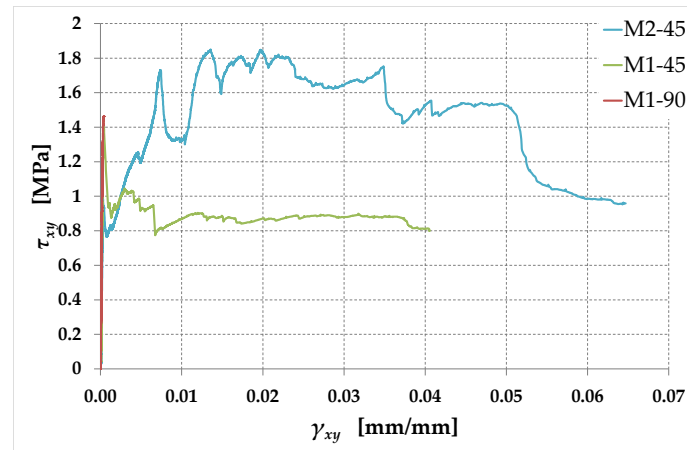
Figure 29. Shear stress/shear strain curves for the tested specimens.

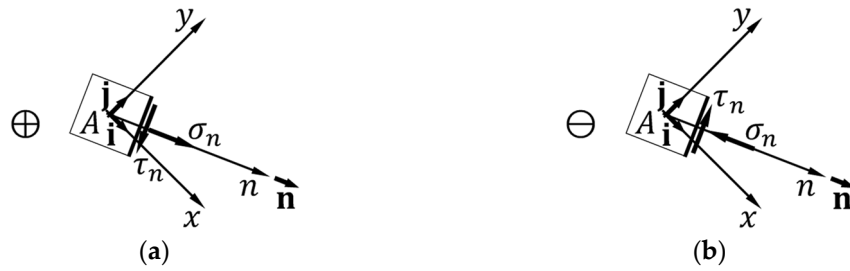
**Figure A3.** Stress components acting on the plane with unit normal vector  $\mathbf{n}$  (the plane perpendicular to the outward-pointing line  $n$ ) in the reference frame of Figure A1: (a) For normal and shear stresses that are positive in the Mohr plane; (b) For normal and shear stresses that are negative in the Mohr plane.
