Incidental Findings Following Dental Implants Procedures in Mandible: A New Post-Processing CBCT Software Analysis

Abstract: Background/Objectives: To evaluate incidental findings in the mandible after the placement of dental implants using a new cone-beam computed tomography (CBCT) software. **Methods:** The initial sample consisted of 2,872 CBCT scans of patients of both sexes. The parameters evaluated in this study were the location of the implants in the mandible, implant length, anatomical relationship of the implant with the mandibular canal, presence or absence of damage to the adjacent teeth, presence or absence of implant fractures, and presence or absence of bone support. Fisher's exact test was performed to compare the variables. The significance level was set at $p = 0.05$. **Results:** Out of 2,872 CBCT scans, 214 images of patients with an average age of 44.5 years were included. The most frequent location of the implants was the posterior region (93.5%), with 54% of the implants having a length between 9 and 14 mm. It was found that 92% of the implants were positioned above the mandibular canal. Three damage to adjacent teeth was observed, with no correlation with t

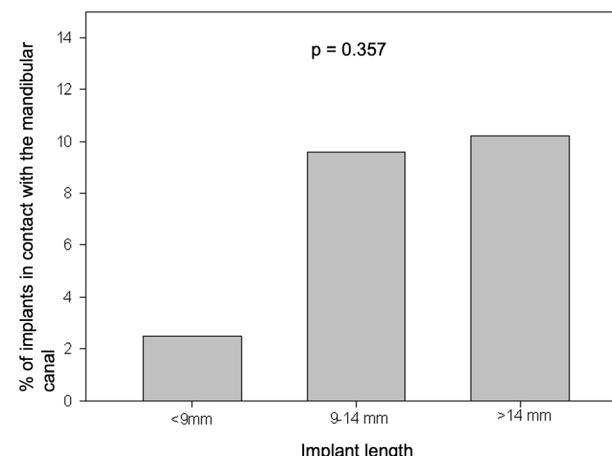
Among implants with a length of less than 9 mm, 1 (2.5%) had contact with the mandibular canal. For implants with a length between 9 mm and 14 mm, 11 (9.6%) showed contact with the mandibular canal, while for implants longer than 14 mm, 6 (10.2%) also had contact with the mandibular canal. There was no observed association between implant length and invasion of the mandibular canal ($p = 0.357$) (Figure 1).

Figure 1. Relationship between implant length and number (%) of implants in contact with the mandibular canal.

The present study did not identify a statistically significant relationship between implant length and invasion of the mandibular canal ($p > 0.05$), consistent with the findings of Safi et al. [21]. The relationship between implant dimensions and success rates remains controversial in the literature. Although a higher number of failures is often associated with short and narrow implants, it cannot be asserted that these dimensions are the primary factors responsible for low implant survival rates [13].

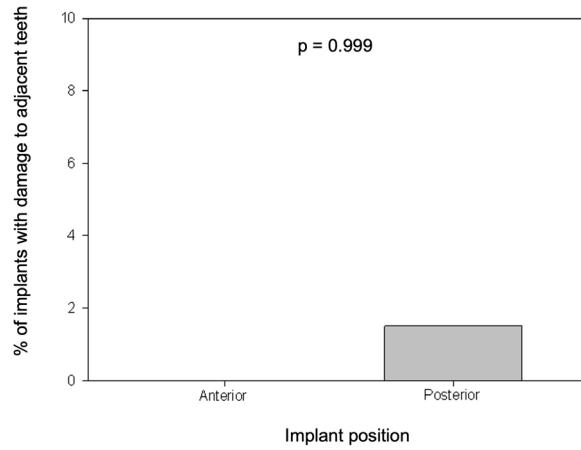
None of the implants installed in the anterior region caused damage to adjacent teeth, while 3 (1.5%) of the implants in the posterior region resulted in damage to adjacent teeth. There was no statistically significant difference found between teeth with damage and the implant position ($p = 0.999$) (Figure 2).

Figure 2. Relationship between implant positioning and number (%) of implants with damage to adjacent teeth.

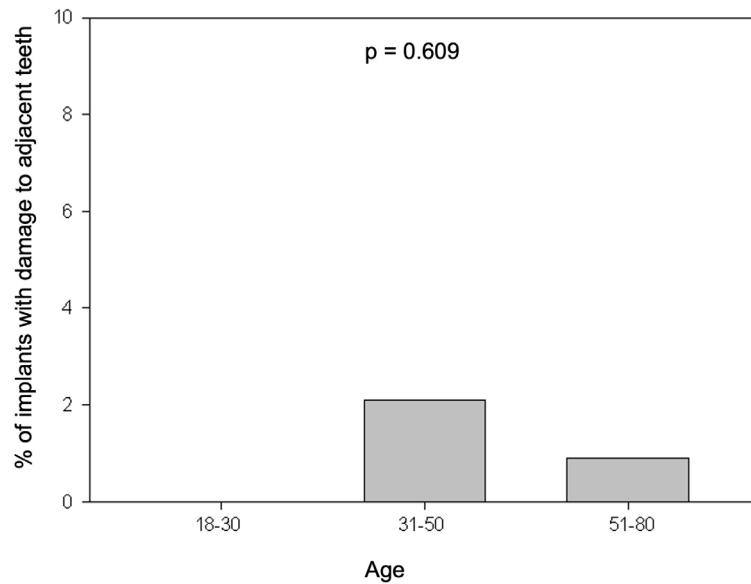
None of the implants performed on patients aged 18 to 30 years caused damage to adjacent teeth. Among implants performed on patients aged 31 to 50 years, 2 (2.1%) resulted in damage, while among those performed on patients aged 51 to 80 years, 1 (0.9%) caused damage to adjacent teeth. There was no statistically significant difference found between the groups ($p = 0.609$) (Figure 3).

Figure 3. Relationship between age and number (%) of implants with damage to adjacent teeth.

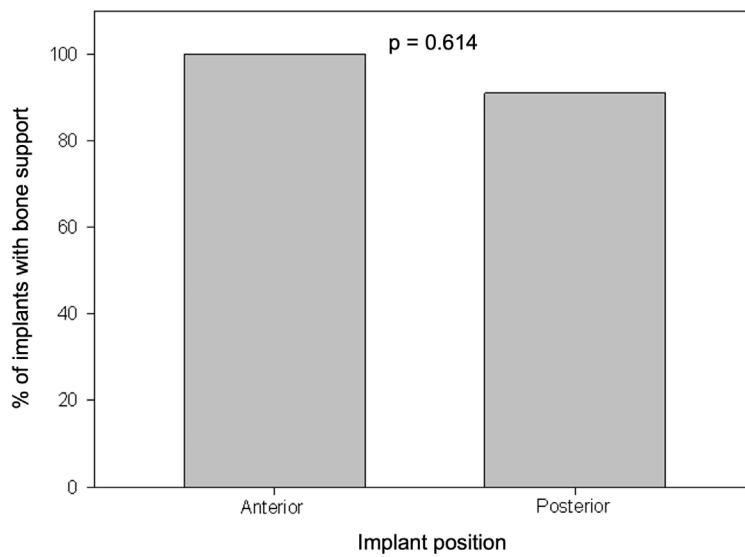
All anterior implants (100%) had bone support, while among posterior implants, 91% had bone support, with no statistically significant difference between them ($p = 0.614$) (Figure 4).

Figure 4. Relationship between implant positioning and number (%) of implants with bone support.

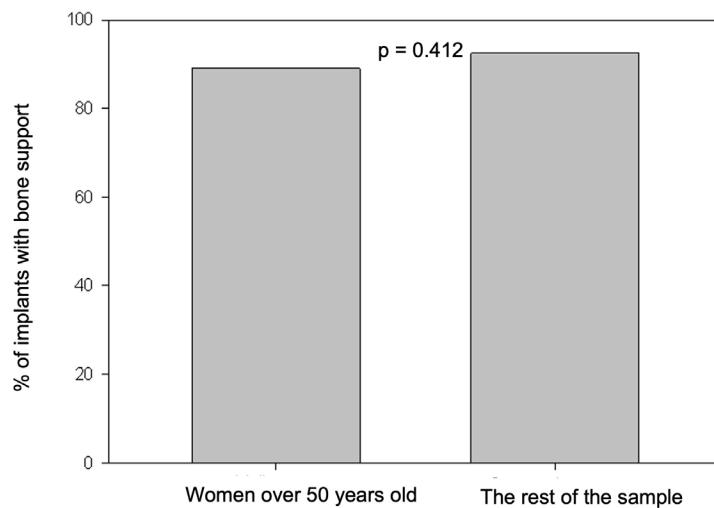
Among women over 51 years old, 49 (89.1%) had bone support for the implant, while in other age groups, bone support was observed in 147 (92.5%). There was no statistically significant difference found between the two groups ($p = 0.412$) (Figure 5).

Figure 5. Relationship between sex, age, and number (%) of implants with bone support.

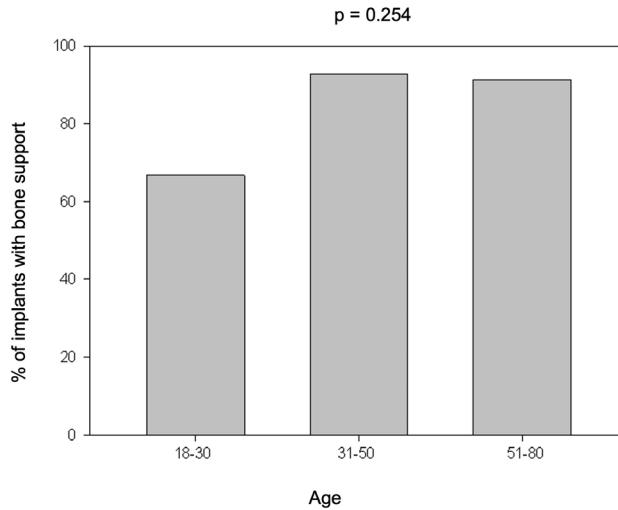
There was no statistically significant difference in bone support among age groups ($p = 0.254$). Among patients aged 18 to 30 years, 66.7% had bone support for the implant, in the age group of 31 to 50 years, 92.7% exhibited bone support, and among patients aged 51 to 80 years, 91.3% (Figure 6).

Figure 6. Relationship between age and number (%) of implants with bone support.

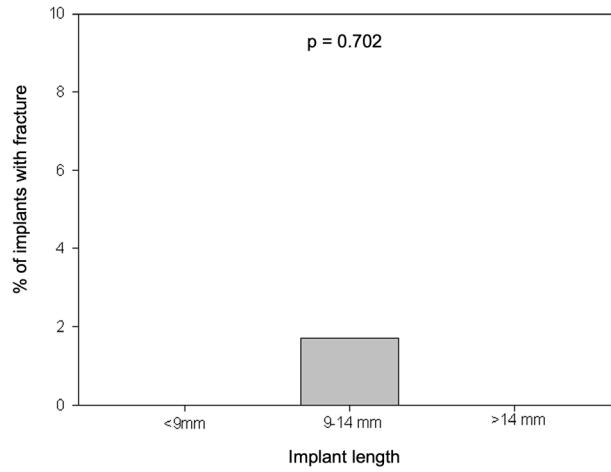
No fractures were observed in implants with lengths less than 9 mm or greater than 14 mm. However, among implants with lengths between 9 mm and 14 mm, 2 (1.7%) fractures were found. There was no statistically significant relationship between implant length and occurrence of fractures ($p = 0.702$) (Figure 7).

Figure 7. Relationship between implant length and number (%) of implants with fracture.
